VEHICLE DAMAGE INSPECTION REPORT

Handling Insurer:	Sompo Insurance Singapore Pte. Ltd.	Policy No:	D18MTPV01017118
Claimant Vehicle No :	SLA6307D	Insured Vehicle No :	SKC8661T
Date of Loss:	07/11/2018	Nature of Claim:	TP
		Claim No:	CMTD1804890

Reg No:	SLA6307D	Engine No:	L13Z11042462
Make & Model:	HONDA JAZZ, 1.3 (A)	Chassis No:	JHMGE67509S242426
Reg. Date:	30/06/2010 (Man. Year: 2009)	Odometer:	165966 km
Colour:	Blue		
Engine Capacity:	1339 cc		
Market Value/New Car Price:	N/A		
Sum Insured (S\$):	Market Value/New Car Price

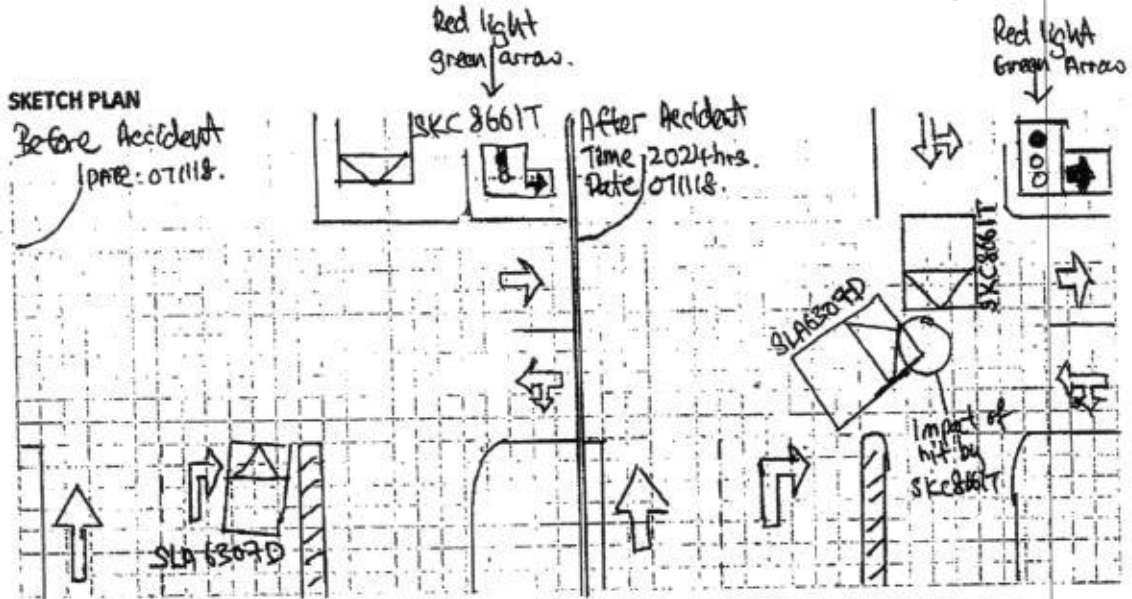
Sketch Plan #2 Pg. 1

On 07/11/18 at about 2024hrs, I was driving SLA6307D along Upper Changi Road North heading towards Tanah Merah Besar Road to drop off my friends. I was at traffic light junction waiting for green arrow to turn right into Tanah Merah Besar Road. Traffic was in Red and when the green arrow for turning right appear, I proceed to turn right. While I was turning right, I received an oncoming vehicle SKC8661T moving towards my direction. I immediate stopped my car but ~~SKC8661T~~ SKC8661T did not stop and proceed and collided into my car right hand front. There are huge damage to my right hand front vehicle and my vehicle door have problem opening.
