SKV 5053T

Triple H Automotive

VEHICLE DAMAGE INSPECTION REPORT

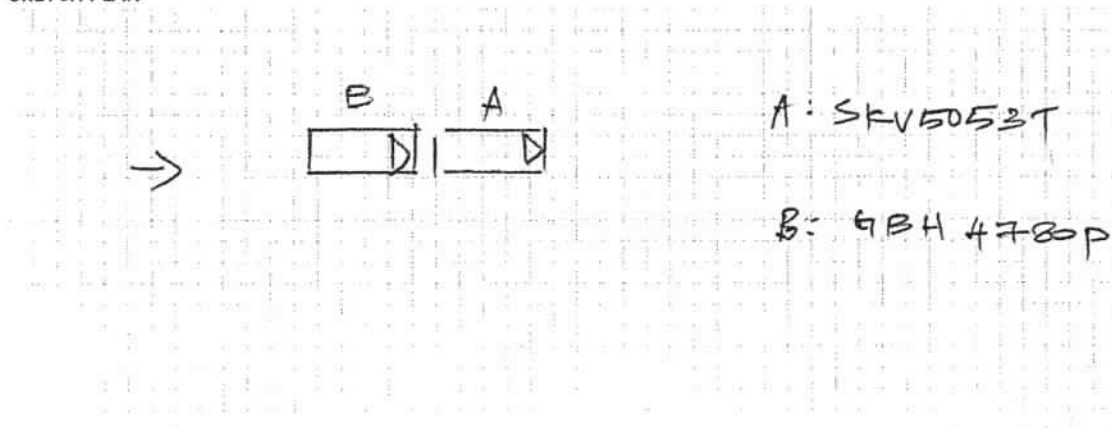
SKETCH PLAN

I was driving along the straight road. The car in front slow down, so I slow down, the lorry came from behind at a very high speed from quite a distance and ran into me. The impact is so hard I hit my head. I called for an ambulance and police came shortly after.
