VEHICLE DAMAGE INSPECTION REPORT

Claimant Vehicle No : FBF2734Y

**ACCIDENT INVOLVING FBF 2734Y & SHB 4073H ALONG TAMPINES CENTRAL 1 ON
 28 JULY 2018**

ADJUSTMENT ON REPAIR COST FOR VEHICLE NO. FBF 2734Y

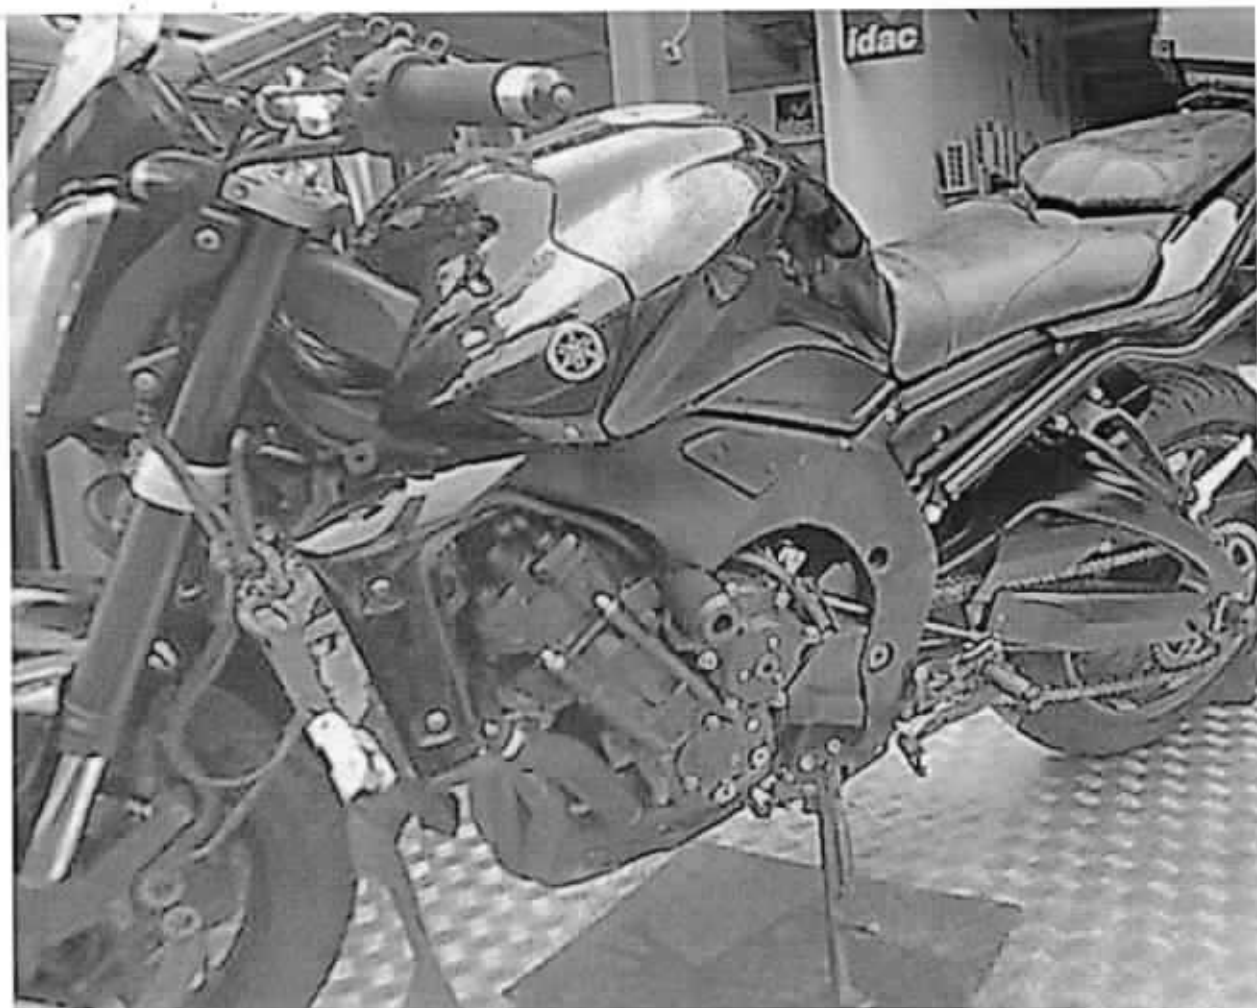
TP's nature and extent of damage :

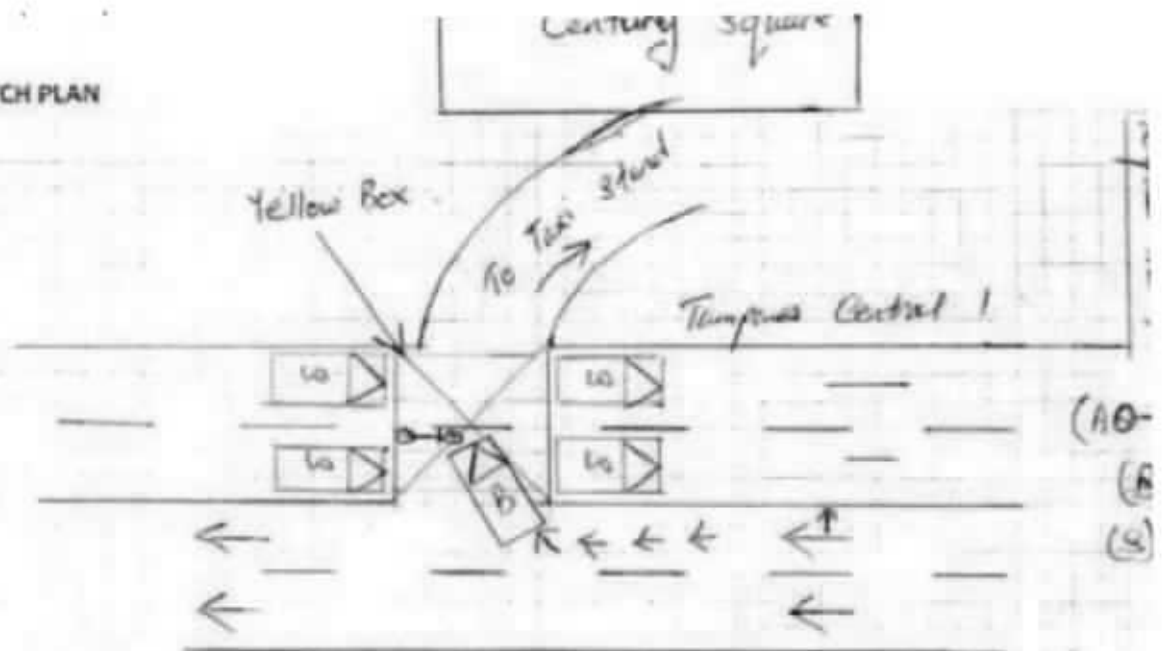
SKETCH PLAN

TP's version – vehicles stopped at yellow junction:

On 28/07/18 at @ 2030hrs, I was riding my motorcycle (CBF 2734Y) along Tampines Central 1 towards the direction Tampines Ave 4 on the right. I saw the vehicle ahead start to move off and I proceed to move forward. Suddenly a taxi (3HB 403H) from opposite direction make a right turn and collided onto the right front portion of my

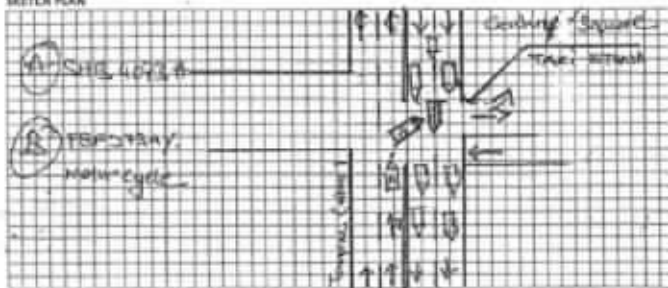
SKETCH PLAN

Insured's version :

ON 20 June 2018 (A) 20:30 hrs. I was waiting at central 1 to turn Right to Century Square. The traffic was heavy. I was a stop before Box Junction. I was a notice. Both on coming vehicle stop due to intent. When I was a just move. Suddenly, Veh B. in-between. Both vehicle to go through. I was a cannot see him coming and hit him. at the point of accident. Veh A. carry 4 passengers. 1 was injured.

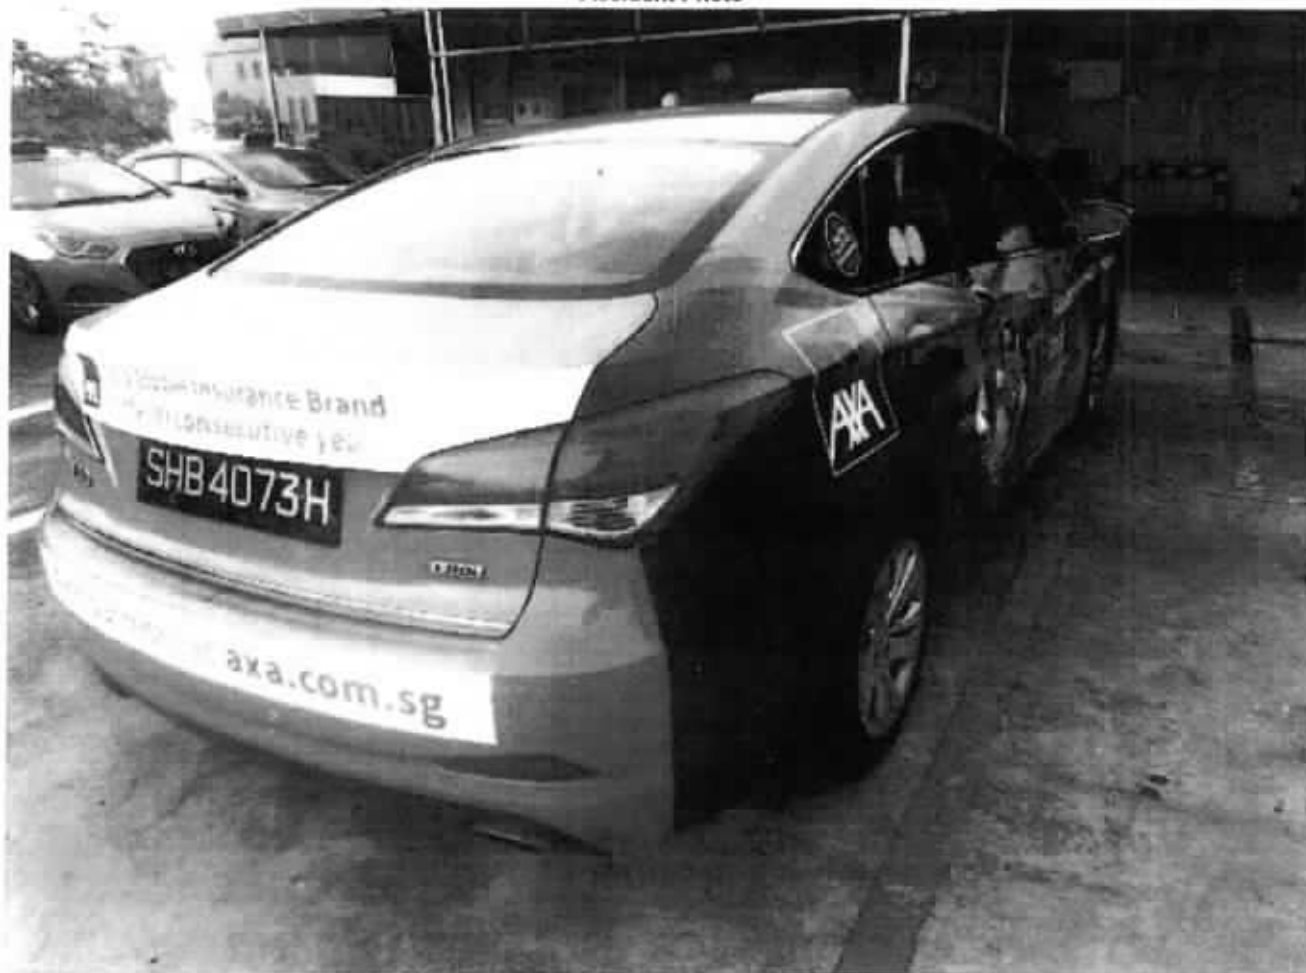
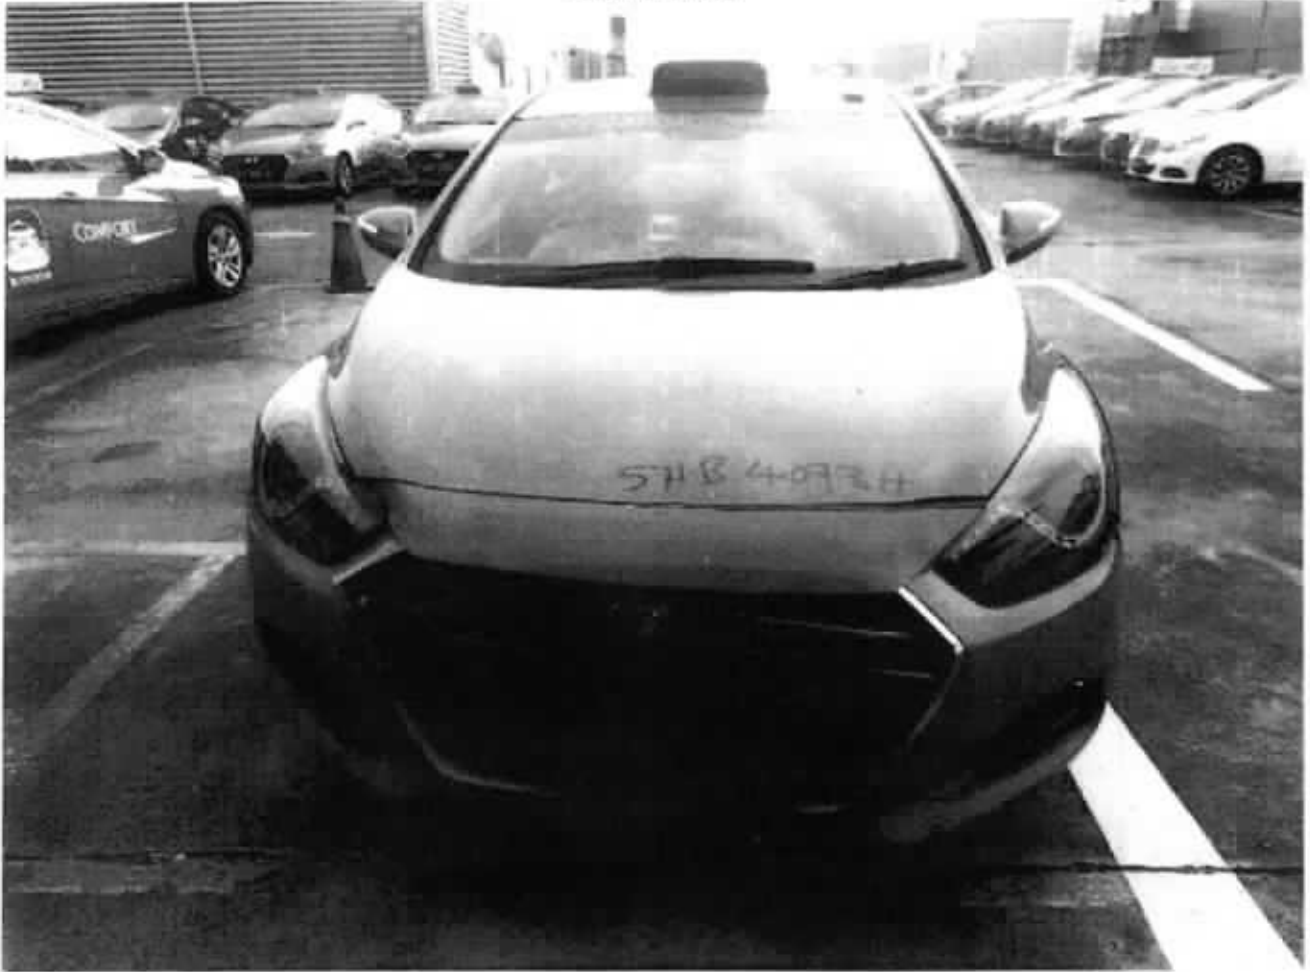
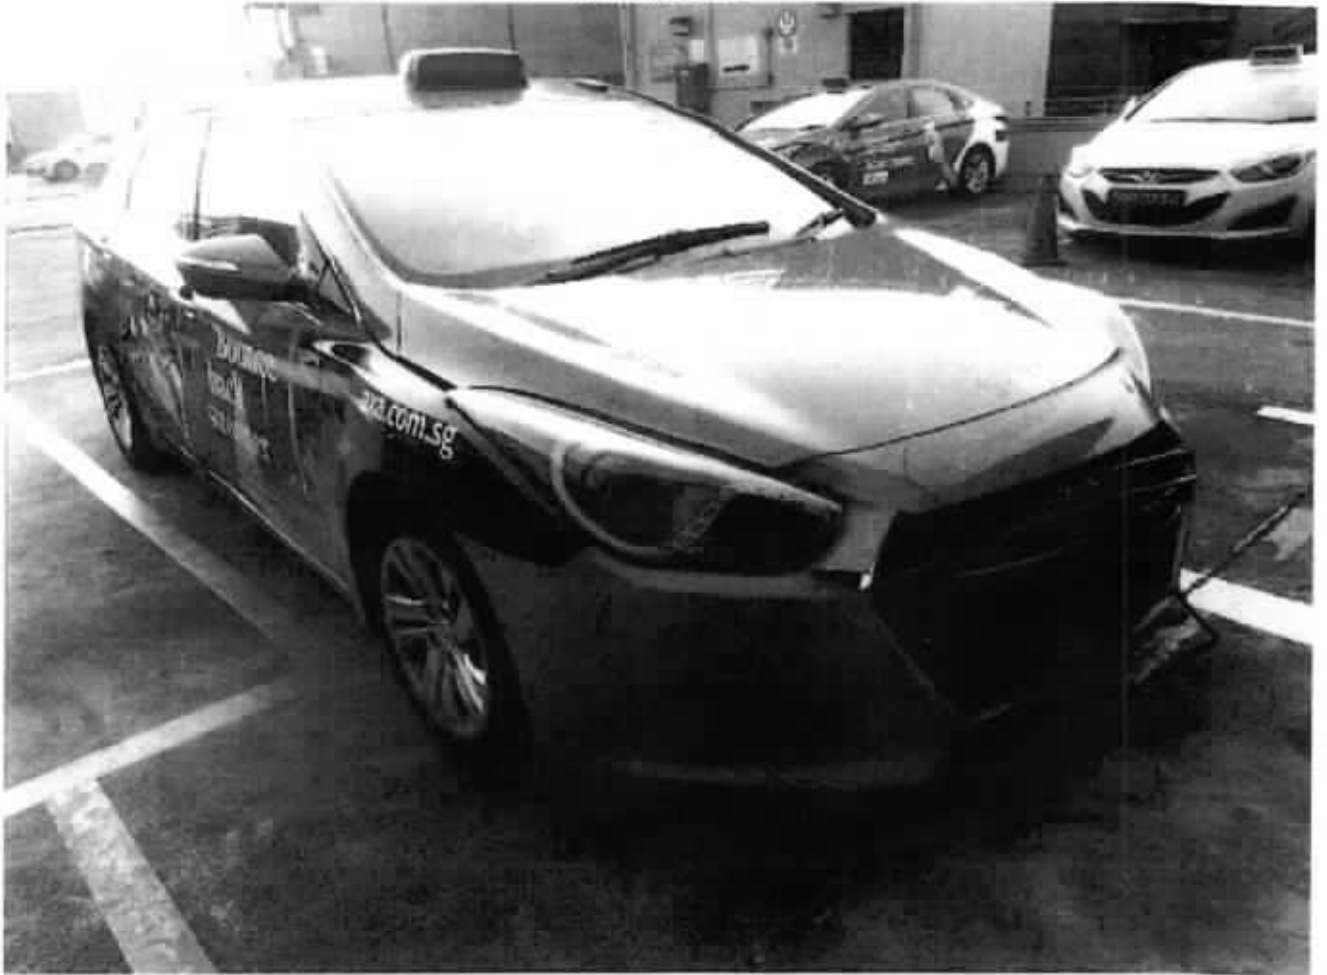
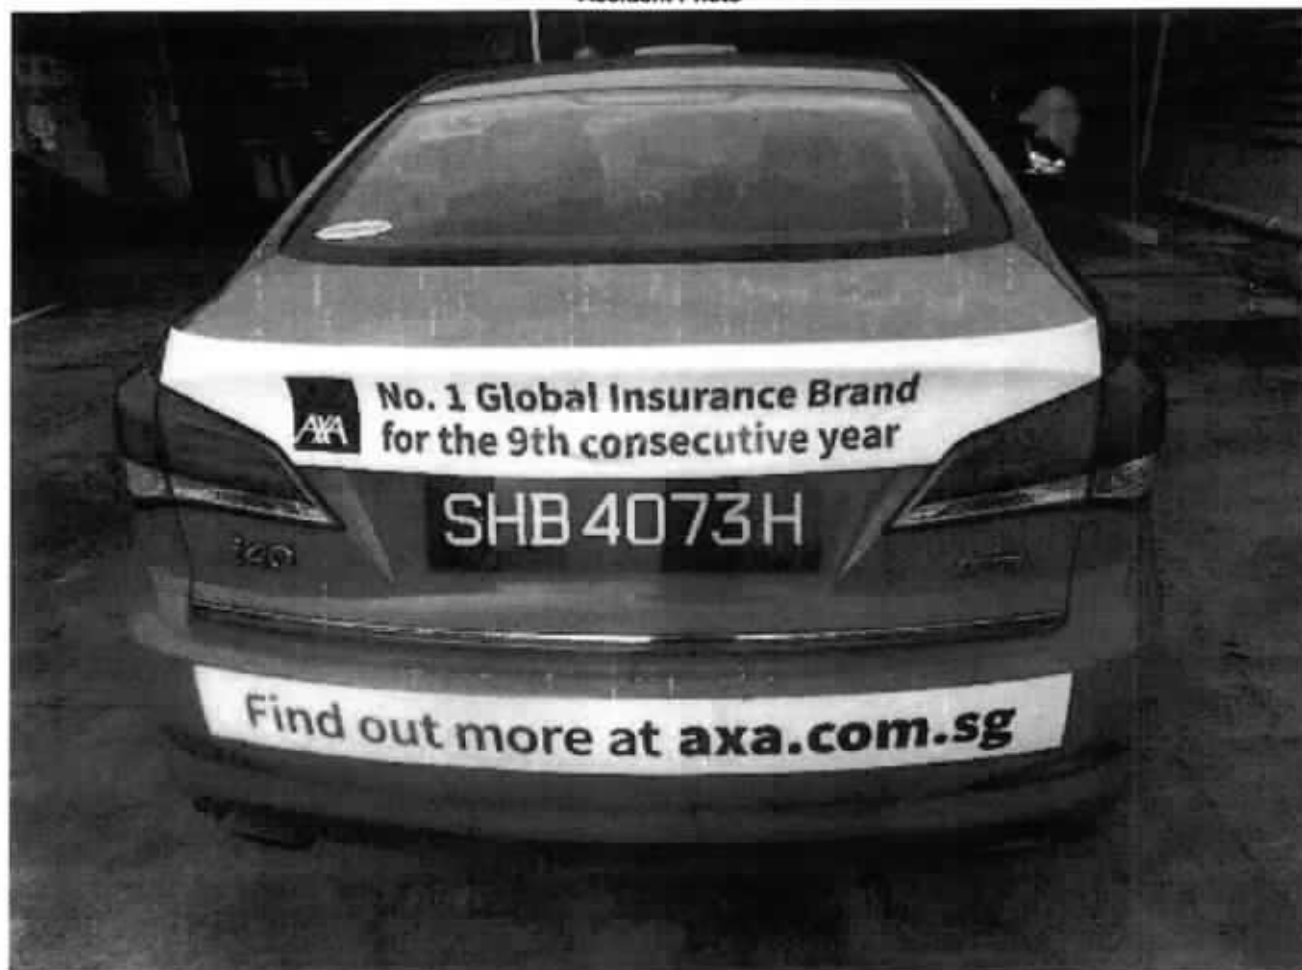
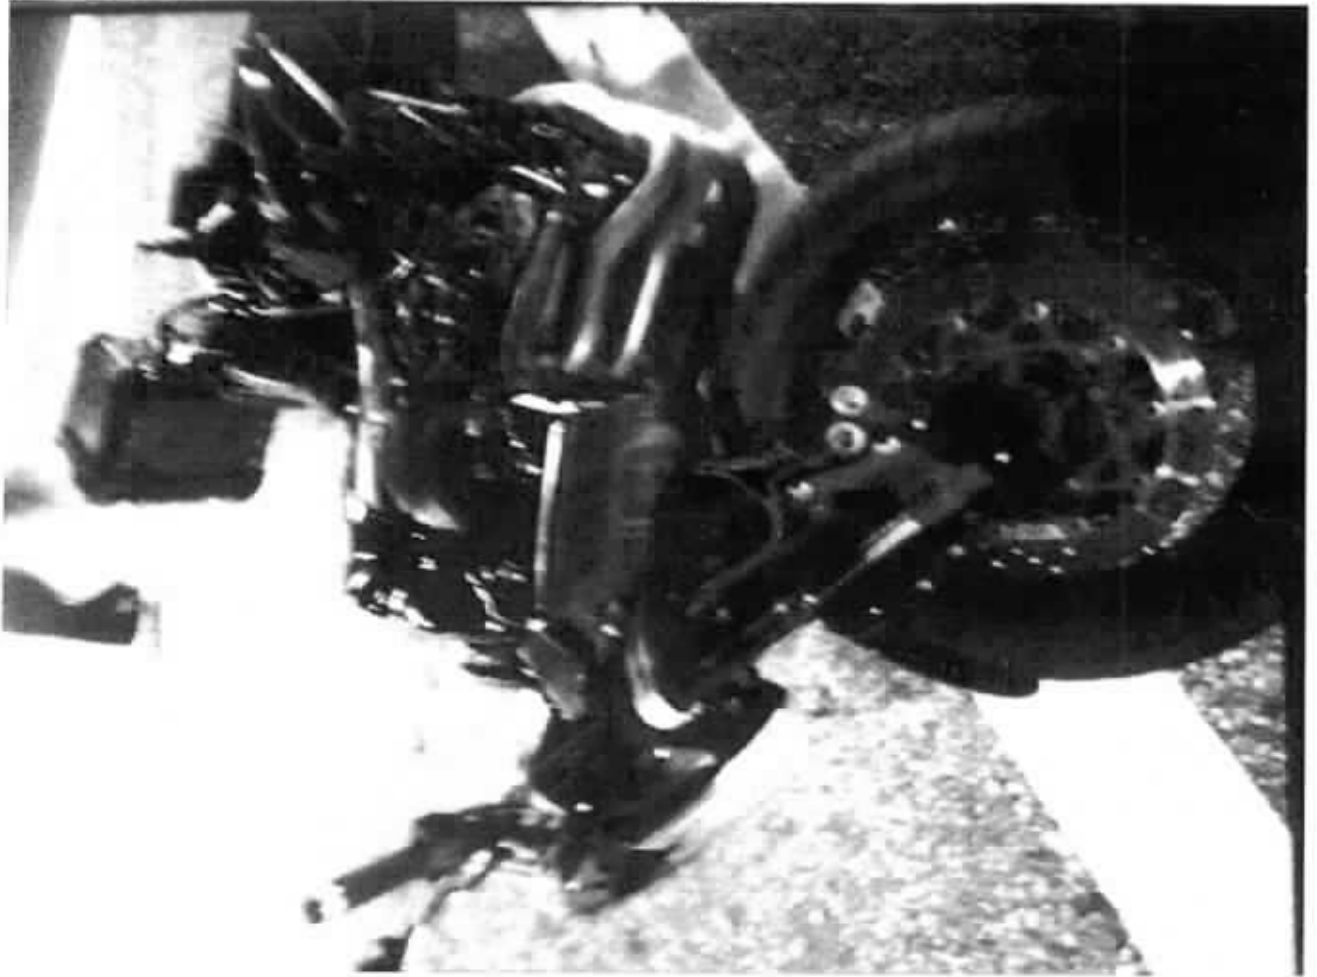
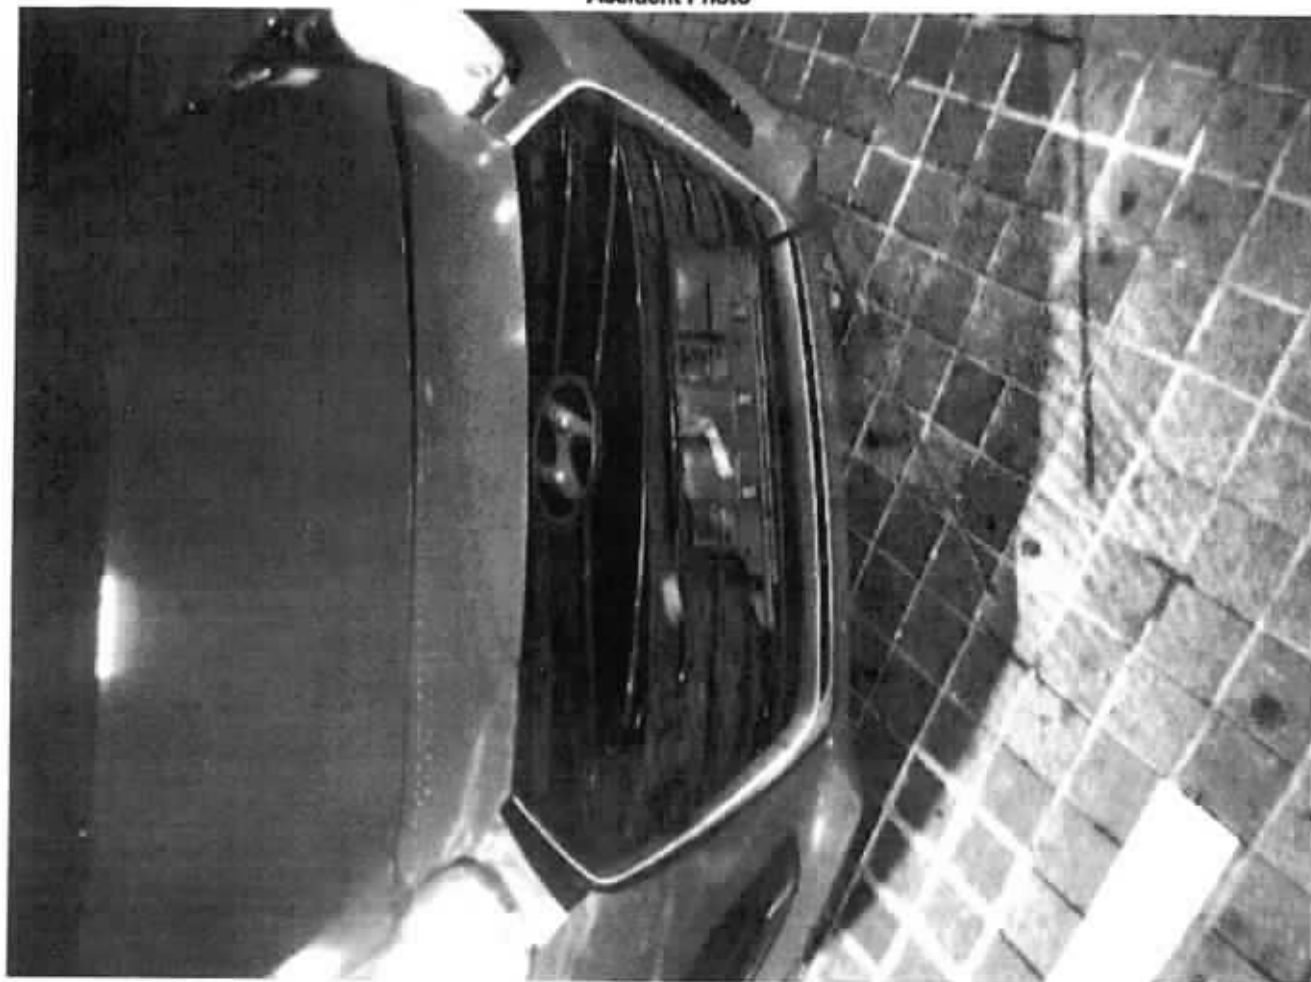
4. Description of Damages				
THE VEHICLE SUSTAINED DAMAGES AT THE O/S BODY. DAMAGES SEE DETAILS.				
5. General Information				
Accident Date	28/07/2018	Inspection Date	01/08/2018	
Survey held at	ONG MOTOR - 464 MACPHERSON ROAD.			
Repairer	MOTO 51 PTE LTD			
5a. Remarks				
A)THE INSPECTION WAS CONDUCTED ON A"WITHOUT PREJUDICE" BASIS. B)IN ACCORDANCE TO YOUR INSTRUCTIONS, WE HAVE NOT AUTHORISED REPAIRS.				
5b. Estimate Days of Repair				
ESTIMATED NORMAL PERIOD FOR REPAIR:		5 Working Days

Qty	Description of Parts	Condition	Estimate By Workshop (\$)	Our Adjusted (\$)
	TO STRAIGHTEN BODY FRAME TO THE ORIGINAL POSITION.		400.00	200.00
			1,760.00	830.00
GRAND TOTAL			18,604.80	5,476.30
RECOMMENDED COST OF LUMP SUM REPAIRS (TO ITS PRE-ACCIDENT CONDITION)				4,400.00

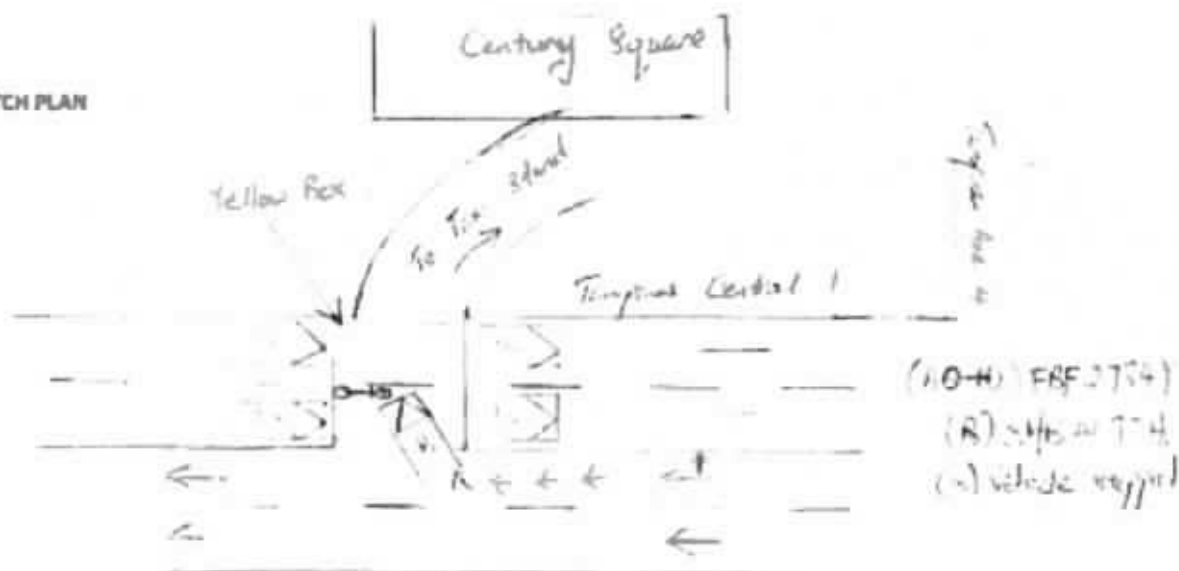
Sketch Plan #2

On 2/15/18 at 10:00 AM I was riding my motorcycle
 (2734) on the highway when I noticed the driver of
 a car (2/15/18 T-4) in the right lane of traffic
 going to the right. I was in the left lane of traffic
 and I noticed the car was going to make a right
 turn and collided with the right front portion of my bike.
