SH 6471S

o/s Rear

VEHICLE DAMAGE INSPECTION REPORT

NOTE : DAMAGES CONSISTENT TO ACCIDENT REPORT

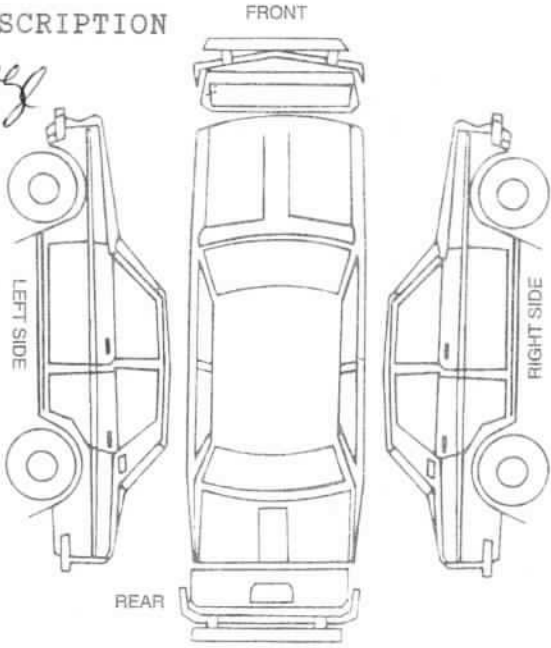
TOKO - Rear Right damage
LRR/Kabin

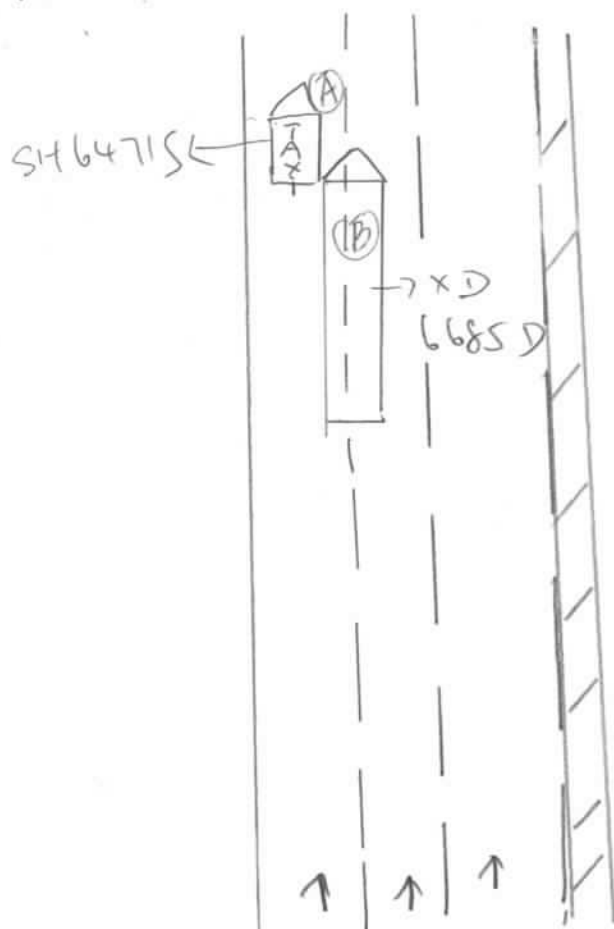
SKETCH PLAN

A - SH 6471S
B - XD 6685D

Along Alexandra Rd Towards Pasir Panjang Rd

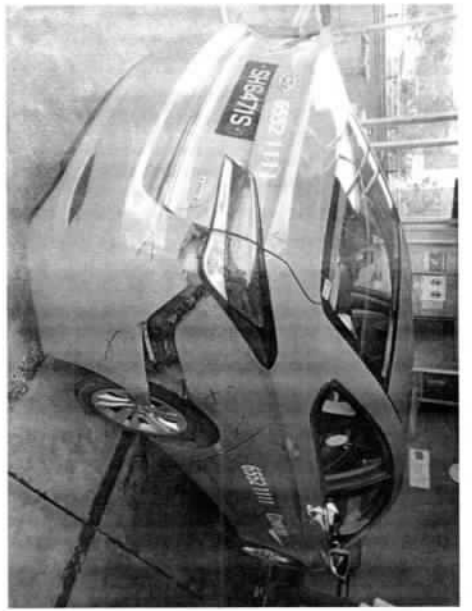
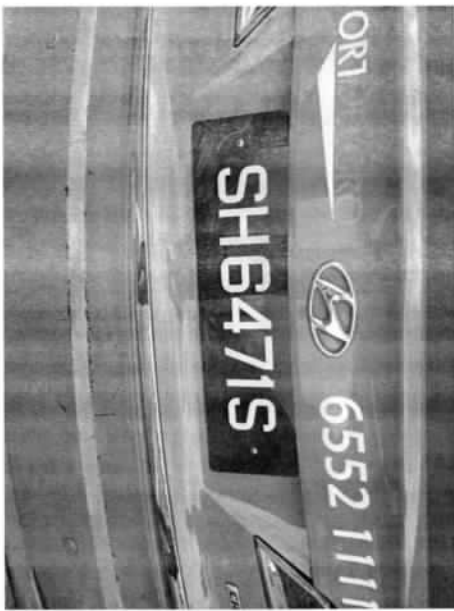
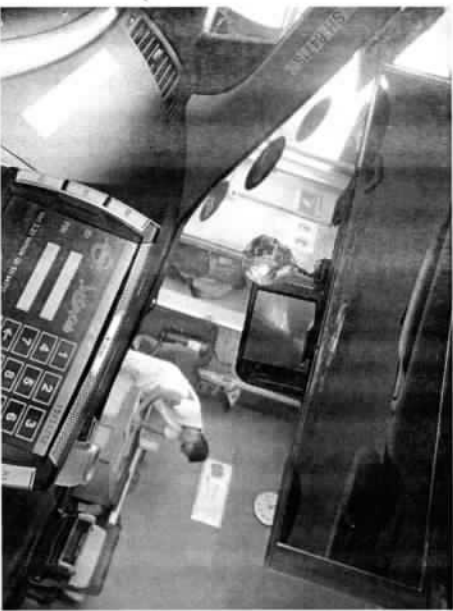
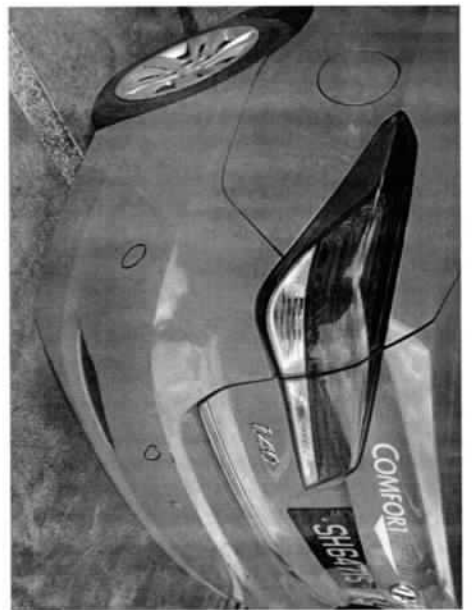
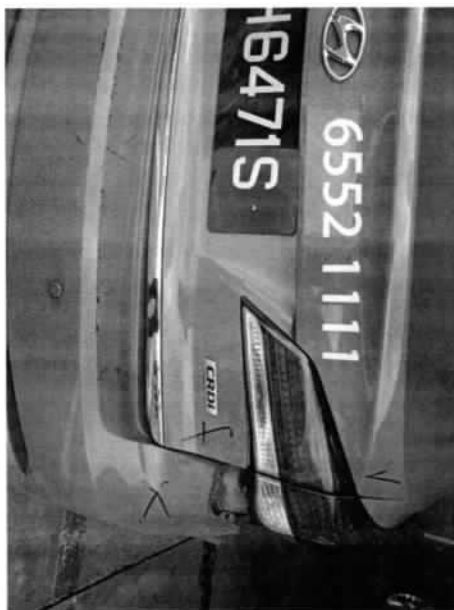
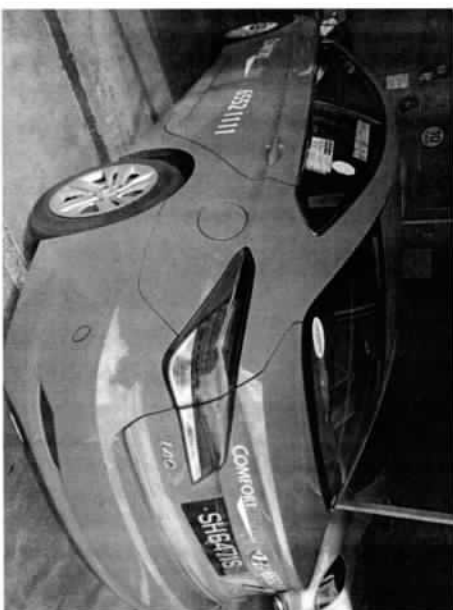
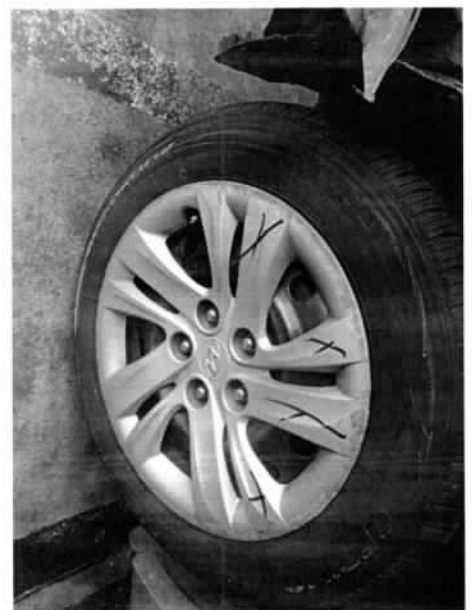
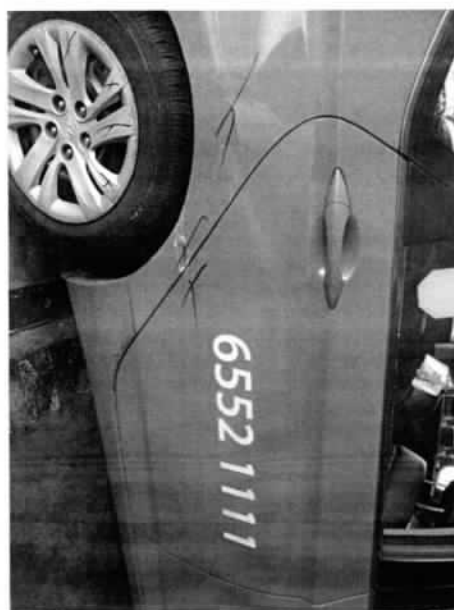
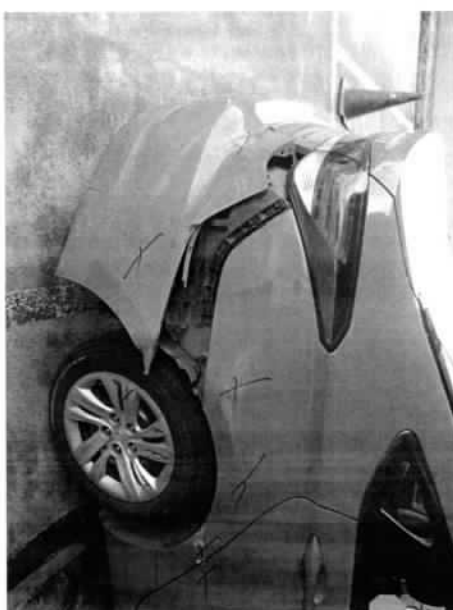
The UIC / Chassis frame / Body Structure affected due to collision.

No.	Qty	Part No.	Particulars	Condition	Repairer's	Amount
1	1		*REAR BUMPER	Deformed	553.00 FL	*553.00 FL
2	1		*REAR BUMPER SPONGE	Serviceable	118.40 FL	*- FL
3	1		*REAR BUMPER SIDE BRACKET - RH	Cracked	35.60 FL	*35.60 FL
4	10		*REAR BUMPER CLIPS	Necessary	22.00 FL	*22.00 FL
5	1		*REAR WHEEL COVER - RH	Grazed	107.10 FL	*107.10 FL
6	1		*REVERSE SENSOR	Serviceable	135.70 FS	*- FS
7	1		*REAR TYRE - RH	Serviceable	216.00 FS	*- FS
8	1		*REAR DOOR TEL NO. STICKER - RH	Necessary	10.00 FS	*10.00 FS
9	1		*REAR FENDER (RH) (NPA)	Repair	-	*- FL
					Sub Total (S\$)	1,197.80 727.70
					- List Item Discount on L Items 20.00/20.00% (S\$)	167.22 143.54
					Total Parts (S\$)	1,030.58 584.16

No	Particulars	Lab.Type	Repairer's	Amount
Labour Items				
1	PANEL BEATING	New	750.00	400.00
2	SPRAY PAINTING	New	750.00	600.00
3	WIRING CHARGE	New	50.00	0.00
4	TUFF KOTE	New	80.00	0.00
5	REMOVE/REFIX REVERSE SENSOR	New	120.00	30.00
6	REAR WHEEL ALIGNMENT	New	120.00	0.00
Gross Labour Cost (S\$)			1,870.00	1,030.00

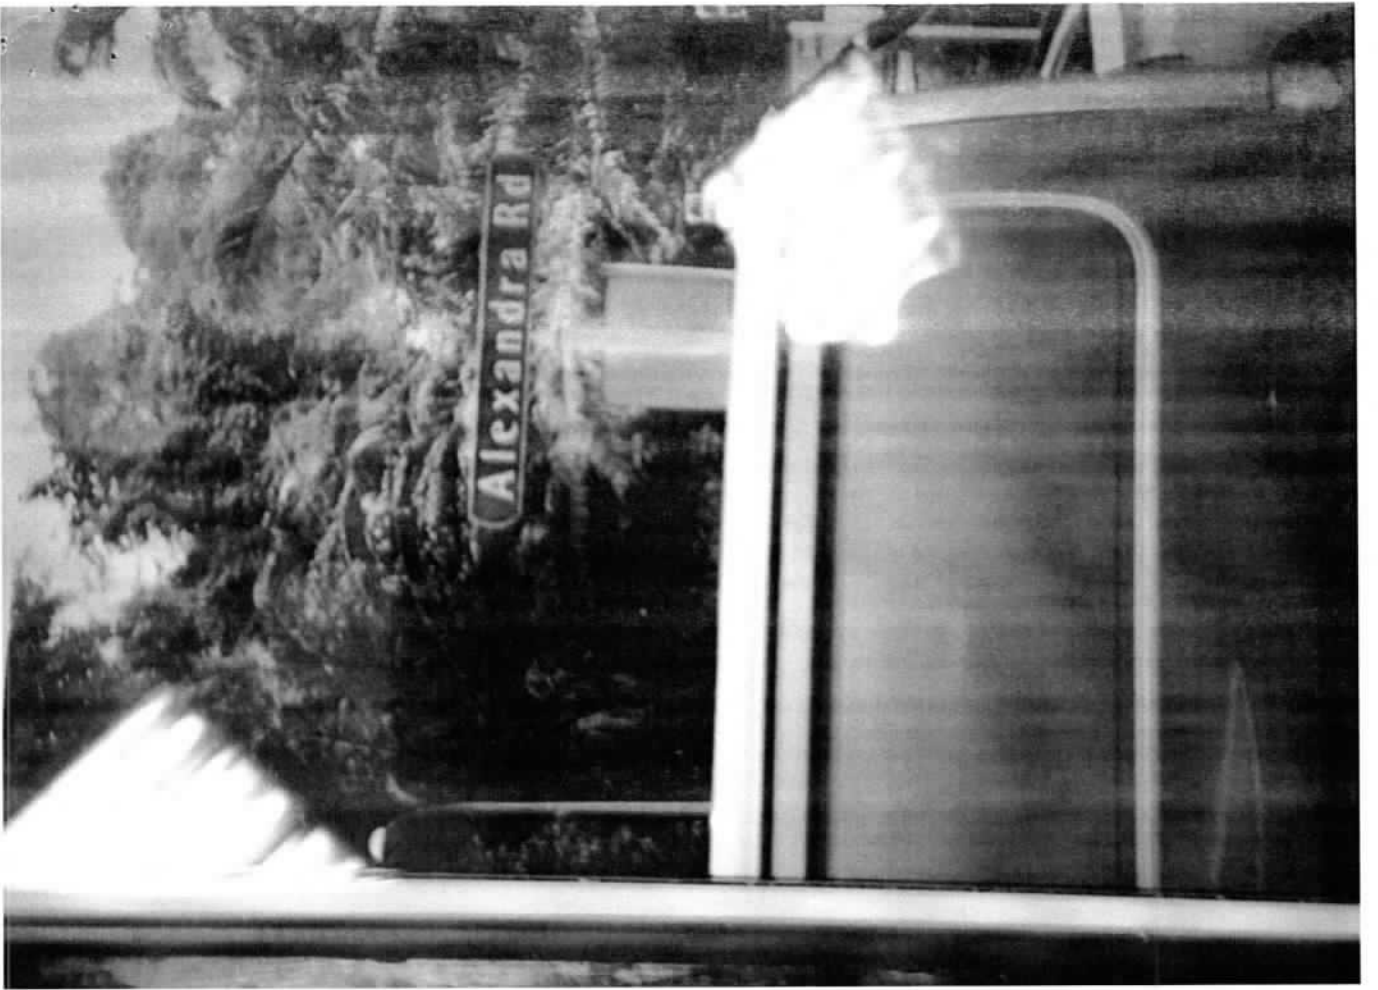
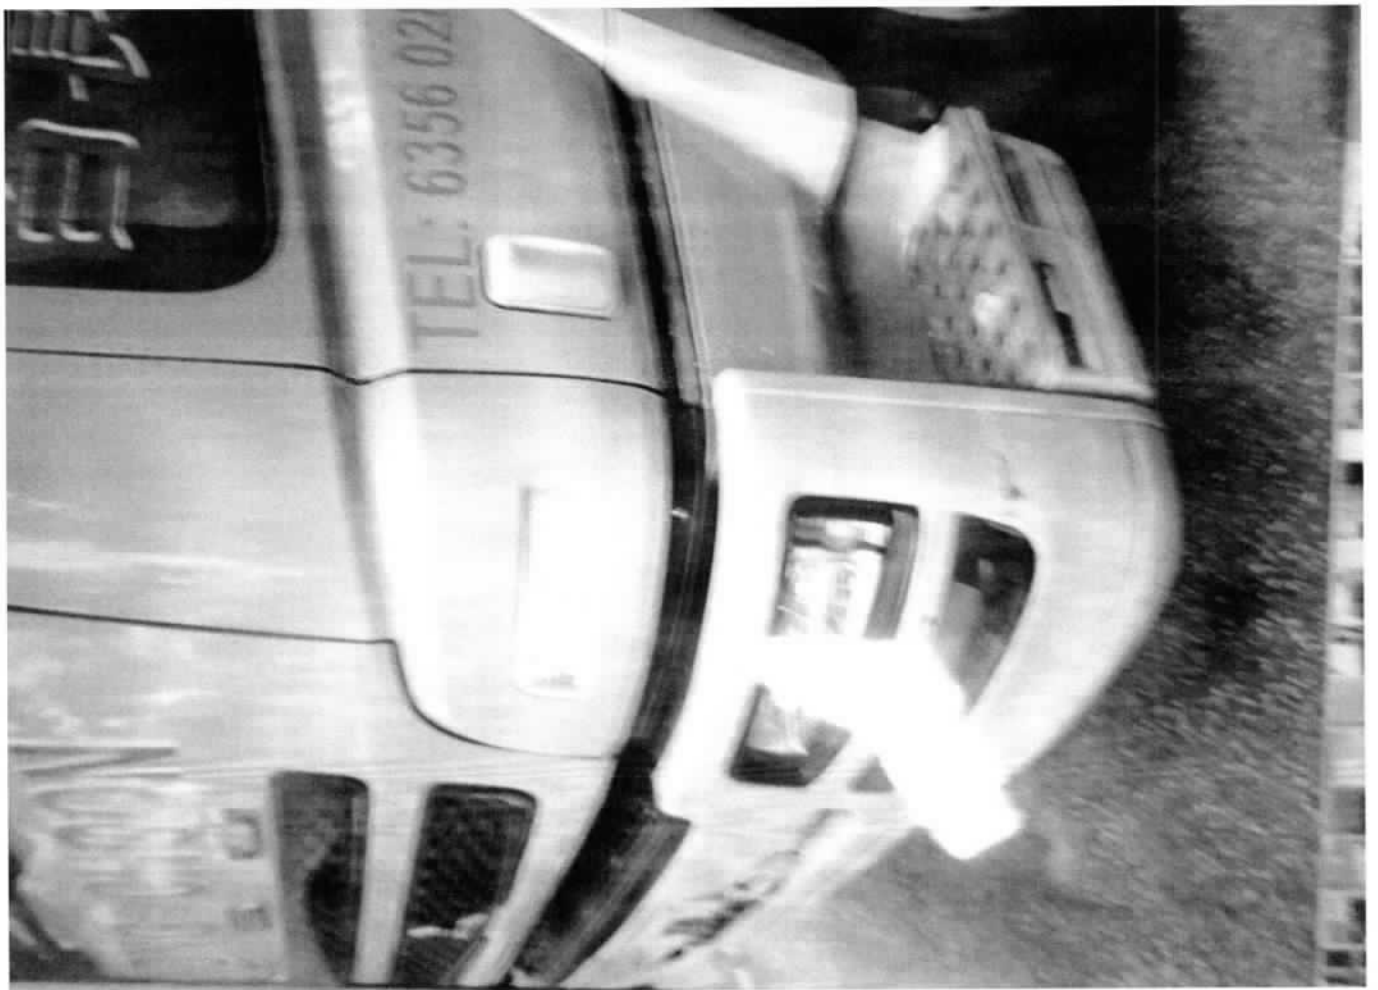
Remark: The veh had commenced its repair at the time of inspection.

Des. of Damages: Frt / Rear / O/S / N/S / UIC / Rooftop or

The survey and estimates of the repairs of the above-mentioned vehicle are as follows:-

Final Lumpsum Repair cost \$1,300.00

3. Estimated normal period for repairs: 3 working days.
