From: KKLau <kklau@lkkauto.com>
Sent: Wednesday, 21 November 2018 5:05 PM
To: Irene Tan; Bryan Ang (LKKAuto); Simon Ho (LKKAuto)
Cc: Olivia Lau (LKKAuto); Veron Chen (LKKAuto); Shiau Chan (LKKAuto); Denise Tay (LKKAuto); Admin-D (LKKAuto); Jason Sim; Celine Fong (LKKAuto)
Subject: Re: Mr Xing Guo Qiang's survey report on SLT1357S; Our claim no.: 550353/IT

Bearing in our minds on our insured's comments on the minor scratches on the 3rd party's car body only, we refer to Mr Xing's final survey report dated 19.11.18 on his recommended parts for replacement as follows:

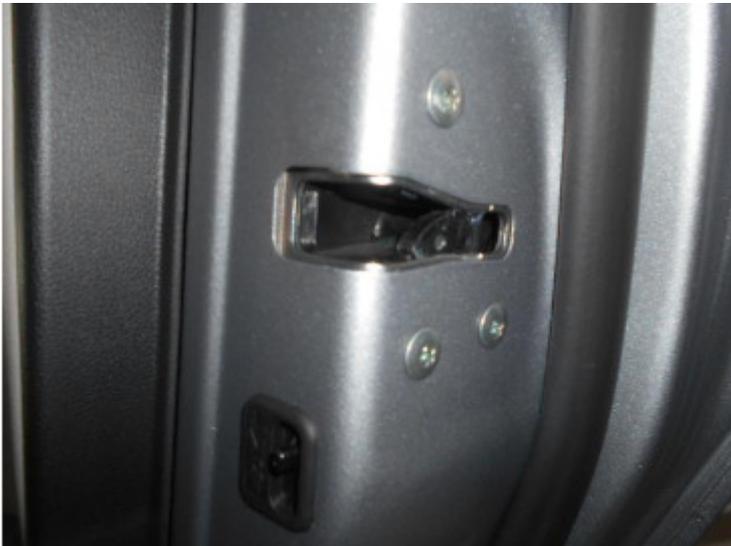
1) Picture showing the damaged area _____

Looking at the accident reporting picture below, the impact damage within the red circle is **much lower than** that of the rear door handle within the black circle and the area within this black circle appears to be **undamaged**.

- (i) So how would the above Recommended Parts nos. 12 & 13 on the Rear RH Door Inner Trim Board & Door Mechanism Lock be found to be broken & bent ?
- (ii) How would these 2 parts be damaged whether directly or indirectly by our insured's car? Please explain.

(III) Can you circle the

broken and bent portions of the door on the 2 pictures below?

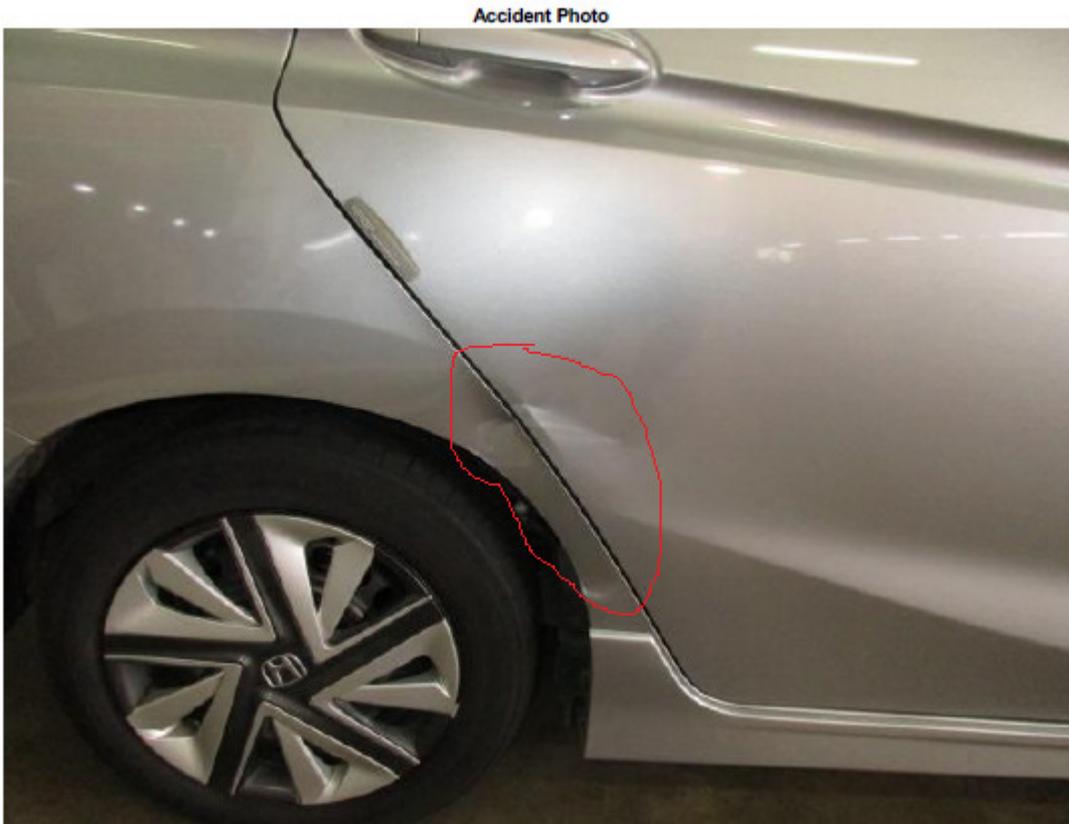
2) 2nd picture with a closer zoomed-in view of the subject car

Looking at the picture below on the subject 3rd party's car, the rear wheel hub does not appear to be damaged, cut or dislodged.

(i) Please explain how our insured's car could have damaged, cut or dislodged the recommended parts nos. 21 & 22 Rear RH Wheel Cap and Wheel Hub Bearing respectively?

(II) Please circle or point with arrow on the cut or dislodged areas on the pictures
