REF: CS3/III/8017351/GH87
 ASSIGNMENT (Office)
 Date/Time: 19.11.2018
 Estimated Cost: Bill to:
 OD: TP/WS/TP RES/OD RES/EVA/INV/MV/CS
 To Inspect Vehicle No: SJR 6860G Insured: SHA 1993C
 at Workshop no: Toh Motor Tel: 9348 3351
 of: 160 Sin Ming Drive # 05-16
 Policy No: Claim No: MCT18090593
 Sum Insured: Excess:
 Make of Veh: D.O.A. 21/09/18
 (Client's Record) 25/9/18
 CA / REV / REP. / REV 24 HRS lup
 Date/Time: 2:20pm @ 29/11/18 Person Contacted: Ash Vehicle: IN/OUT

To inspect Vehicle No: SJR 6860G
at Workshop no: Toh Motor
at 160 Sin Ming Drive # 05-16

ADJUSTMENT ON REPAIR COST FOR VEHICLE NO. SJR 6860G

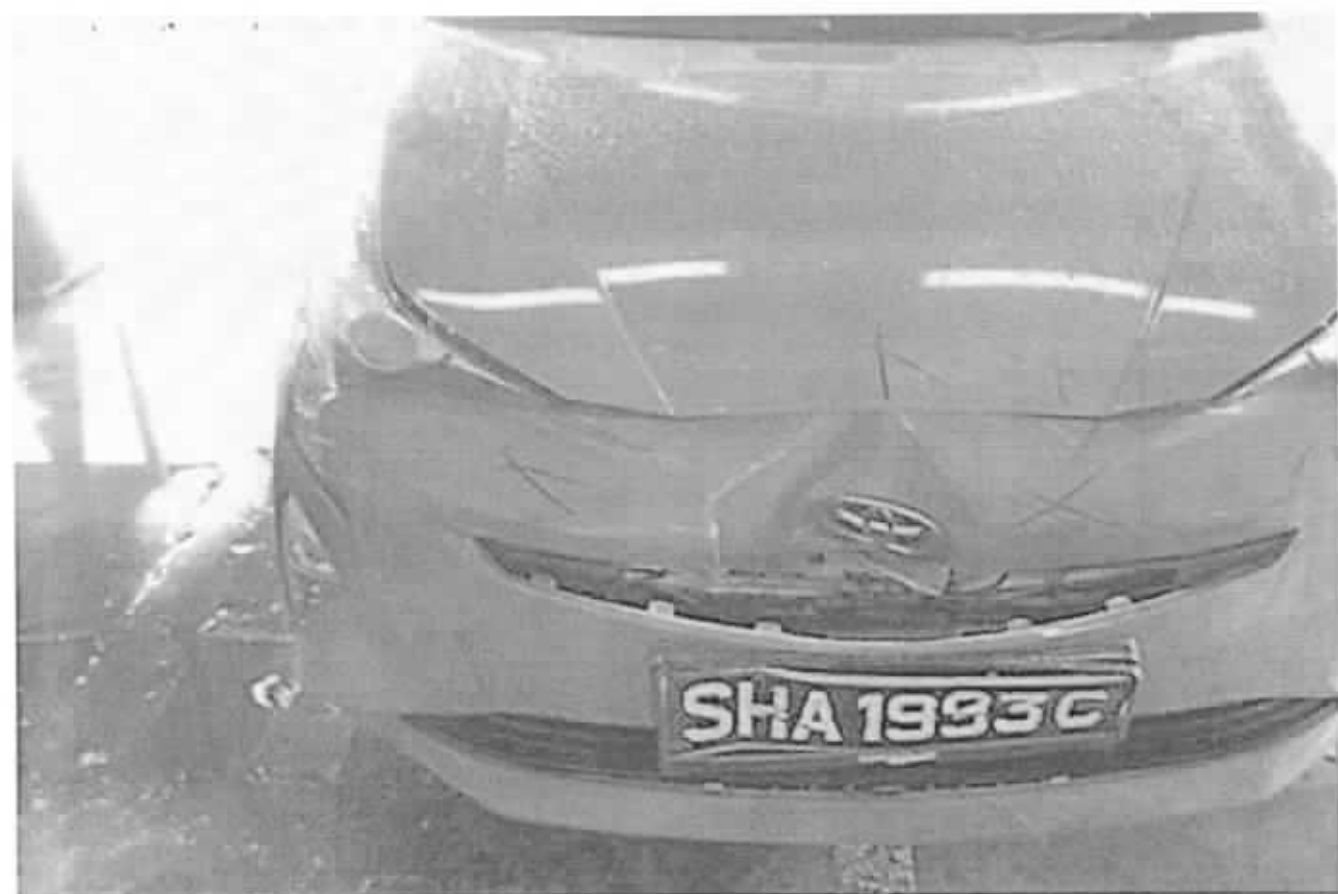
SKETCH PLAN

On the stated date & time, traffic was congested along PIE. While suddenly there was a vehicle which cut in & brake that vehi to brake to a stop as well. Seconds later I was braked behind by vehicle B.

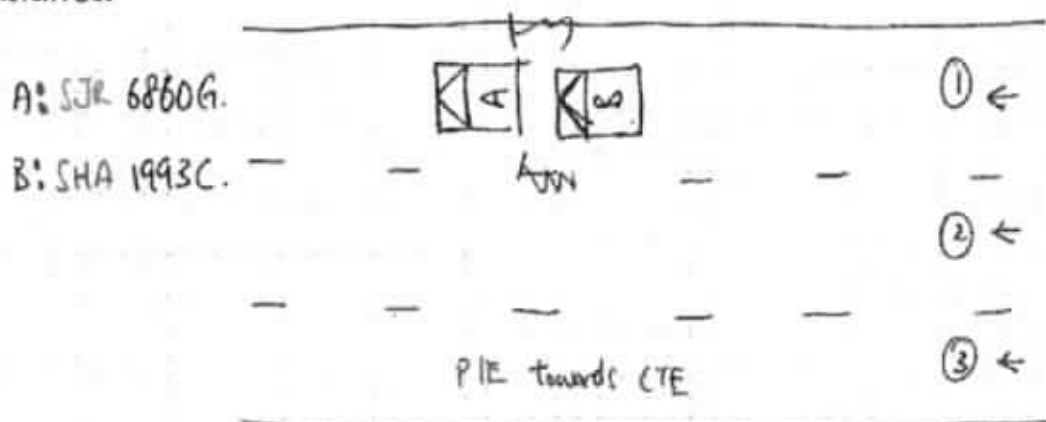
SKETCH PLAN

On the stated date & time, traffic was registered along PIE. While on lane 1 suddenly there was a vehicle which cut in & brake that vehicle A had to brake to a stop as well. Seconds later I was barged from behind by vehicle B.

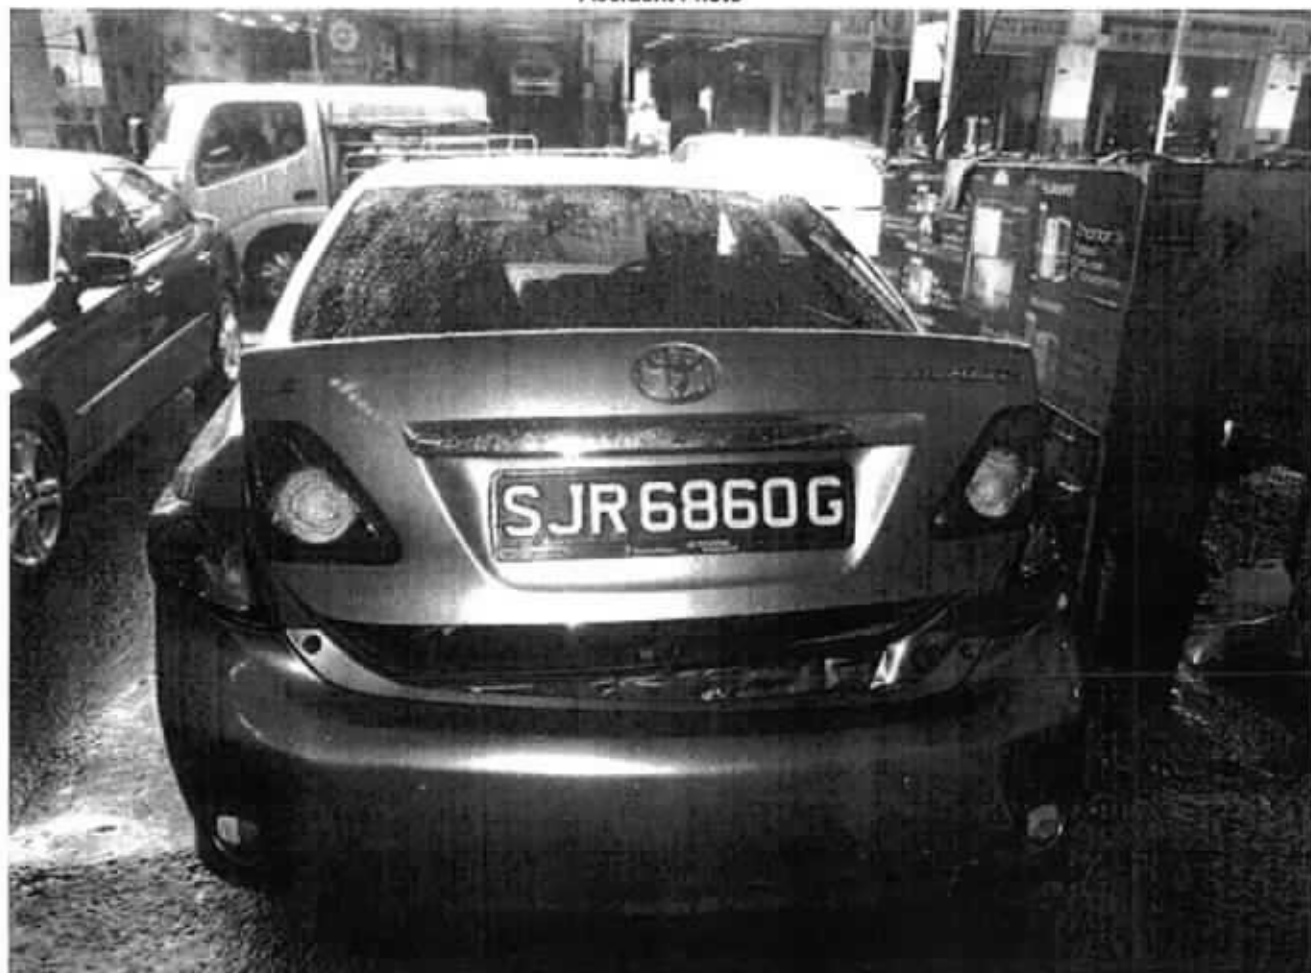
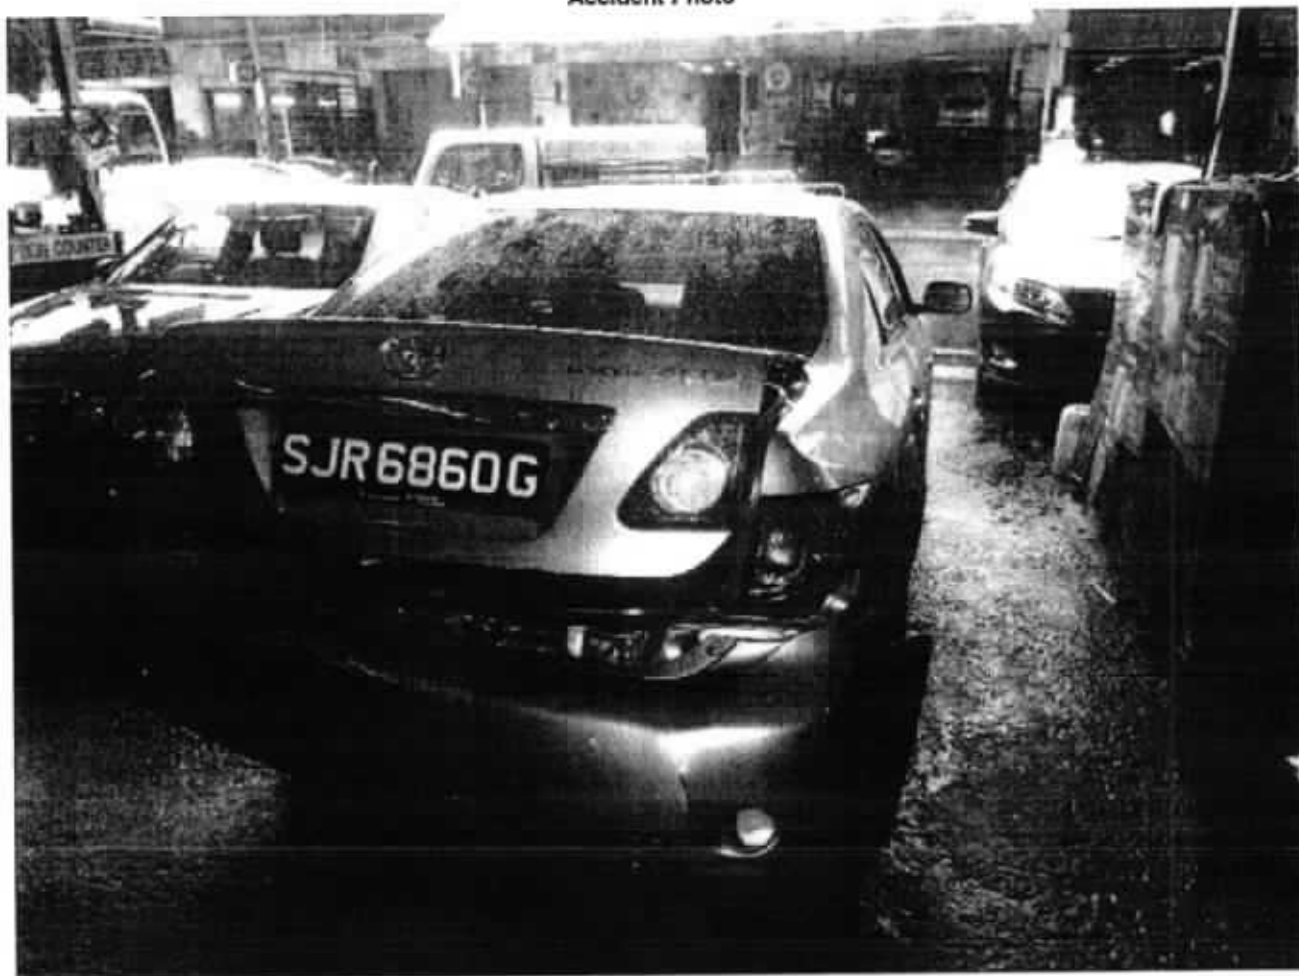
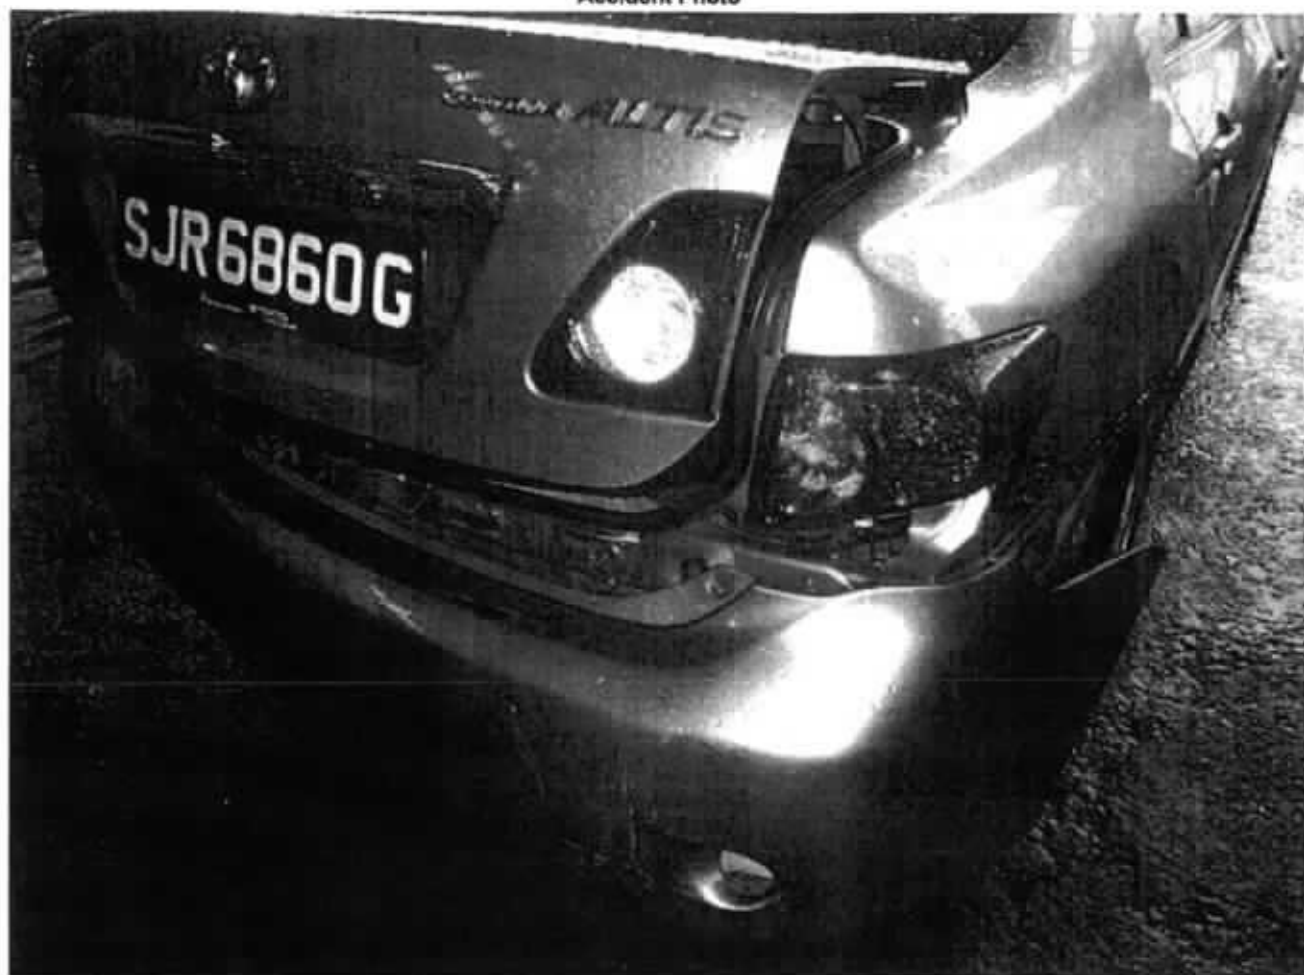
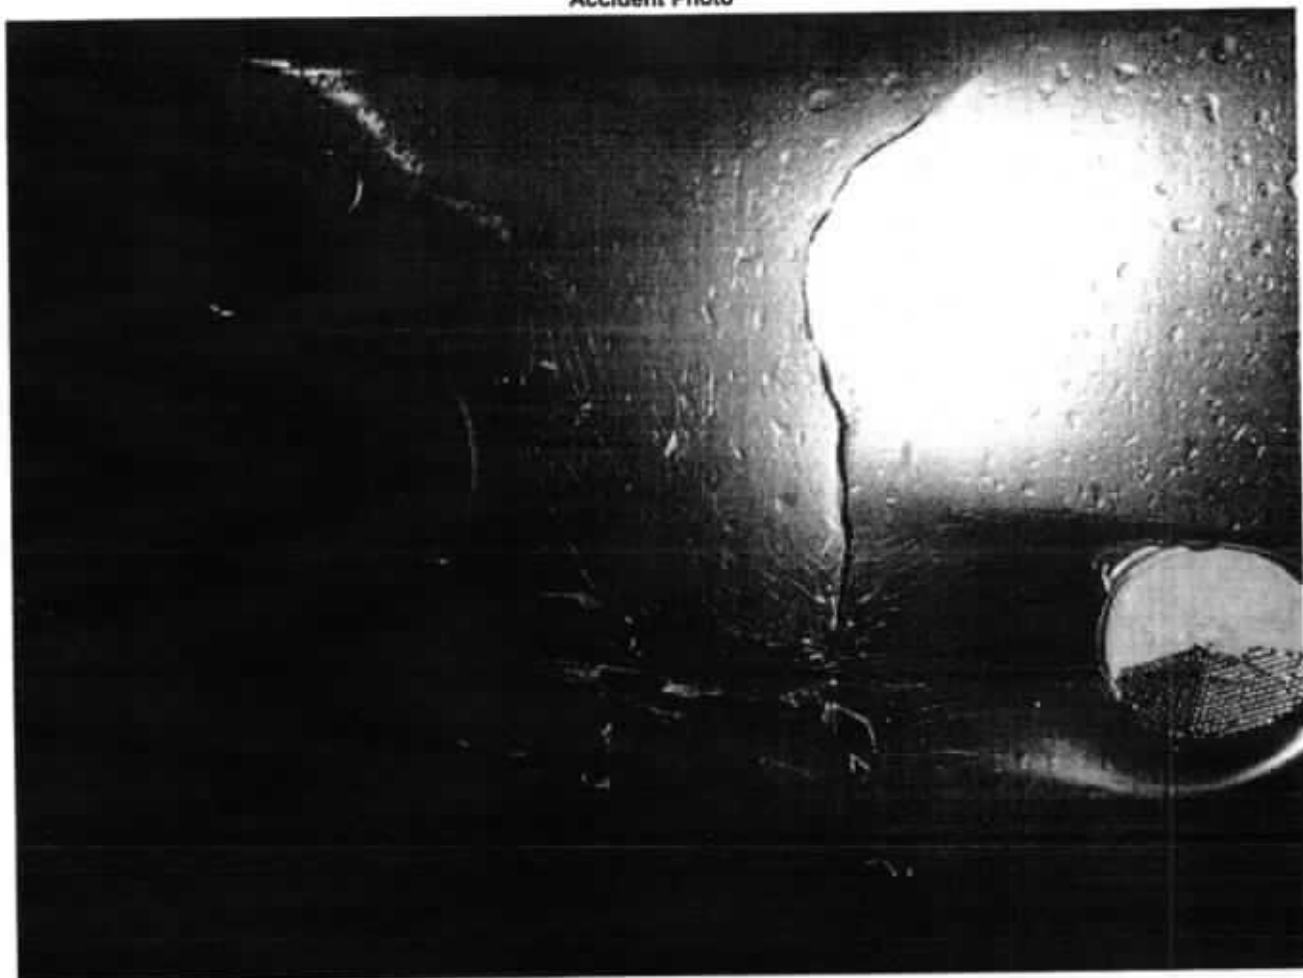
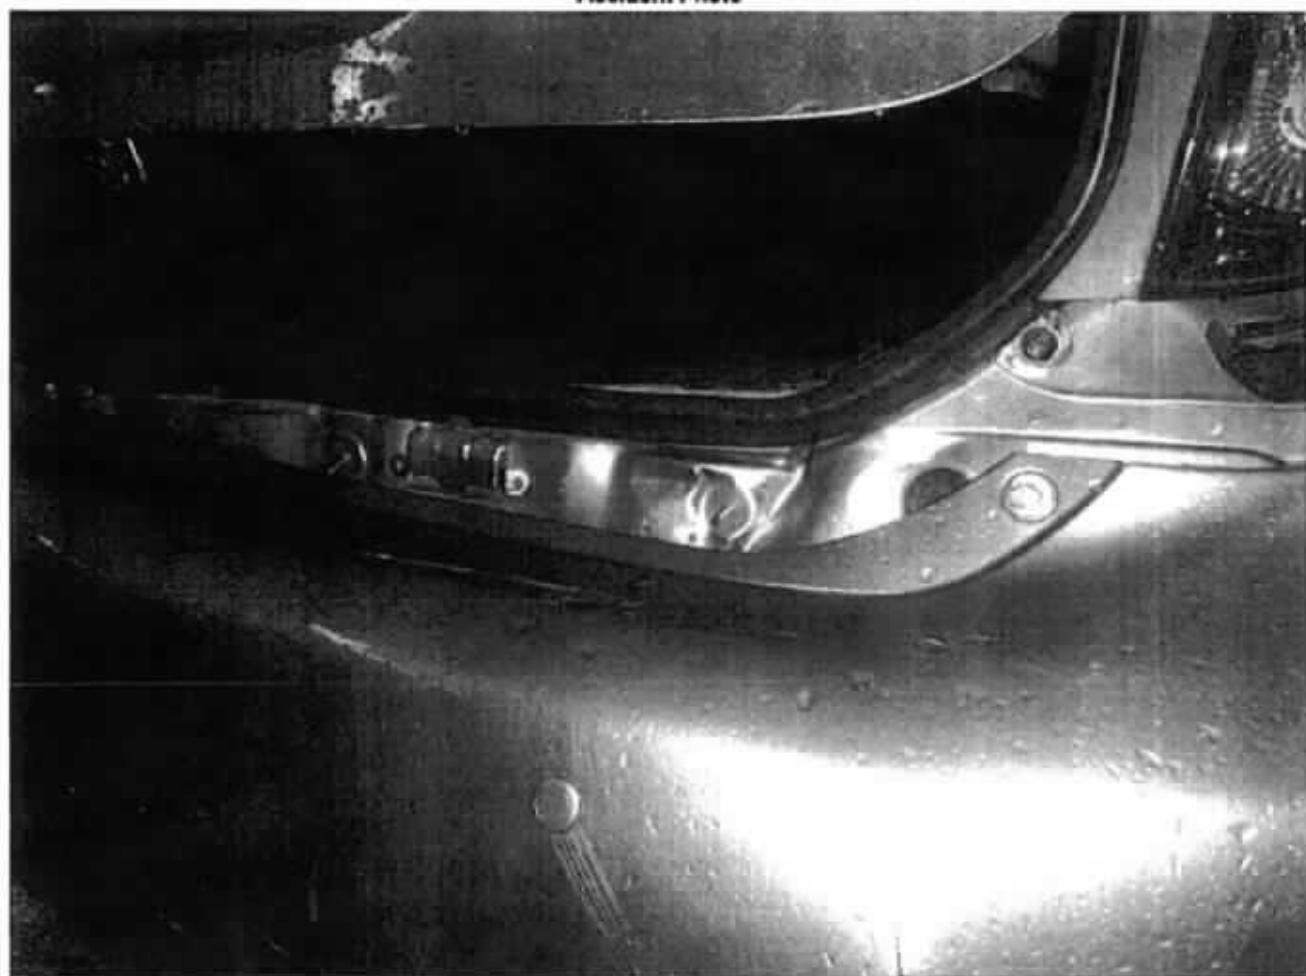
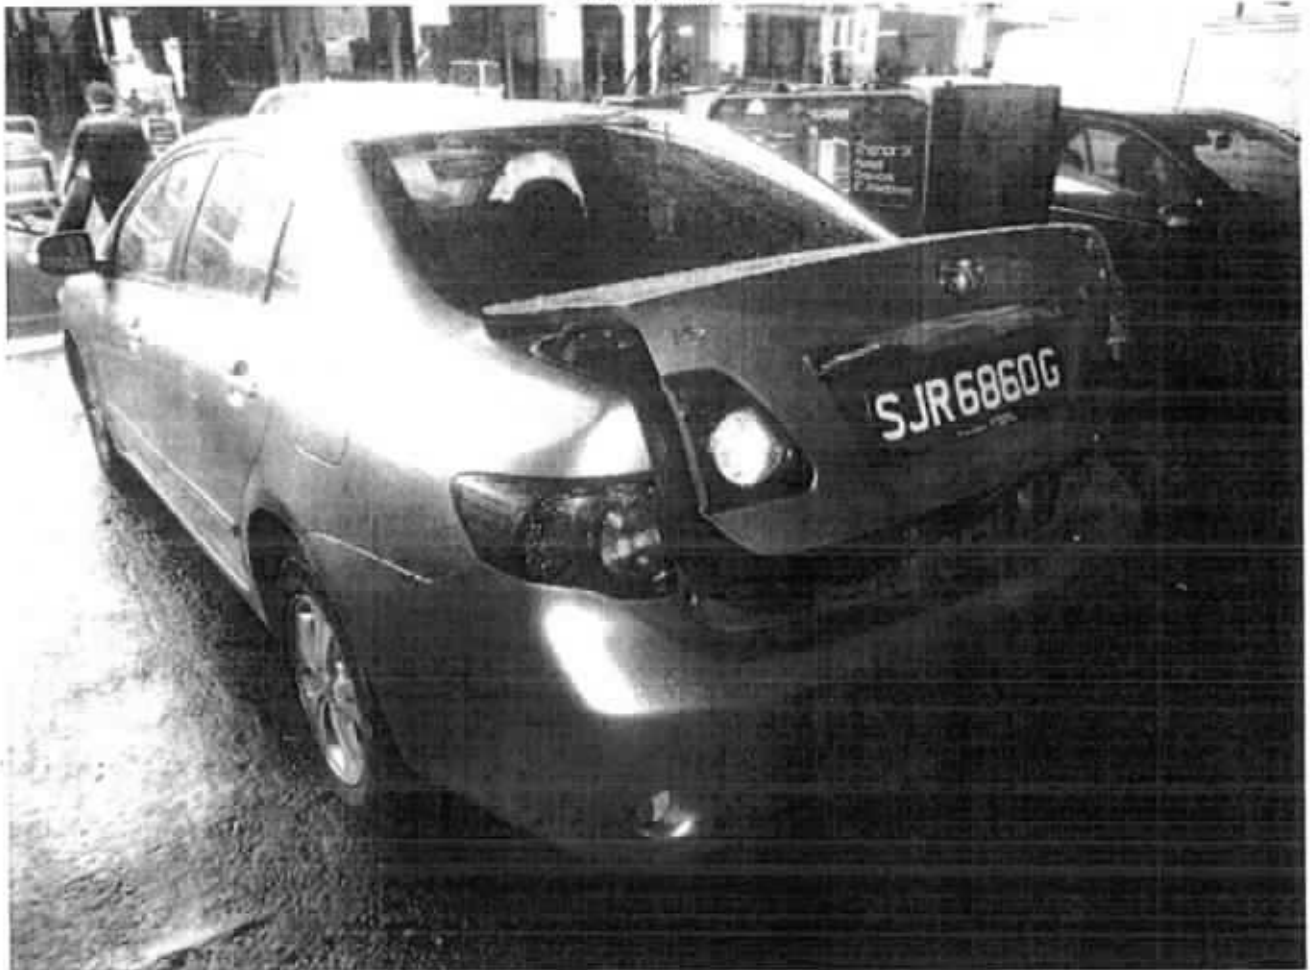
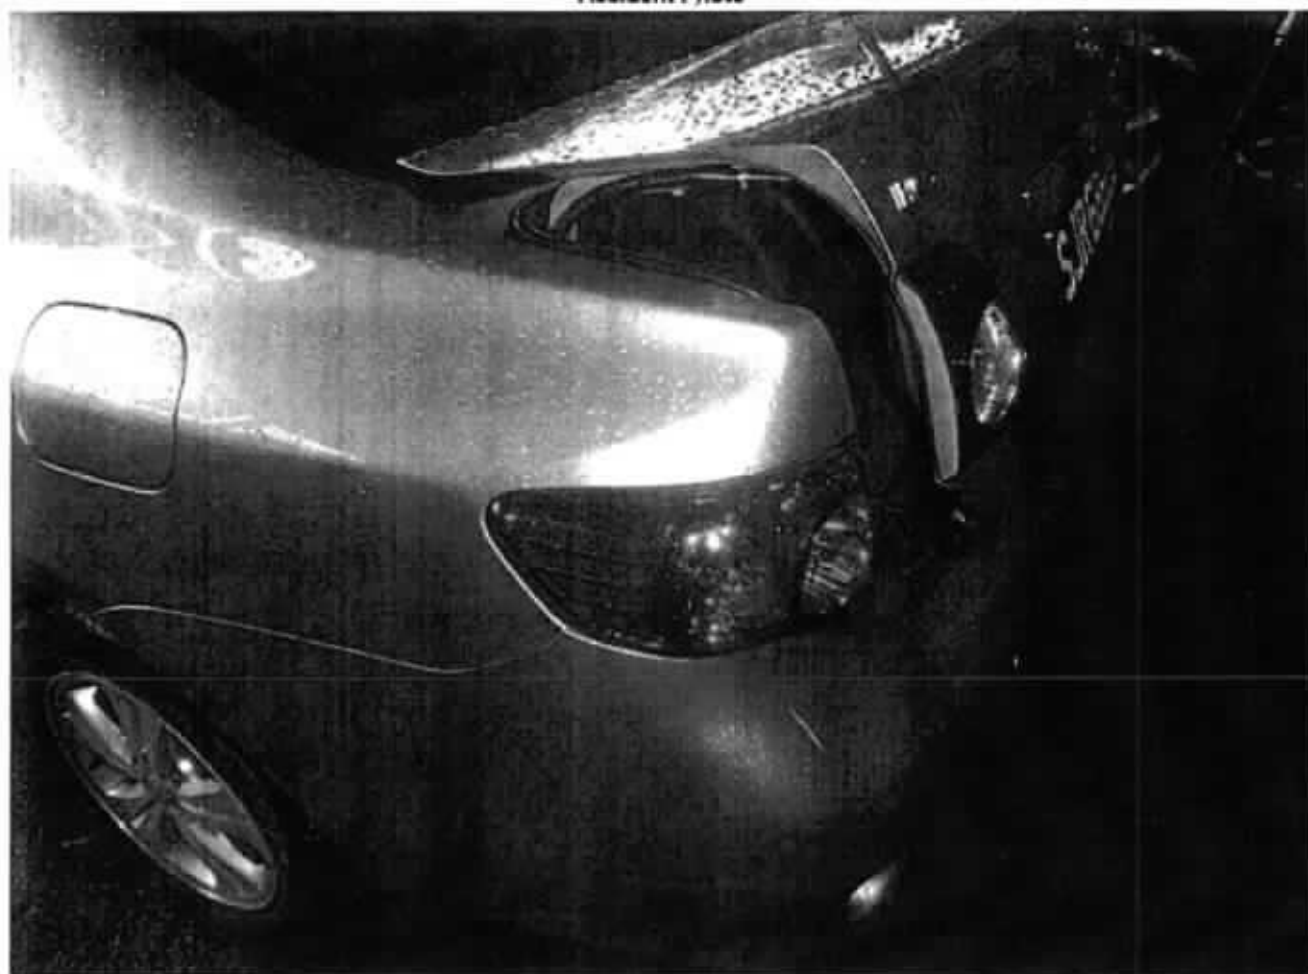
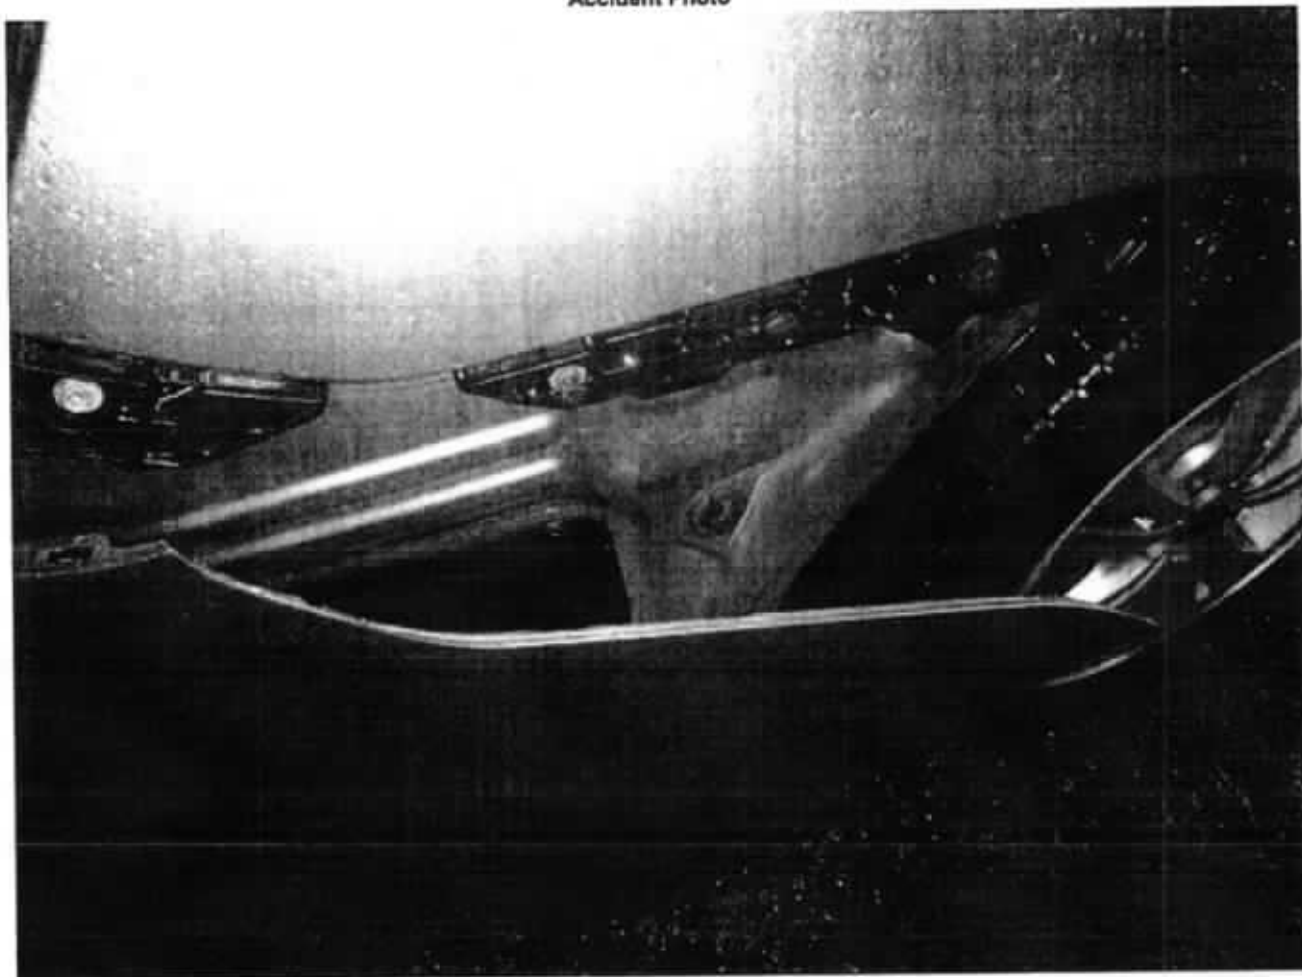
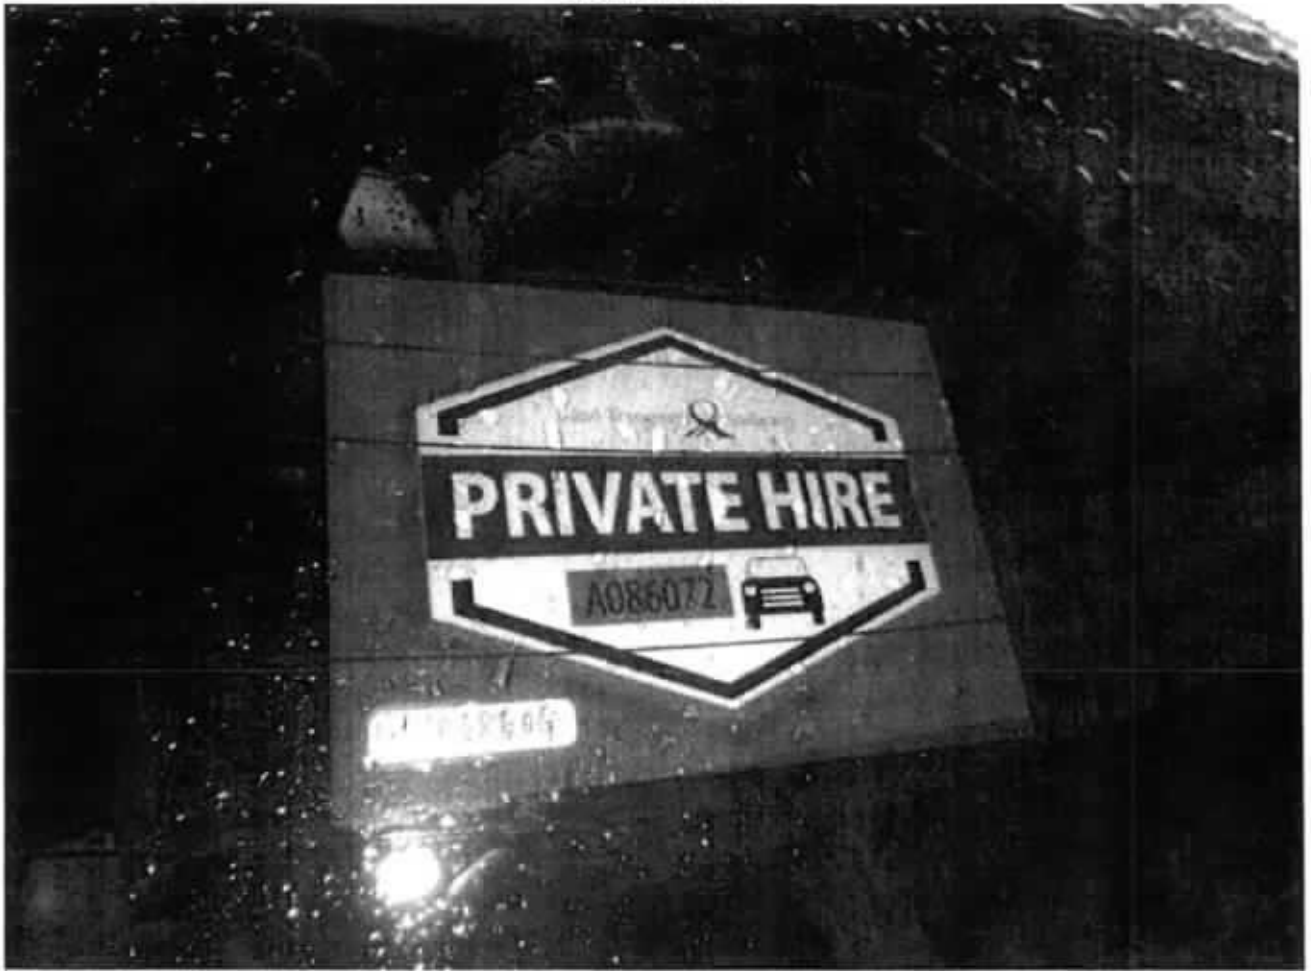
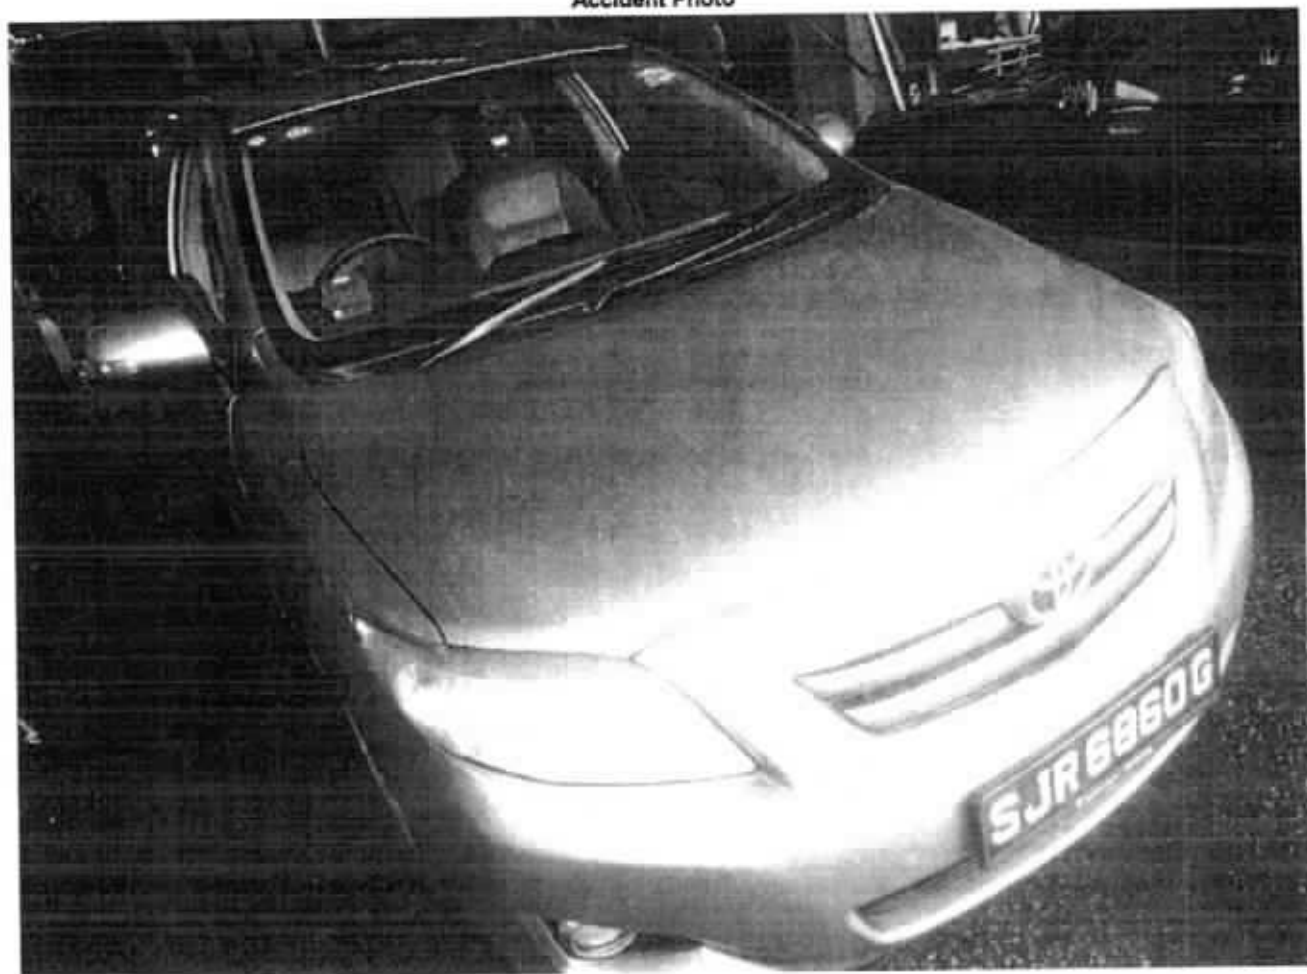
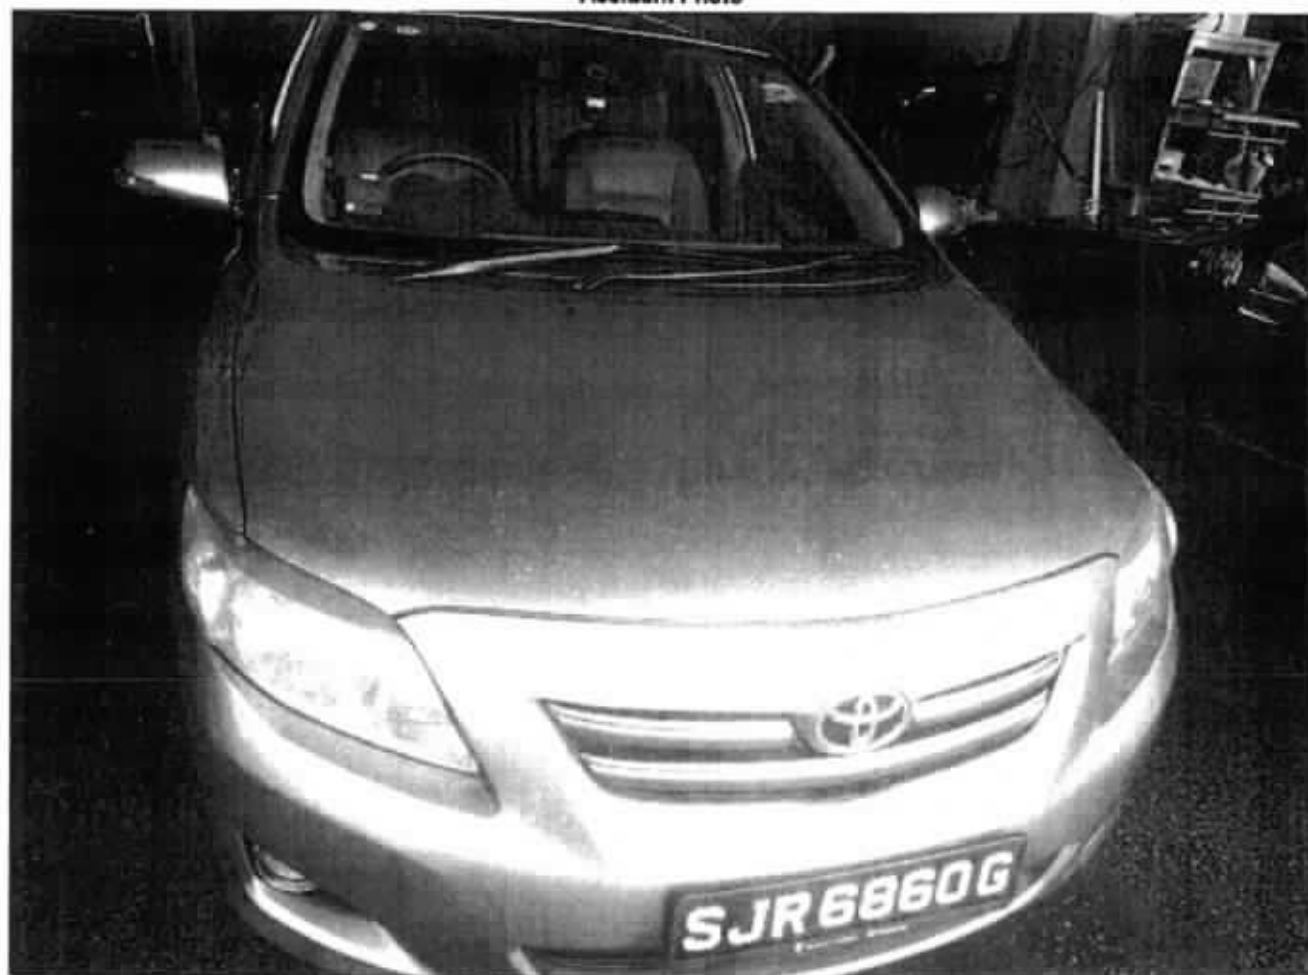
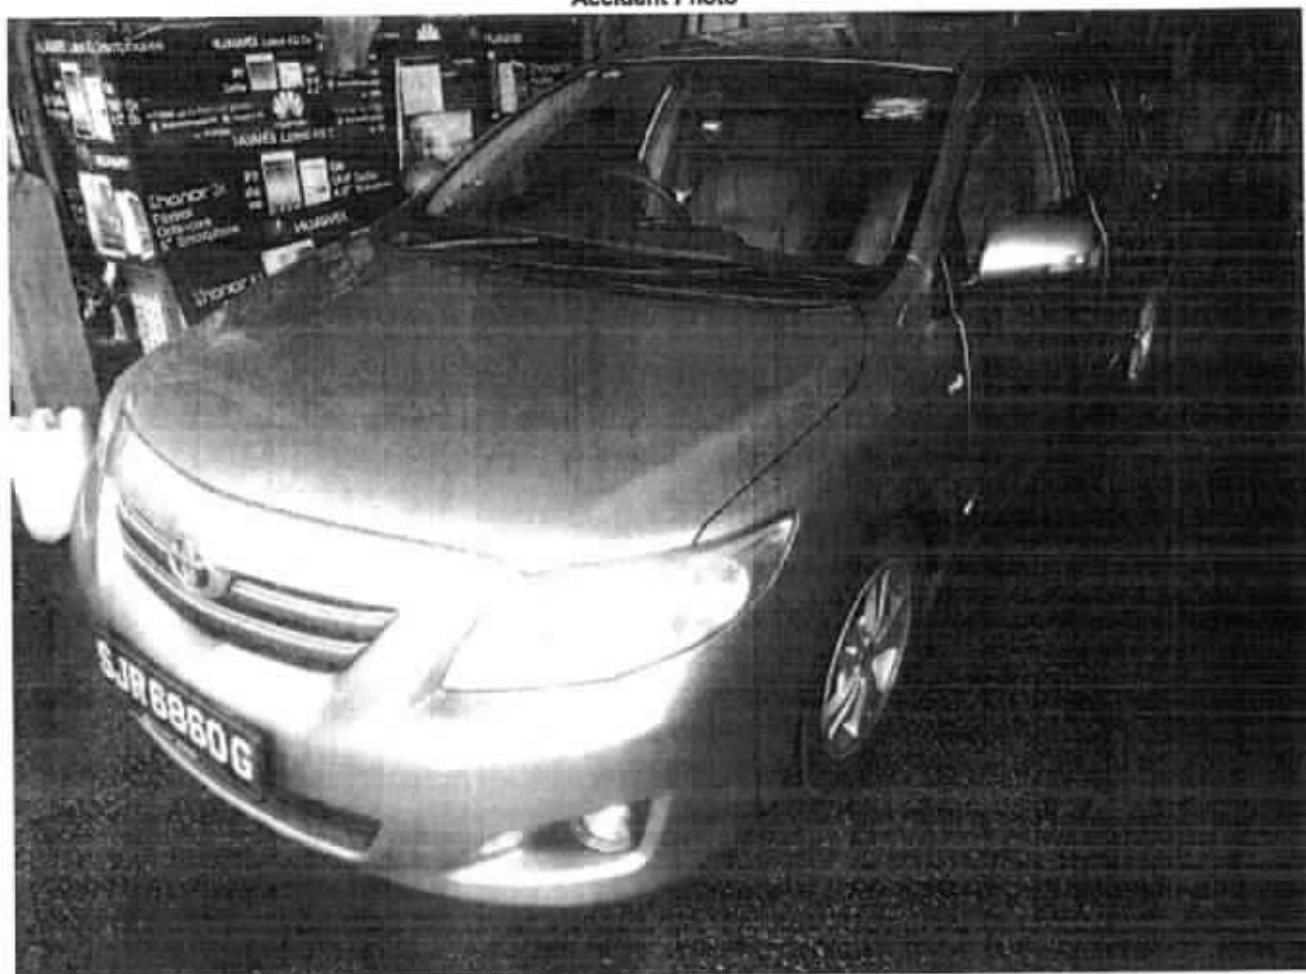
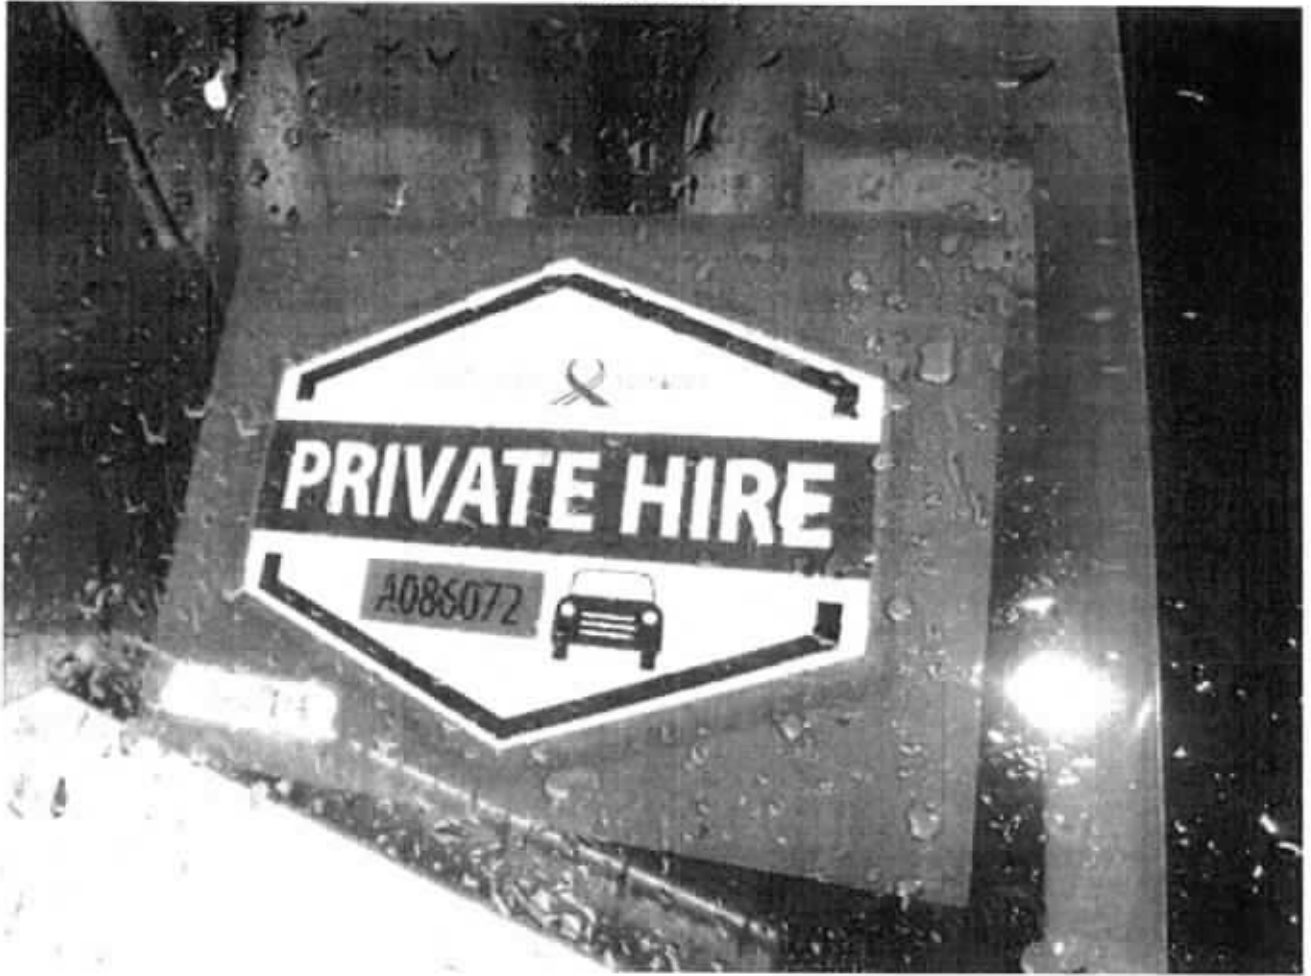
Accident Photo

THE VEHICLE SUSTAINED DAMAGES AT THE REAR PORTION.
DAMAGES SEE DETAILS.
