ASSIGNMENT

Veh No: **SHC 667R** Yr Regn: **15 Dec, 2017**
 Type: M.Car / M.Cycle / Bus / Van / Lorry / Taxi / Prime Mover /
 Truck / Trailer or
 Make: **Hyundai Ix0** C.C. **1685**
 Colour: **Yellow** A/C: Insured / Std / NI / NA
 Sp. Reading: **150044** T/Radio: Insured / Std / NI / NA
 Eng. No: _____
 C/No: **KMHCB4111111111111111**
 Gen. Cond: Good / Fair / Poor / Burnt
 Steering: In order / Jammed / Leaked / Burnt or
 Brake: In order / Jammed / Leaked / Burnt or
 Modi: Nil / S/Rim / STD / A/Rim or
 Tyre Size: F: **205/60R16**
 R: _____

Please be informed that we had inspected the vehicle SHC 667R, M/s: COMFORTDELGRO ENGINEERING PTE LTD, 59 LOYANG DRIVE SINGAPORE 508969 on 19/11/2018.

VEHICLE DAMAGE INSPECTION REPORT

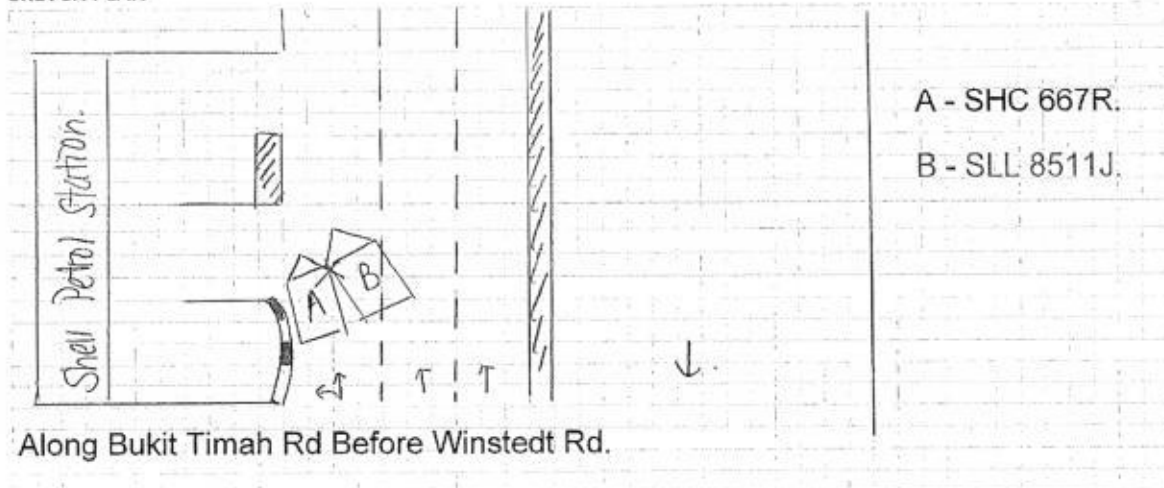
SKETCH PLAN

On 16.11.2018 at about 11:00 hrs, I was travelling along Bukit Timah Rd before Winstedt Rd
with no passenger on board.
I was travelling on the extreme left lane. I slowed down my vehicle and wanted to turn left into
the petrol kiosk on my left. Suddenly, veh (B) (SLL 8511J) cut into my lane from my right and
collided into my taxi (A) front right portion.
Both of us then alighted and exchanged the particulars. I have company video fixed in my taxi
and photos taken at scene to support my claims.
Veh (B) (SLL 8511J) was driven by Mr. Tan Jian Sheng. NRIC : S 8212459D. Hp : 9756 2193.
No injury in this accident.

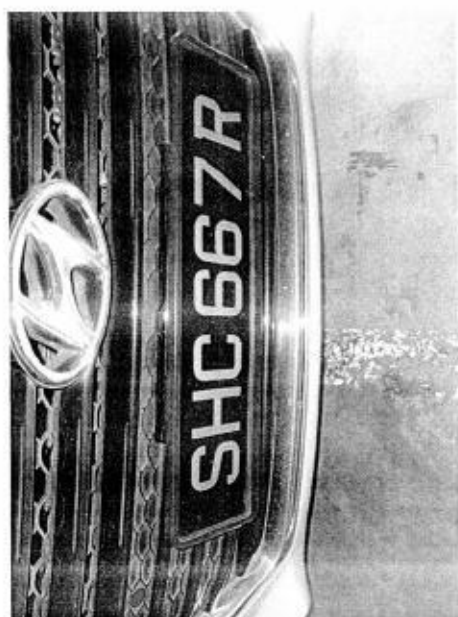
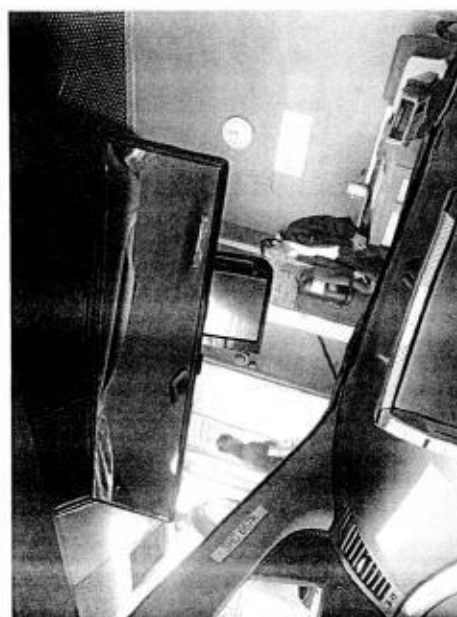
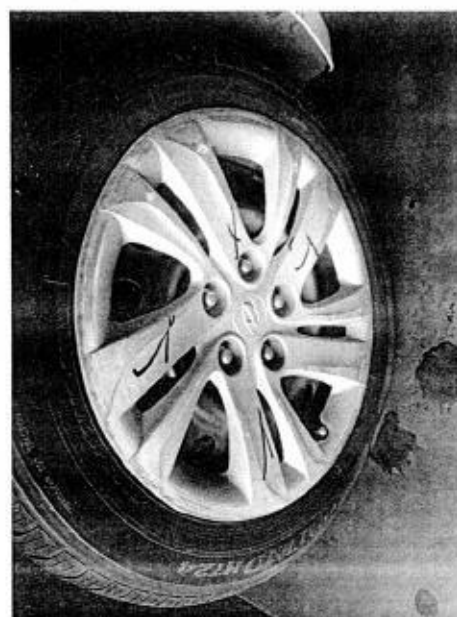
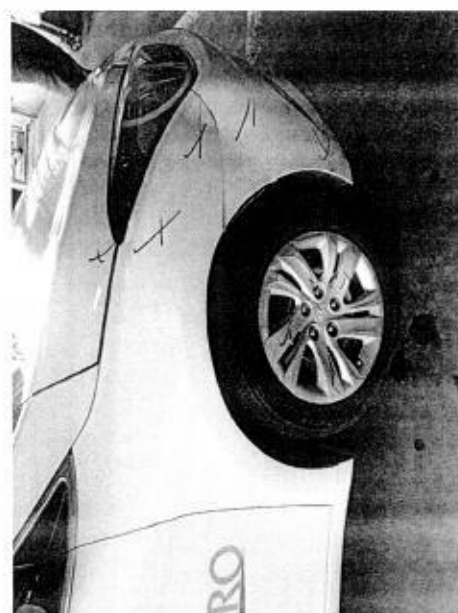
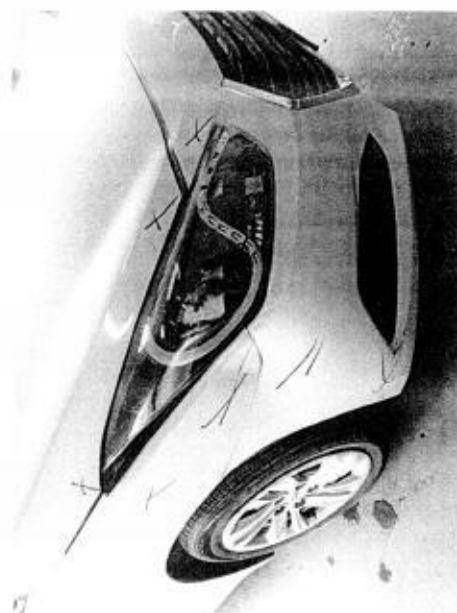
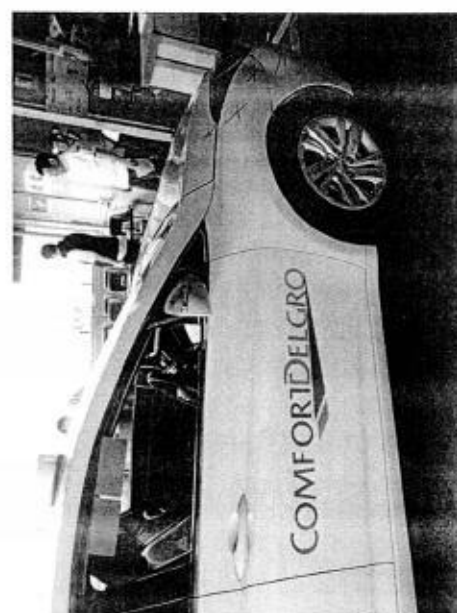
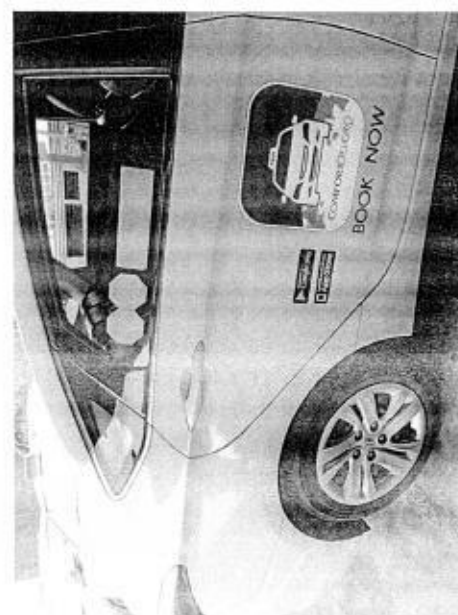
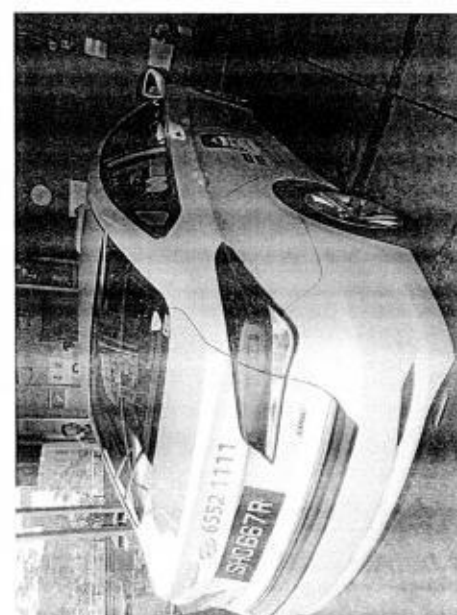
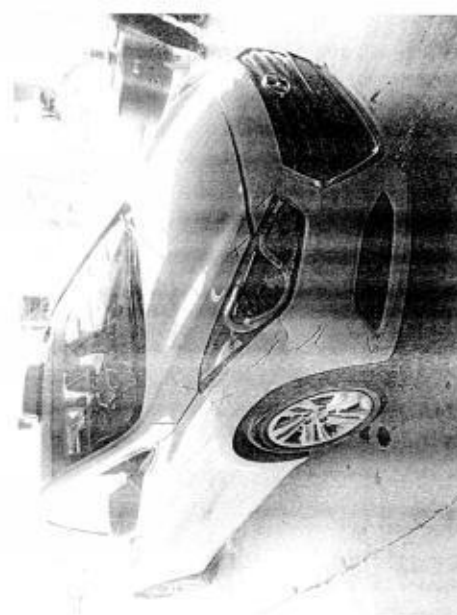
Des. of Damages: Frt / Rear / O/S / N/S / U/C / Rooftop or
O/S Front

The U/C / Chassis frame / Body Structure affected due to collision.

* DAMAGES CONSISTENT TO ACCIDENT REPORT.

No.	Qty	Part No.	Particulars	Condition	Repairer's	Amount
1	1		*FRONT BUMPER	Deformed	1,052.20 FL	*1,052.20 FL
2	1		*FRONT BUMPER BRACKET RH	Serviceable	24.60 FL	*- FL
3	1		*HEADLAMP RH	Cracked	1,388.00 FL	*1,388.00 FL
4	1		*FRONT FENDER RH	Dented	566.30 FL	*566.30 FL
5	1		*FRONT WHEEL HUP CAP RH	Grazed	107.10 FL	*107.10 FL
6	1		*FRONT FENDER SIDE RETAINER	Serviceable	24.60 FL	*- FL

No	Particulars	Lab.Type	Repairer's	Amount
<u>Labour Items</u>				
1	PANEL BEATING	New	500.00	300.00
2	SPRAY PAINTING CHARGE	New	500.00	400.00
3	WIRING CHARGE	New	50.00	20.00
4	TUFF KOTE	New	50.00	20.00
5	FRONT WHEEL ALIGNMENT	New	80.00	-
Gross Labour Cost (S\$)			1,180.00	740.00

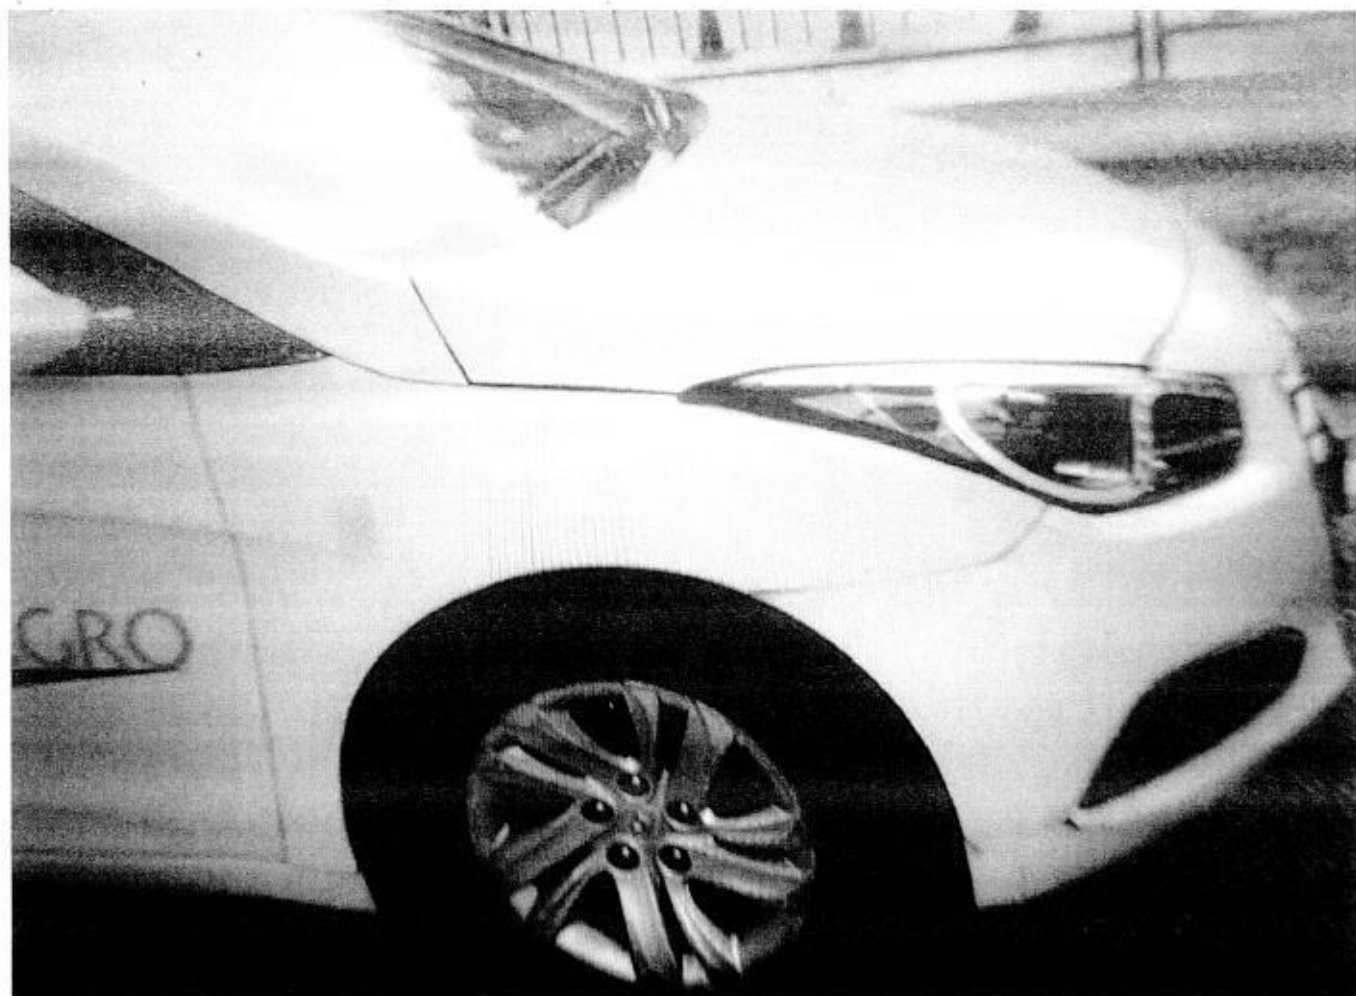
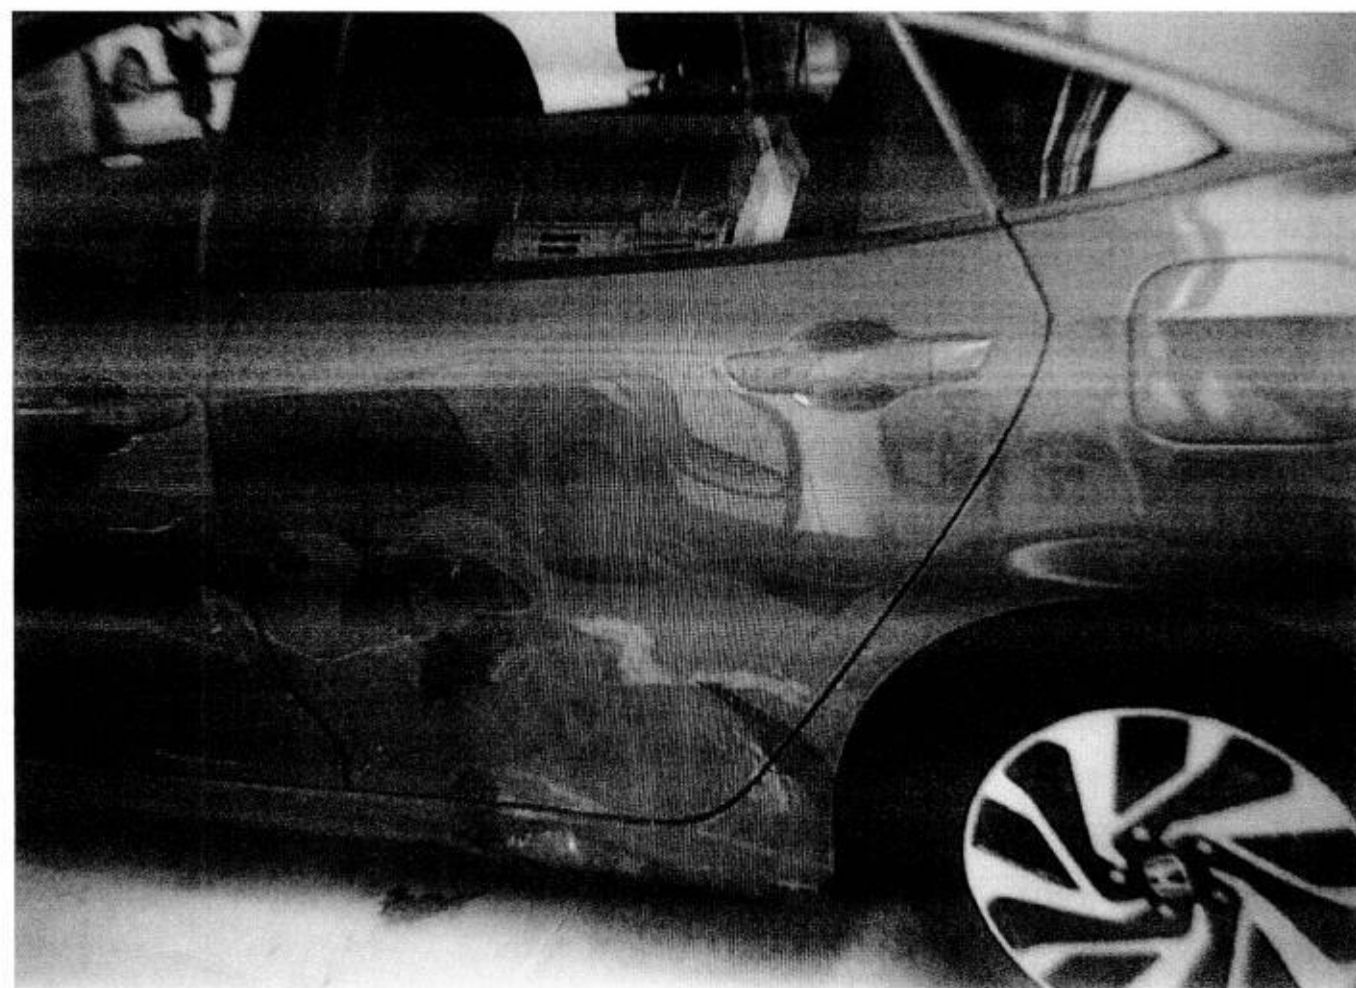
Remark: The veh had commenced its repair at the time of inspection.
