Preliminary Advice

VEHICLE DAMAGE INSPECTION REPORT

Our File No: CS/SMO18020929/R1QBN2

Handling Insurer:	Sompo Insurance Singapore Pte. Ltd.	Policy No:	D18MTPV01008085
Claimant Vehicle No :	SLN8522S	Insured Vehicle No :	SLF56R
Date of Loss:	15/11/2018	Nature of Claim:	TP
		Claim No:	CMTD1805016

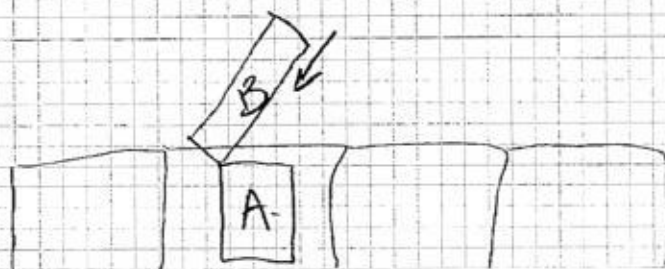
SKETCH PLAN

Public carpark behind Seacane Hotel.

A: SW 8522-S

B: SLF 56R

LICENSE PLATE: SW 8522-S	ACCIDENT DATE & TIME: 15.11.2018
CONTACT NUMBER: 9765 9807	E-MAIL ADDRESS:
LOCATION: Public carpark behind Seacane Hotel.	
My car A (SW 8522-S) was parked at the above mentioned carpark and car B (SLF 56R) hit my front left area while reversing.	
I was not in the vehicle when incident happen, a note ^{was} by left	
car B on my windscreen by car B owner.	
NOTE: PLEASE NOTE THAT YOUR INSURER MAY HAVE 14 DAYS TIME FRAME FOR YOU TO SUBMIT AN OWN DAMAGE CLAIM UNDER YOUR OWN POLICY. PLEASE CHECK YOUR POLICY FOR MORE INFORMATION	
Please state:	
<input type="checkbox"/> Claim Own Policy <input checked="" type="checkbox"/> Claim Third Party <input type="checkbox"/> Claim OD/TP at other workshop <input type="checkbox"/> Reporting Only
