PAPER SURVEY OF FBC2957L

VEHICLE DAMAGE INSPECTION REPORT

Reg No:	FBC2957L	Make &	Honda
Reg date:	16/1/2008	Model	ANF 125MSS A
Colour:	Red	Engine No:	NF125MME5000736
Type:	Motorbike	Chassis No:	NF125MM5000736
Type of Claims:	Third Party	Odometer No:	N.A
		Engine Cap:	125cc

ADJUSTMENT ON REPAIR COST FOR VEHICLE NO. FBC 2957L

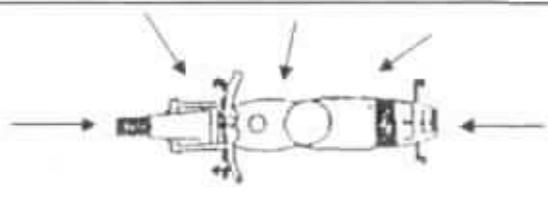
POINT OF IMPACT

Damaged at the front, right hand front, right hand rear and rear portion

Our visual inspection of the vehicle revealed that the damages noted are the front, right hand front, right hand rear and rear portion.

We have inspected the actual damages found on the vehicle and recommend the replacement of parts and repairs accordingly. The estimated repair cost is \$5,478.50. The repairer has agreed to undertake the repairs at our adjusted lump sum amount of \$4,200.00.
