Veh No: SHA 34 020 Yr Regn: 24 Mar 2016
 Type: M. Car / M. Cycle / Bus / Van / Lorry / Taxi / Prime Mover /
 Truck / Trailer or
 Make: Hyundai I40 c.c. 1685
 Colour: B/wh A/C: Insured / Std / NI / NA
 Sp. Reading: 38 6809 T/Radio: Insured / Std / NI / NA
 Eng/No: _____
 C/No: KMHLDX1UH4085780
 Gen. Cond: Good / Fair / Poor / Burnt
 Steering: In order / Jammed / Leaked / Burnt or
 Brake: In order / Jammed / Leaked / Burnt or
 Modi: Nil / S/Rim / STD A/Rim or
 Tyre Size: F: 205/60R16
 R: _____
 BS / DUN / EXNOVA / GY / FS / LIZA / MIC / OHTSU / PIR / SUMI /
 TOYO / YOKO or Westlake
 Front: _____ Rear: _____
 R/Bal. 7 mm R/Bal. 7 mm
 L/Bal. 7 mm L/Bal. 7 mm
 D.O.A. 20/11/18 D.O.I. 21/11/18
 Survey held at CDGE (Loyang)
 Des. of Damages: Frt / Rear / O/S / N/S / U/C / Rooftop or
0/5 Rear
 The U/C / Chassis frame / Body Structure affected due to collision.

SINGAPORE ACCIDENT STATEMENT

VEHICLE DAMAGE INSPECTION REPORT

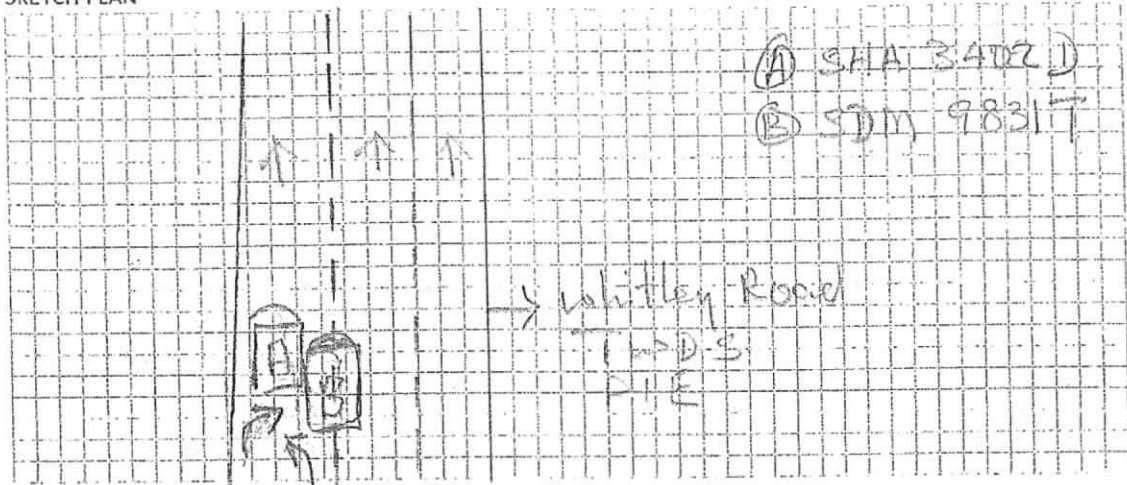
SKETCH PLAN

On 20/11/2018 at about 1500 hrs, I vehicle A was driving along Whitley road toward PIE on most-left lane. There was merger lane and I'm ahead of him in the merger lane, he didn't slow down and brush-into vehicle A right rear portion. When I got out from my taxi I took some picture and vehicle B body was half of dot line.

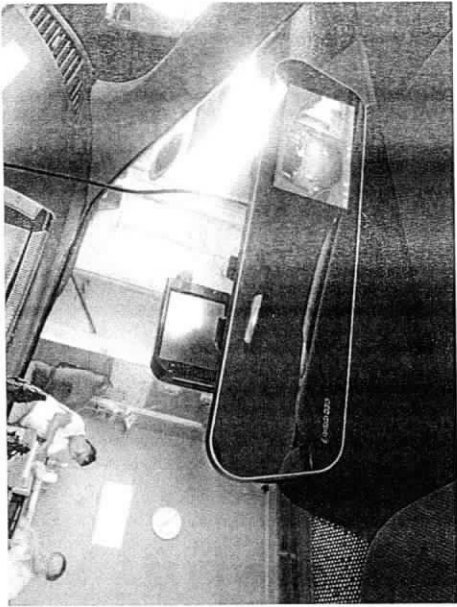
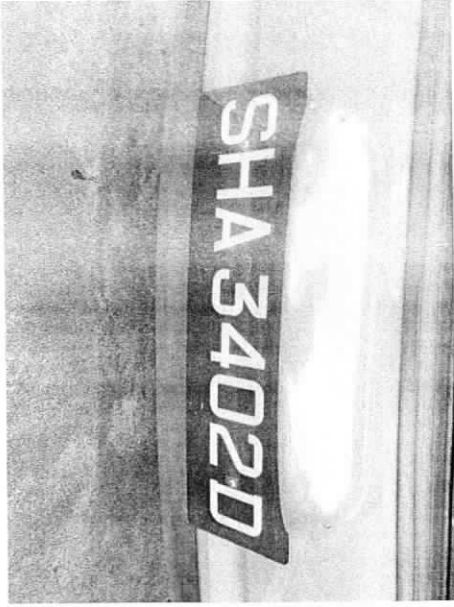
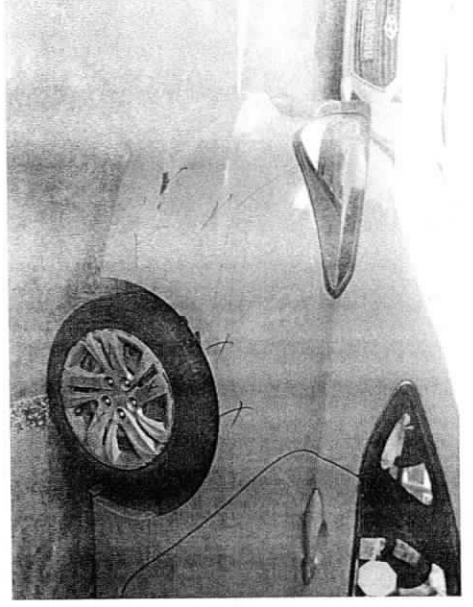
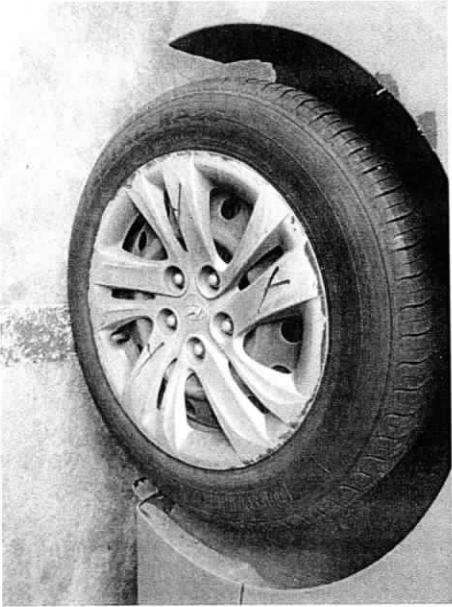
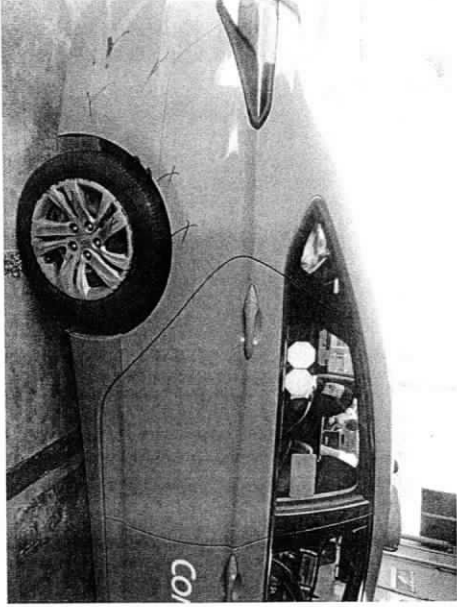
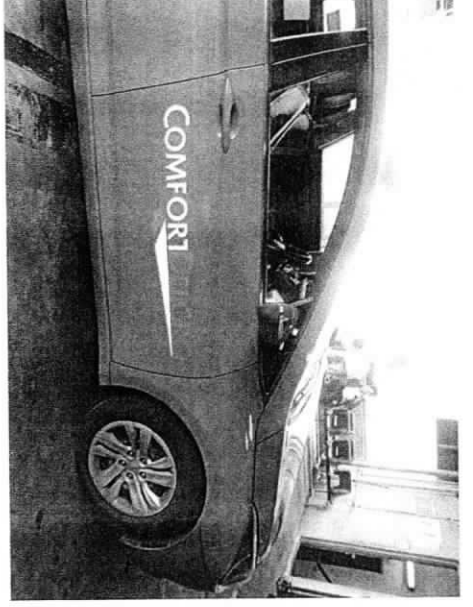
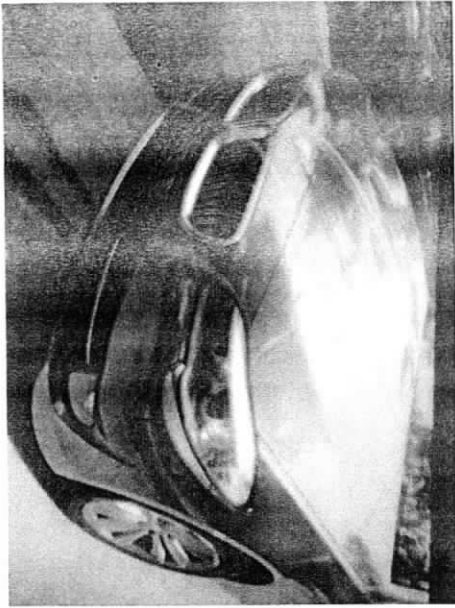
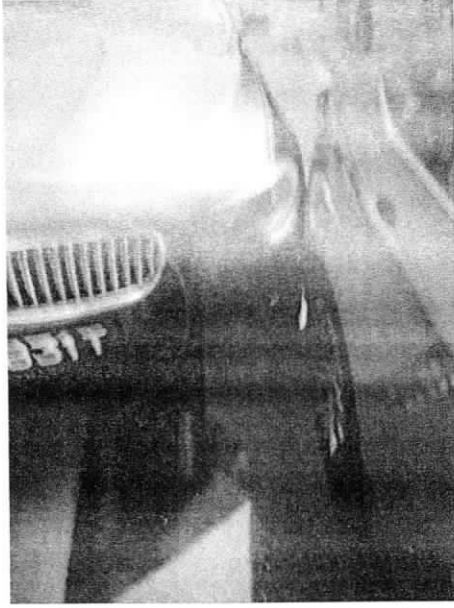
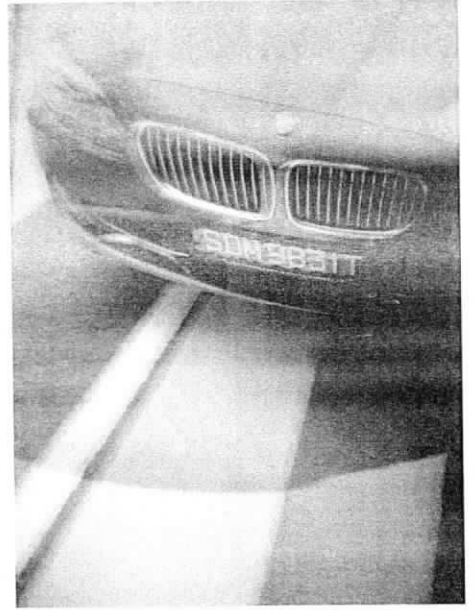
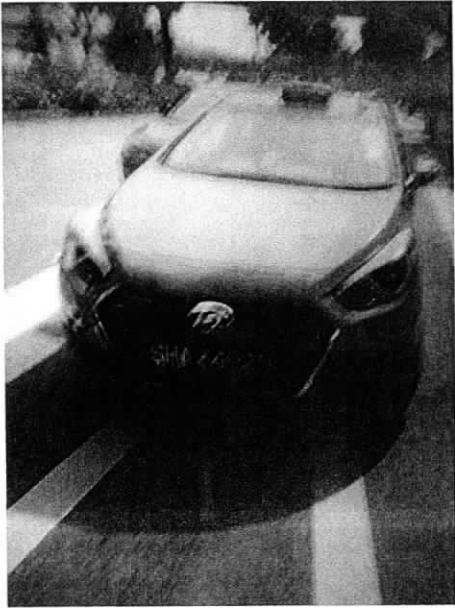
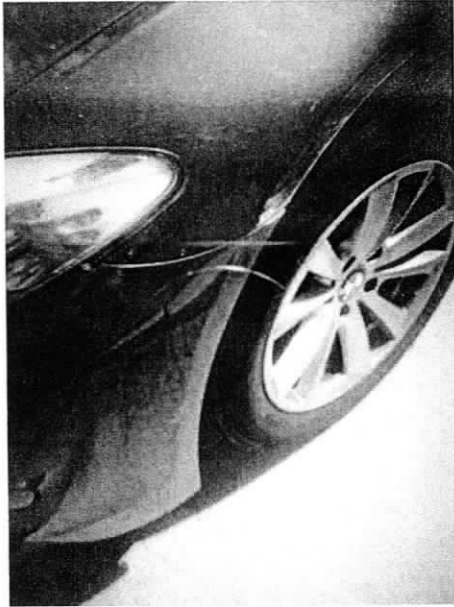
Date / Time	Action / Instruction
22/11/18	Subm PIP \$ 695.68 / 2 Dgs. Used \$ 1038.48, 60% Tolko
	* DAMAGES CONSISTENT TO ACCIDENT REPORT.

NOTE: DAMAGES CONSISTENT TO ACCIDENT REPORT

No.	Qty	Part No.	Particulars	Condition	Repairer's	Amount
1	1		*REAR BUMPER	Repair	553.00 FL	*- FL
2	1		*REAR BUMPER BRACKET - RH	Serviceable	35.60 FL	*- FL
3	10		*REAR BUMPER CLIPS	Not Necessary	22.00 FL	*- FL
4	1		*REAR BUMPER RUBBER	Not Necessary	50.00 FS	*- FS
5	1		*REAR WHEEL COVER - RH	Grazed	107.10 FL	*107.10 FL
6	1		*REAR FENDER (RH)(NPA)	Repair	-	*- FL

No	Particulars	Lab.Type	Repairer's	Amount
Labour Items				
1	PANEL BEATING	New	500.00	200.00
2	SPRAY PAINTING	New	500.00	400.00
3	REMOVE/REFIX REVERSE SENSOR	New	100.00	-
Gross Labour Cost (S\$)			1,100.00	600.00
