VEHICLE DAMAGE INSPECTION REPORT

Our File No: CS/AIG18021115/UTBN2

Handling Insurer: AIG Asia Pacific Insurance Pte. Ltd. Policy No: 2100414973
 Claimant Vehicle No: SLK4860H Insured Vehicle No: SKT2050G
 Date of Loss: 21/11/2018 Nature of Claim: TP Claim No: 1712031970SG

Reg No: SLK4860H
 Make & Model: TOYOTA PRIUS, 1.5 HYBRID (A) Engine No: 2ZR6842048
 Reg. Date: 18/01/2017 (Man. Year: 2016) Chassis No: ZVW506043506
 Colour: Black Odometer: 161202 km
 Engine Capacity: 1797 cc
 Market Value/New Car Price: N/A
 Price:
 Sum Insured (\$\$): Market Value/New Car Price

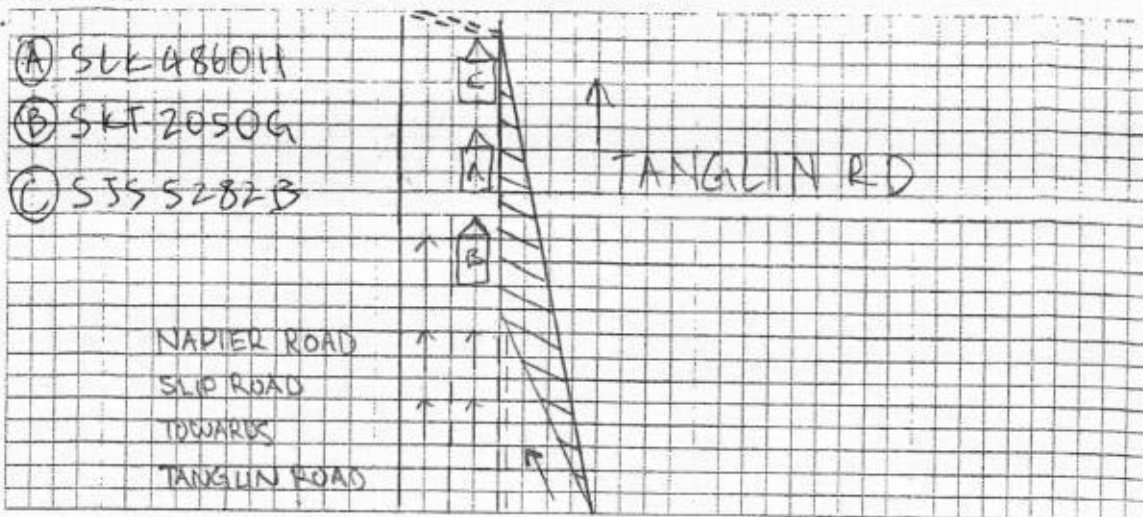
SKETCH PLAN

DESCRIBE CIRCUMSTANCES OF THE ACCIDENT

WAS TRAVELLING FROM NADIER RD ENTERING TANGLIN RD VIA SLIP ROAD WHERE THE ACCIDENT HAPPENED ON 21 NOV 2018 AT 1225 HRS. CAR (C) CAME TO A STOP AND I MANAGED TO STOP IN TIME. THEN SUDDENLY CAR (B) HIT ME BEHIND CAUSING ME TO JERK IN FRONT AND HIT CAR (C). BUT CAR (C) DROVE OFF.
