SKN 5615P

Mazda 3

- Pre repair inspection request - SKN5615P VS SLM4540X (OI) DOA 21/11/2018

VEHICLE DAMAGE INSPECTION REPORT

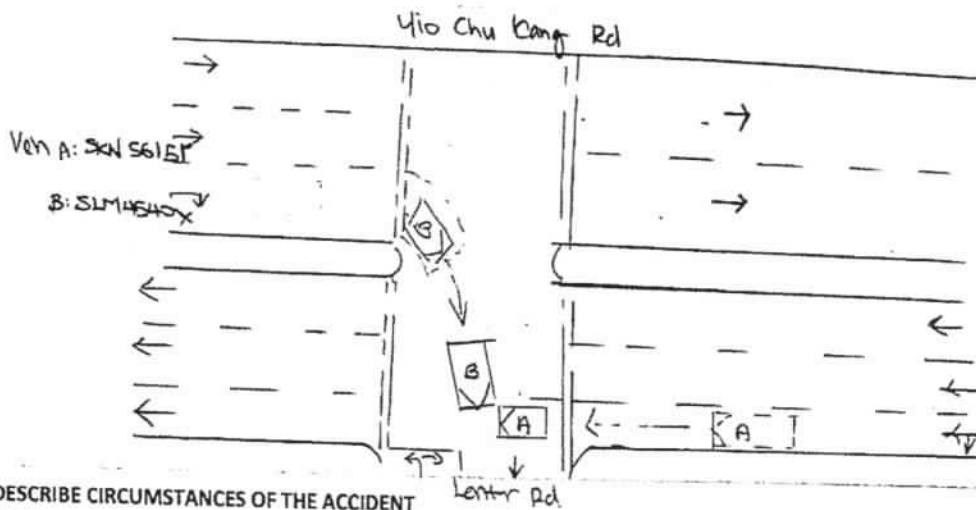
SKETCH PLAN

On 21/11/18 at about 8:47pm, I was travelling on the extreme left lane along Yio Chu Kang Rd. The traffic light at Lenton Rd junction was green in my favour. Hence, I proceeded straight. Vehicle B which was turning right from the opposite direction did not wait for his turn and collided into my vehicle's front right portion. The impact resulted in both the airbags in my vehicle being activated. Both me and my wife felt unwell after the accident.
