## AUTOMOBILE ASSESSMENT REPORT

Assessment of Vehicle No : SJS 6589K  
Date of Accident : 21/08/2018  
Date of Inspection : 28/08/2018

#### 4.DESCRPTION OF DAMAGE

## VEHICLE DAMAGE INSPECTION REPORT

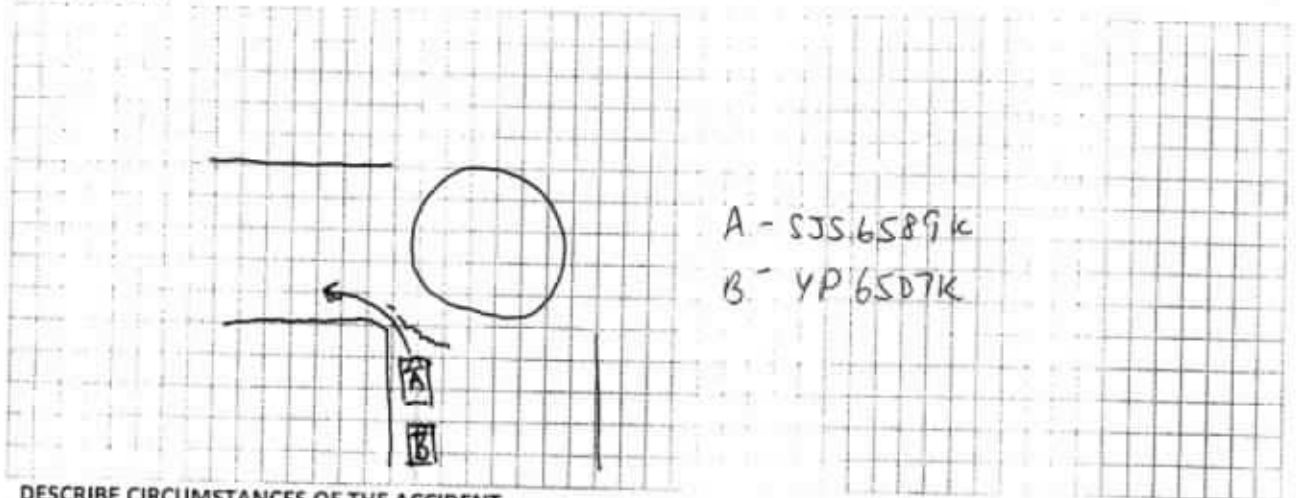
SKETCH PLAN

when I was driving along pioneer Rd North toward Ate and my car stop at the corner beside the road about to give way to other vehicle. Suddenly, there is a hit from behind, a 10 foot long lorry just hit my car back.

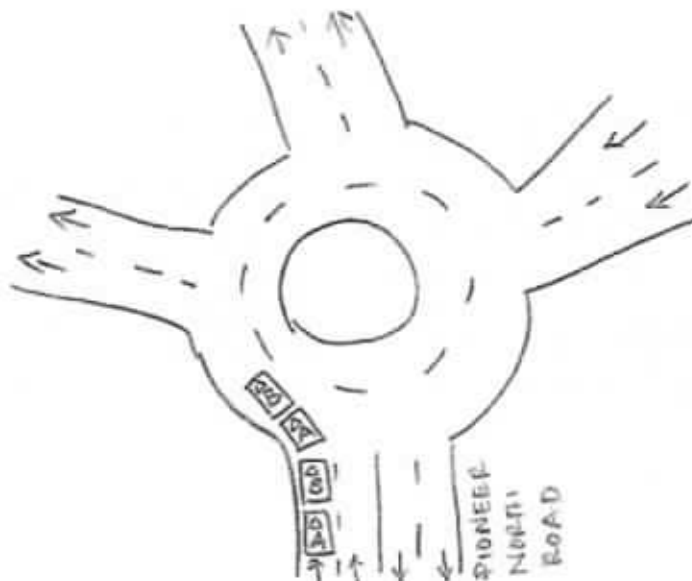
SKETCH PLAN

A: YP6507K

B: SJS6589K

ON THE MENTIONED DATE & TIME, I WAS STATIONARY AT THE JUNCTION OF PIONEER NORTH ROAD & WAITING TO GO INSIDE OF THE ROUNDABOUT. SAW VEHICLE SJS6589K MOVE INTO THE ROUNDABOUT, I RELEASED BRAKES AND FOLLOWED. OUT OF A SUDDEN, VEHICLE SJS6589K E-BRAKE FOR NO REASON. I TRIED TO STOP TO AVOID COLLISION BUT IT WAS STILL TOO LATE. AS A RESULT, MY VEHICLE HIT THE BACK OF THE SAID VEHICLE. NO INJURY WAS INVOLVED. THERE WAS NO VISIBLE DAMAGES TO MY VEHICLE AS THE IMPACT WAS WEAK.
