To Inspect Vehicle No:

### 1. Policy Particulars :- THIRD PARTY CLAIM

### 4. Description of Damages

## ADJUSTMENT ON REPAIR COST FOR VEHICLE NO. SLQ 8971M

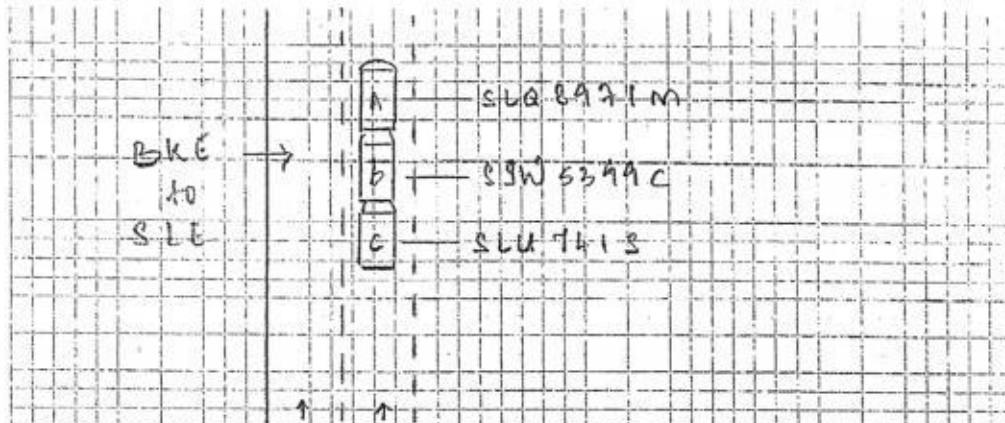
## SKETCH PLAN

I was driving along BKE towards SLE at the 1/2 km. front vehicle slow down and came to a stop and I followed. A few seconds later, I felt a bang from behind. I came out from my vehicle and realised it's a chain collision.

From my video clip, veh B had stop when veh C hit into into veh B and veh B hit into my stationary vehicle
