Loss Adjuster, Consulting Automotive Engineer, Accident Reconstruction & Analyst.**VEHICLE APPRAISAL REPORT**

ASSESSMENT FOR REPAIR : FBH 4236 U

ADJUSTMENT ON REPAIR COST FOR VEHICLE NO. FBH 4236U

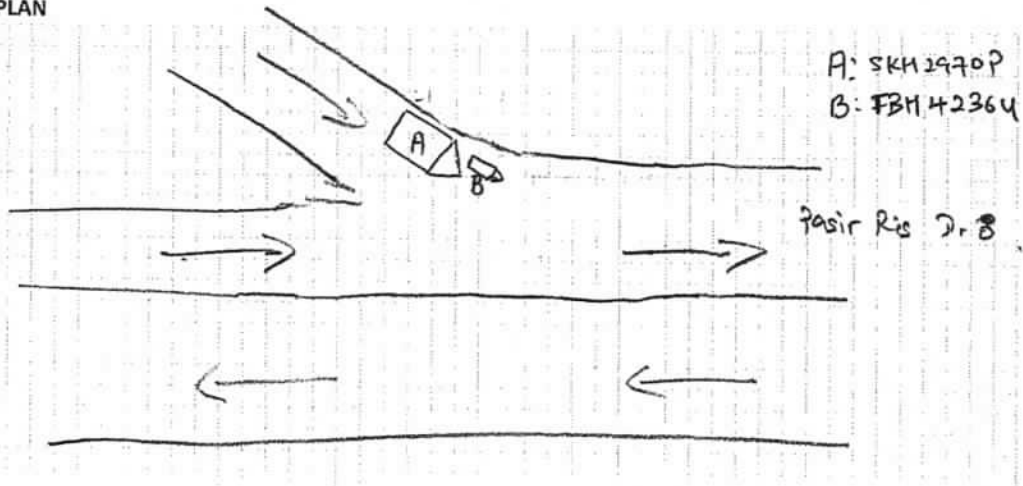
SKETCH PLAN

Along Pasir Ris Dr 8. My car hit the back of a motorcycle FBH4236U. The motorcyclist fell on the ground, however no bleeding to the person only minor bruises. There was a minor oil leak to the motorcycle.
