## VEHICLE DAMAGE INSPECTION REPORT

Our File No: CC3/MSG18021399/USD3N2

Handling Insurer:	MSIG Insurance (Singapore) Pte. Ltd.	Policy No:	A29051188QMX
Claimant Vehicle No :	SLW1253S	Insured Vehicle No :	SLU130E
Date of Loss:	27/11/2018	Nature of Claim:	TP
		Claim No:	577289

Reg No:	SLW1253S	Engine No:	G4FGHH692073
Make & Model:	KIA FORTE K3, 1.6 (A)	Chassis No:	KNAFJ411MJ5761770
Reg. Date:	30/01/2018 (Man. Year: 2017)	Odometer:	7420 km
Colour:	Blue		
Engine Capacity:	1591 cc		
Market Value/New Car Price:	N/A		
Sum Insured (\$\$):	Market Value/New Car Price

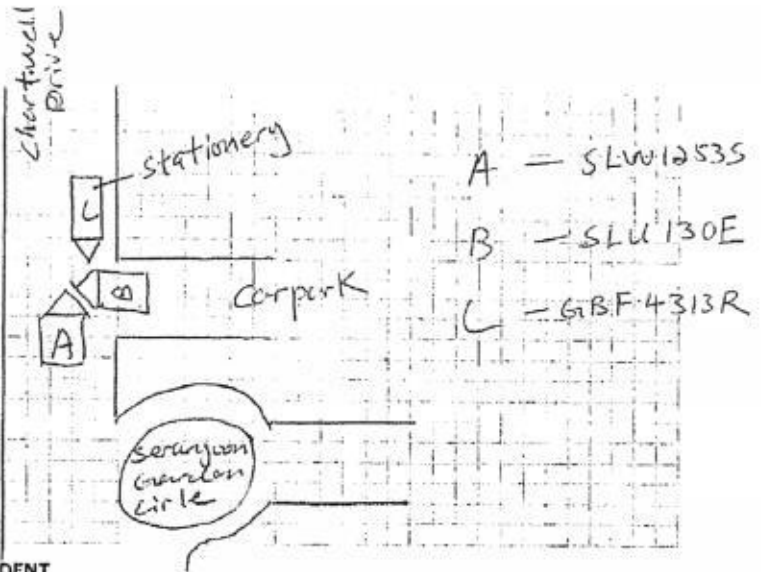
SKETCH PLAN

on the stated date and time, I was driving my vehicle A from Serangam Garden circle, when I reach along chartwell Drive. Suddenly vehicle B rush out from the carpark and hit on my RH side portion, vehicle B also hit on vehicle C that was stationery
