INITIAL INSPECTION REPORT OF VEHICLE NO. SLL 9565Y .

Please be informed that we had conducted the inspection of the abovementioned vehicle on 28/11/2018 at the premises of M/s Glockewerke and have the following to report:-

ADJUSTMENT ON REPAIR COST FOR VEHICLE NO. SLL 9565Y

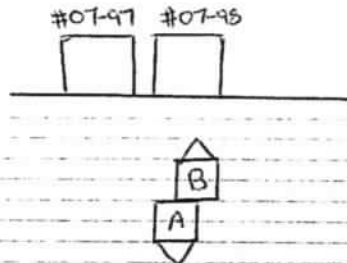
Sketch Plan Pg. 2

Vehicle A - SLL9563Y
Vehicle B - GY4978M

On the 20/11/2018 @ about 12.20pm. My Vehicle A was parked outside unit #07-98 of Enterprise Hub No. 48 Toh Guan Road East. Suddenly a Vehicle B reversed into the rear portion of my Vehicle A causing damages to my Vehicle.
