TP Claims against NTUC Income: Follow-Through Survey

NTUC INCOME INSURANCE CO-OPERATIVE LTD Ref: NS/INC18021520/Nqd3e2			
73 BRAS BASAH ROAD #05-01 NTUC TRADE UNION HOUSESINGAPORE 189556		Date: 16-01-2019	 
Code: INC4

1. Policy Particulars :- THIRD PARTY CLAIM			
Insured Veh.	GBD 8931R	Veh. Inspected	SMB 3522B
Policy No.	5087599956-01	Coverage (\$)	0.00
Claim No.	MT/1021086-002	Excess (\$)	0.00
Assign From		Assign Date	23/11/2018

ADJUSTMENT ON REPAIR COST FOR VEHICLE NO. SMB 3522B

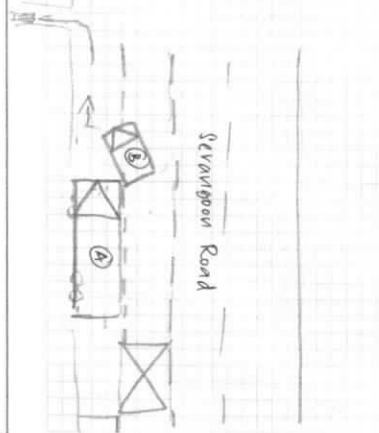
Sketch Plan Pg. 2

While travelling straight on the left most lane along Serangoon Rd, a lorry (GBD8931R) that was on the 3rd lane overtook my bus and in the process of overtaking, the lorry's left rear portion side swipe against bus right view mirror. No injuries reported. Bus sustained right side view mirror cracked.
