## **Preliminary Advice**

Insured Vehicle No	: GBC9300K	Accident Date	: 17/11/2018
TP Vehicle No	: SKS6866Z	Assignment Date	: 03/12/2018
Make	: BMW X1	Est. Duration of Repair	: 6.00
Date of Inspection	: 03/12/2018		
Inspection At	: PERFORMANCE MOTORS LIMITED (BUKIT TIMAH) 896 DUNEARN ROAD #01-01 SIME DARBY CENTRE SINGAPORE 489572

## VEHICLE DAMAGE INSPECTION REPORT

Handling Insurer:	Sompo Insurance Singapore Pte. Ltd.	Policy No:	D18MTHCVE000143
Claimant Vehicle No :	SKS6866Z	Insured Vehicle No :	GBC9300K
Date of Loss:	17/11/2018	Nature of Claim:	TP
		Claim No:	CMTD1805070

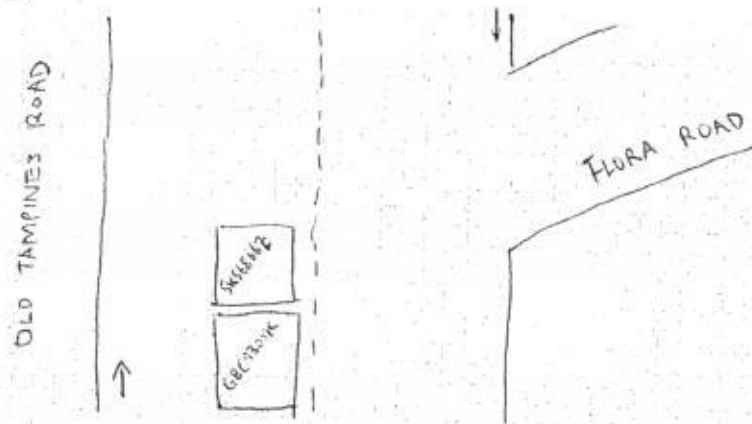
## SKETCH PLAN

Type Of Accident	COLLISION - HEAD TO REAR
Weather Conditions	CLEAR
Road Surface	WET

I WAS WAITING AT THE RED LIGHT TO TURN RIGHT. AFTER THE LIGHT TURNED GREEN, THE CAR IN FRONT OF ME SET OFF. BEFORE I SET OFF, THE DELIVERY TRUCK (GB6930-K) CRASHED INTO MY REAR.
