## VEHICLE DAMAGE INSPECTION REPORT

Handling Insurer:	China Taiping Insurance (Singapore) Pte. Ltd.	Policy No:	DMCVSN1822481800
Claimant Vehicle No :	SLQ6658G	Insured Vehicle No :	GBH6064K
Date of Loss:	28/11/2018	Nature of Claim:	TP
		Claim No:	SNM18D05592C02

Reg No:	SLQ6658G	Engine No:	CTH062494
Make & Model:	VOLKSWAGEN TOURAN, 1.4 TSI (A)	Chassis No:	WVGZZZ1TZDW090037
Reg. Date:	26/06/2013 (Man. Year: 2013)	Odometer:	135908 km
Colour:	White		
Engine Capacity:	1390 cc		
Market Value/New Car Price:	N/A		
Sum Insured (\$\$):	Market Value/New Car Price

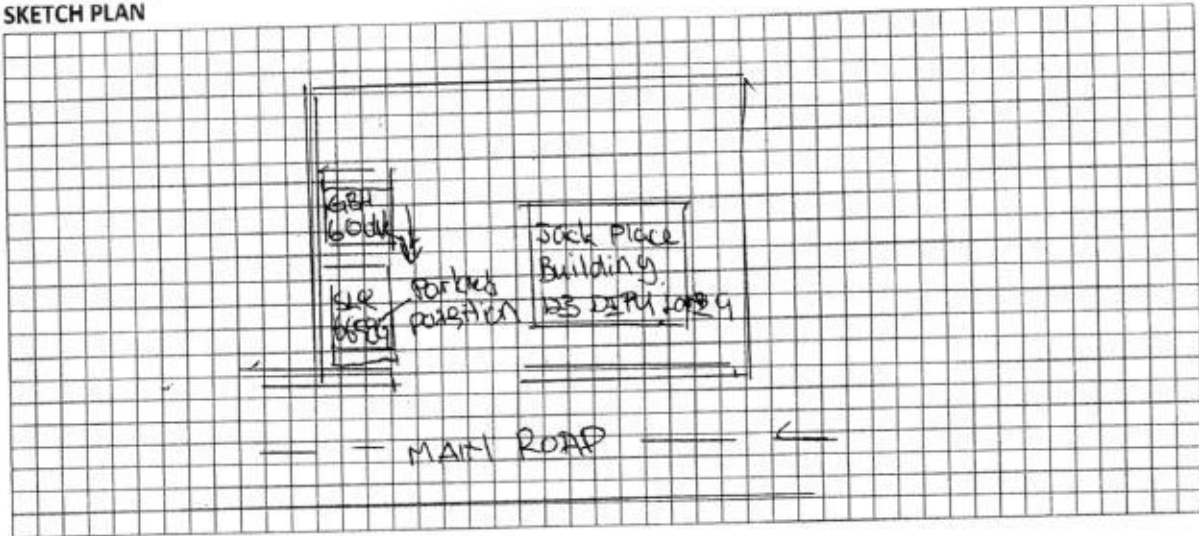
SKETCH PLAN

Accident happened at 9.30 am (approx.) at 123 PEFU LANE 9 (Jack Place Building) My vehicle is on parking position as I went in the building to collect my cake as I have order. The heavy went into the car (GEB 6064 K) went into his vehicle and start reverse and hit my car back. This is all I have to say.
