**RE: ACCIDENT INVOLVING SKP 7995 T / SLG 9100 G ON 4/12/18 ALONG NORTH BRIDGE ROAD JUST BEFORE NORTH BOAT QUAY**

## VEHICLE DAMAGE INSPECTION REPORT

Our File No: CS/AIG18021820/KSD3N2

Handling Insurer: AIG Asia Pacific Insurance Pte. Ltd. Policy No: 0999994427  
 Claimant Vehicle No: SKP7995T Insured Vehicle No: SLG9100G  
 Date of Loss: 04/12/2018 Nature of Claim: TP Claim No: 9543793359SG

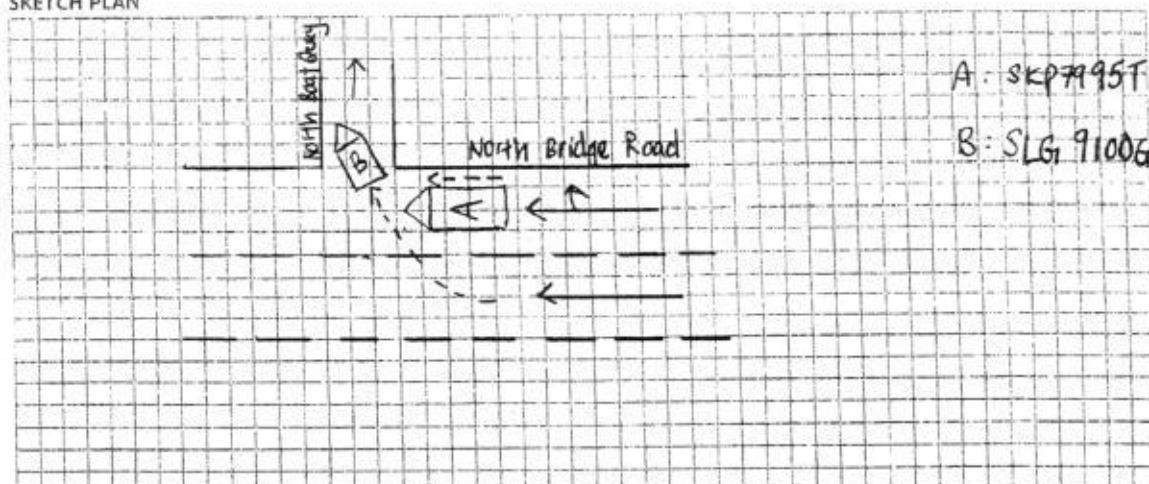
SKETCH PLAN

I was travelling at the first lane of North Bridge Road (before North Boat Quay), going straight at about 8.55am on 4 Dec 2018.

The vehicle on my left, SLG 91006, was travelling on a go-straight lane and made a sudden right turn into North Boat Quay.

I applied the emergency brake at the first instance when I saw the vehicle SLG 91006 making the sudden turn.

my car hit into the right of the vehicle's rear.
