VEHICLE DAMAGE INSPECTION REPORT

Our File No: CS/CTI18021831/DVD3N2
Date: 12/03/2019

Handling Insurer:	China Taiping Insurance (Singapore) Pte. Ltd.	Policy No:	DMPCSN3001021801
Claimant Vehicle No :	GZ9469C	Insured Vehicle No :	SKZ6179L
Date of Loss:	28/11/2018	Nature of Claim:	TP
		Claim No:	SNM18D05585

Reg No:	GZ9469C	Engine No:	1KD1528817
Make & Model:	TOYOTA DYNA 150, 3.0 D (M)	Chassis No:	JTFAT35Y003000131
Reg. Date:	30/11/2006 (Man. Year: 2006)	Odometer:	225842 km
Colour:	White		
Engine Capacity:	2982 cc		
Market Value/New Car Price:	N/A		
Sum Insured (S\$):	Market Value/New Car Price

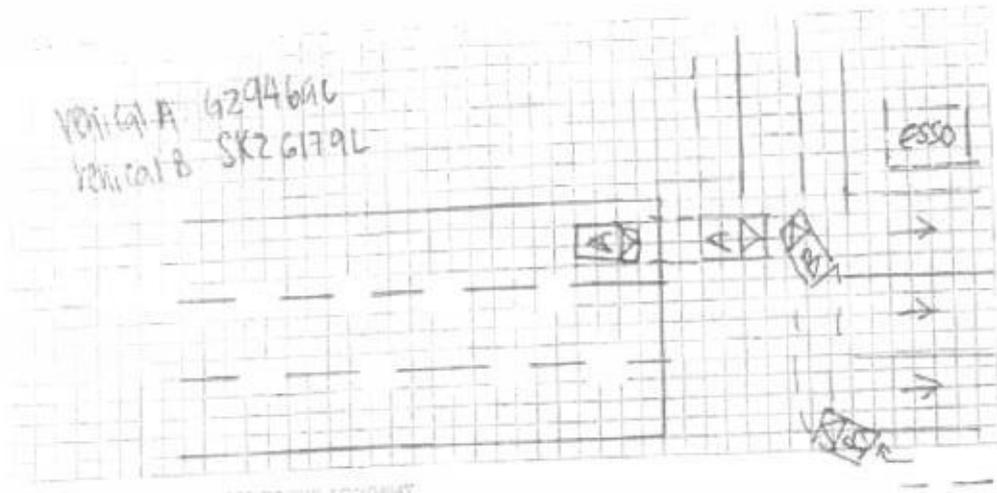
Accident Sketch Plan

I was travelling along Argus Road towards
 Langney along straight. Traffic in my favour as I was
 approaching the junction Vehicle B from the opposite road suddenly
 crossed my path and collided into me
