Preliminary Advice

Insured Vehicle No	: SKW8083G	Accident Date	: 07/12/2018
TP Vehicle No	: SHB8865M	Assignment Date	: 10/12/2018
Make	: KIA OPTIMA	Est. Duration of Repair	: 3 days
Date of Inspection	: 10/12/2018		
Inspection At	: Premier Taxis Pte Ltd - Changi (HQ) 23 Changi South Ave 2 #03-02 Singapore 486443

VEHICLE DAMAGE INSPECTION REPORT

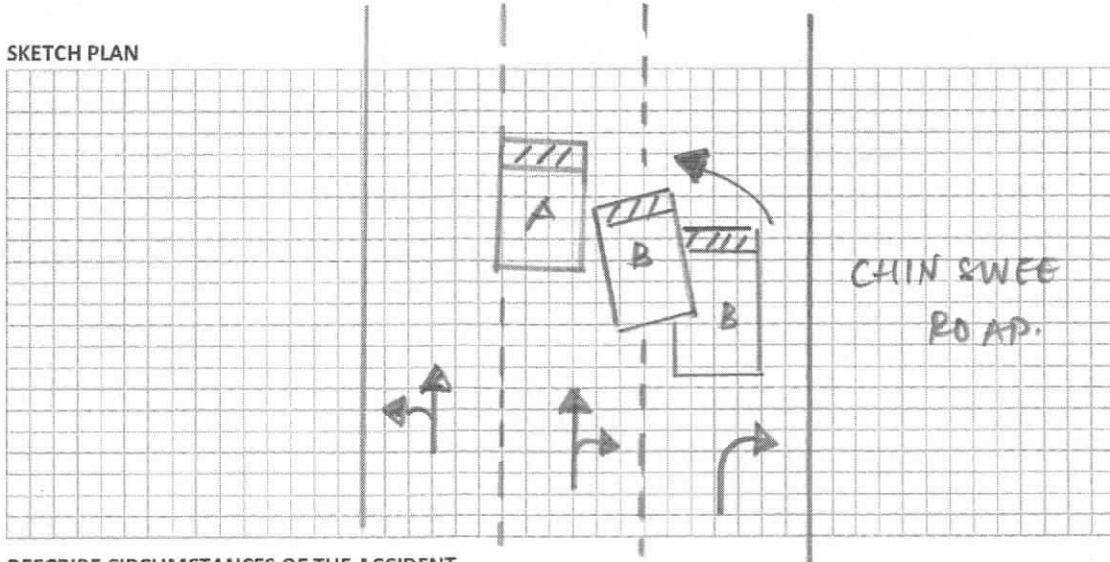
SKETCH PLAN

DESCRIBE CIRCUMSTANCES OF THE ACCIDENT

A: SHB 8865 m

B: SKW 8083 G.

WHEN FILTERING INTO THE MIDDLE LANE (ABOUT $\frac{3}{4}$ INTO THE LANE) SUDDENLY VEHICLE B (SKW 8083 G – NISSAN CEFIRO) WHICH WAS FROM THE RIGHT LANE – FAILED TO KEEP FOR PROPER LOOK OUT, ENCROACHED ONTO MY PATH ON MY RIGHT ABRUPTLY WITHOUT ANY ADVANCE SIGNAL.

AS SUCH, THE LEFT FRONT OF VEHICLE B COLLIDED ONTO THE RIGHT PORTION OF MY TAXI.

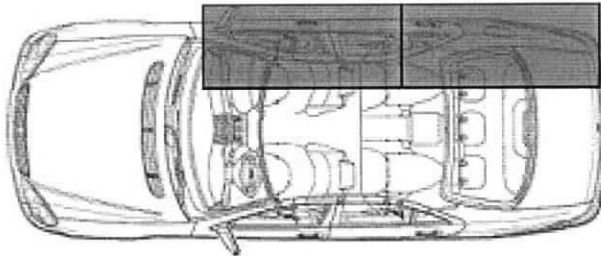
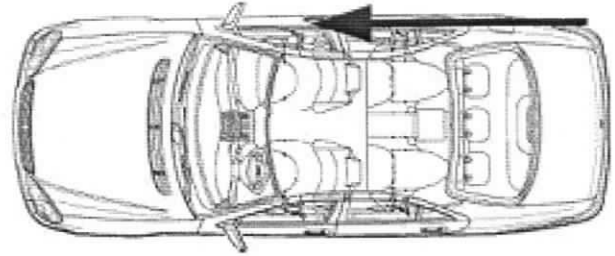
Pre-Accident Condition:	Severity of Impact:	
Steering:	Vehicle Status on Inspection:	
Brakes Pedal Travel:	Date of Inspection:	10/12/2018
Place of Inspection:		
Pre-Accident Damage:		
Tyres Condition:		
Tread Depth LHF:	Tread Depth RHF:	
Tread Depth LHR:	Tread Depth RHR:	
Damage Areas:	Direction of Impact:

Guide Number	Repair Details	WU	Cost Price (\$)
77000R00	RENEW R/R DOOR	18.0	90.00
	INCLUDES: R + R DOOR AND ALL NECESSARY ATTACHED PARTS, RENEW IF NECESSARY		
2208	REPAIR R/SILL PANELLING	10.0*	50.00
3486	REPAIR R/R OUTER SIDE PANEL	20.0*	100.00
LABOUR COST			
	Total Work Units	48.0	
	Corrosion Protection External Labour	0.0HRS	0.00
	Corrosion Protection Internal Labour	0.0HRS	0.00
	Sub Total	4.8HRS	\$240.00
	Paint Labour	7.6HRS	\$380.00
	Total Labour	12.4HRS	\$620.00
