# LKK Auto Consultants Pte Ltd

## 1. Policy Particulars :- THIRD PARTY CLAIM

## 4. Description of Damages

## ADJUSTMENT ON REPAIR COST FOR VEHICLE NO. GBD 7526J

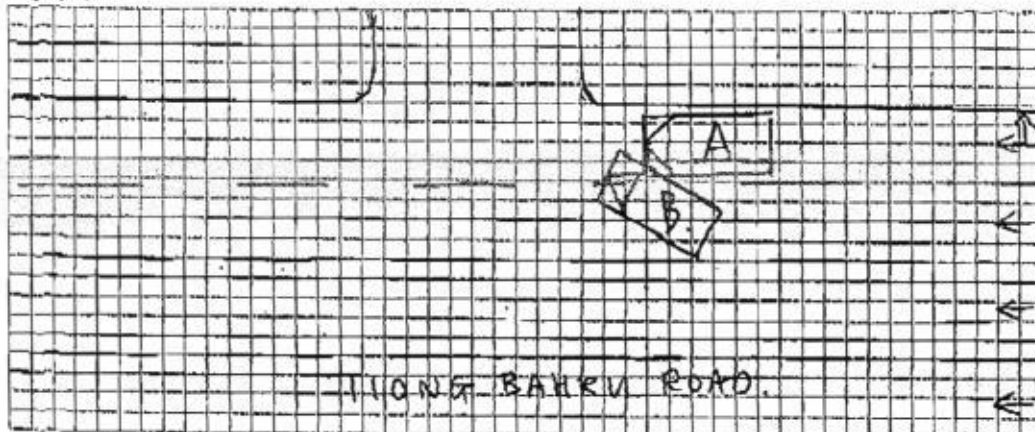
## SKETCH PLAN

On 08/12/2018 at about 07:00pm, I was driving along Tiong Bahru Road on the most outer right lane. Vehicle B which was on my left suddenly cut into my lane and we collided.
