INITIAL INSPECTION REPORT OF VEHICLE NO. GBE 625Y .

4. Description of Damages				
THE VEHICLE SUSTAINED DAMAGES AT THE REAR PORTION AND REAR WINDSCREEN SHATTERED. DAMAGES SEE DETAILS.				
5. General Information				
Accident Date	01/12/2018	Inspection Date	12/12/2018	
Survey held at	NPH AUTO SERVICE BLK 9005 TAMPINES STREET 93 #01-246/254 SINGAPORE 528839			
5a. Remarks				
A)THE MARKET VALUE IS S\$45,000.00(EST. AVERAGE) B)IN ACCORDANCE TO YOUR INSTRUCTIONS, WE HAVE AUTHORISED REPAIRS.				
5b. Estimate Days of Repair				
ESTIMATED NORMAL PERIOD FOR REPAIR:		5 Working Days

ADJUSTMENT ON REPAIR COST FOR VEHICLE NO. GBE 625Y

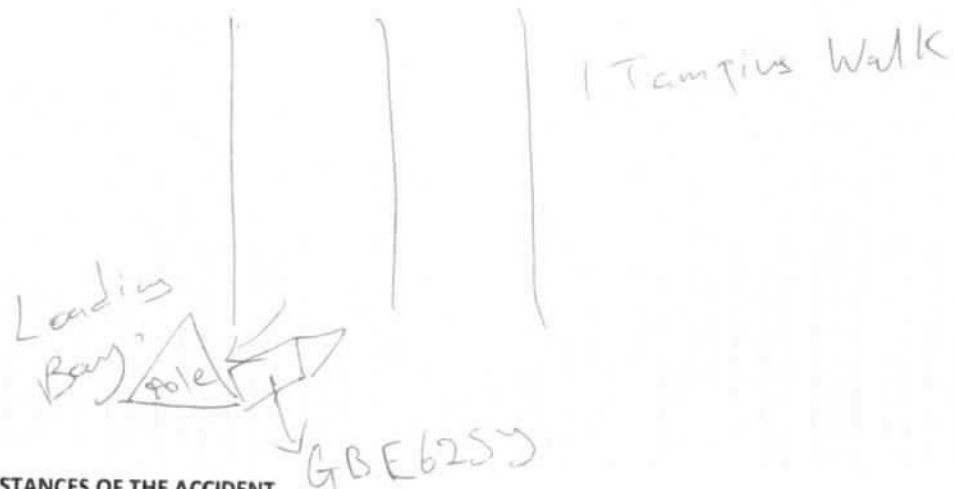
SKETCH PLAN

On 1/12/18, at 18 10 hrs. at Our Tampines Hub. 1 Tampines Walk Loading bay. It was raining heavily & I was driving GBE625Y. As vision was poor, I reversed & hit a pillar. Nobody was injured. I was with a colleague named Malick.
