ESTIMATE BILL ON VEH. NO. : SJR 4748L

- Pre repair inspection request - SJR4748L VS SLK2496P (OI) DOA: 10/12/2018

ACCIDENT BETWEEN VEHICLE NO. SJR 4748L AND VEHICLE NO. SLK 2496P ON 10-12-18 @ 1610hrs AT Traffic Junction Between Upper Bt. Timah Rd & Old Juncy Road.

VEHICLE DAMAGE INSPECTION REPORT

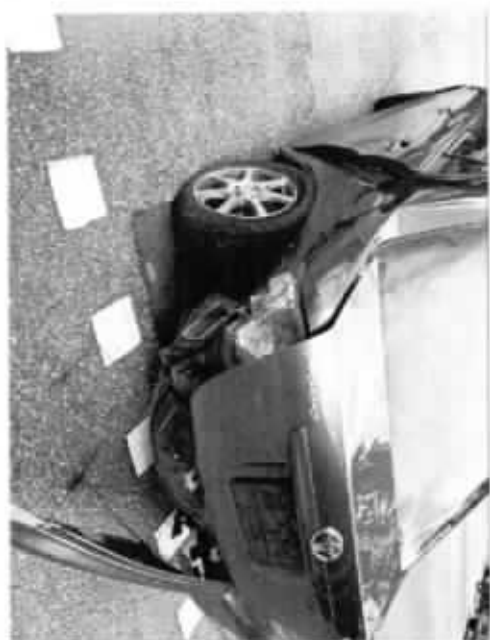
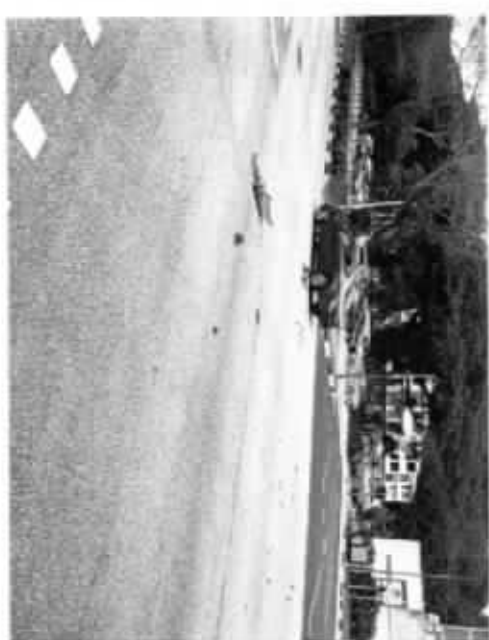
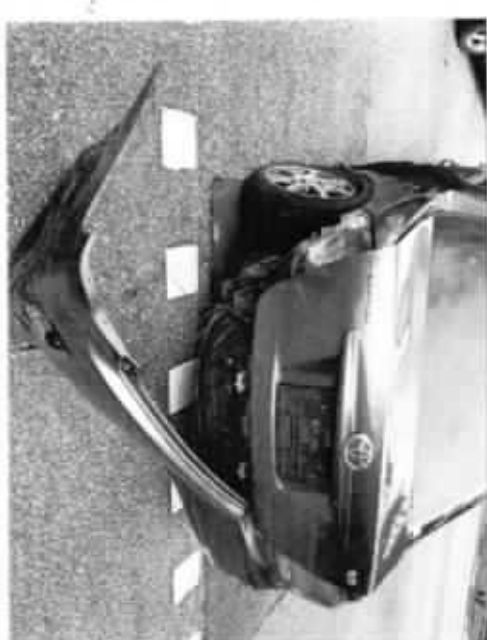
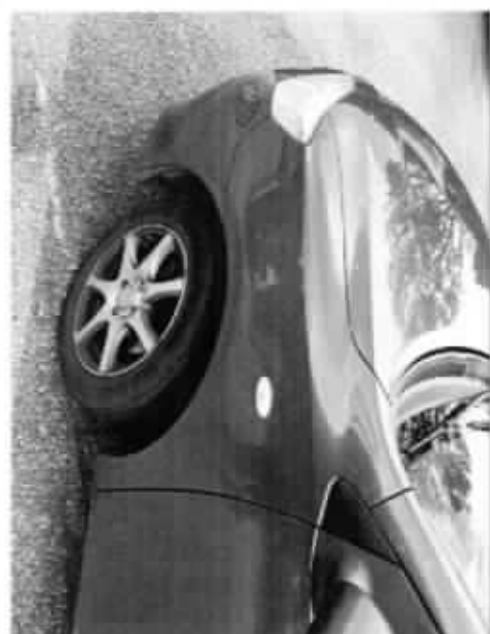
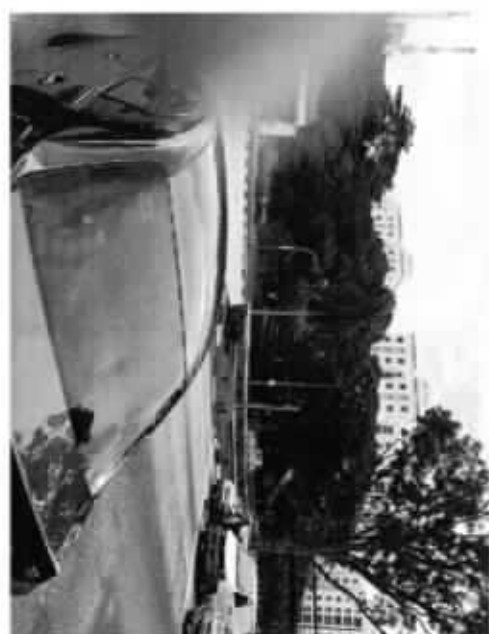
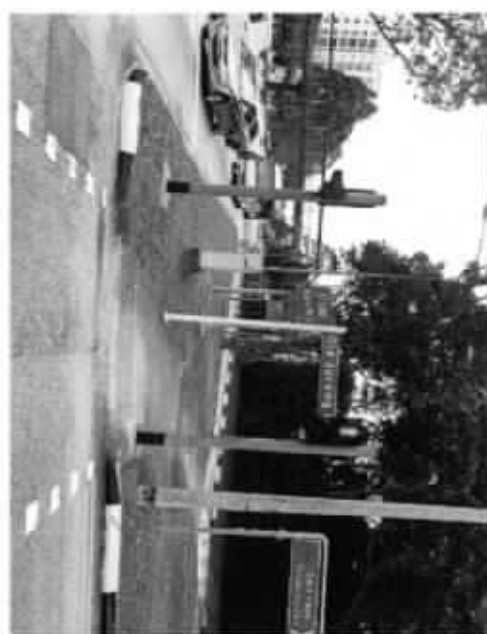
Remark: The veh had commenced its
repair at the time of inspection.

The U/C / Chassis frame / Body Structure affected due to collision.
