ESTIMATED COST OF REPAIRS TO SYM JOYRIDE 200i EVO

VEHICLE DAMAGE INSPECTION REPORT

Our File No: CS/CTI18022423/GVBE2

Handling Insurer:	China Taiping Insurance (Singapore) Pte. Ltd.	Policy No:	DMCVSN3029931800
Claimant Vehicle No :	FBK2788R	Insured Vehicle No :	GY9910A
Date of Loss:	05/12/2018	Nature of Claim:	TP
		Claim No:	SNM18D05680C02

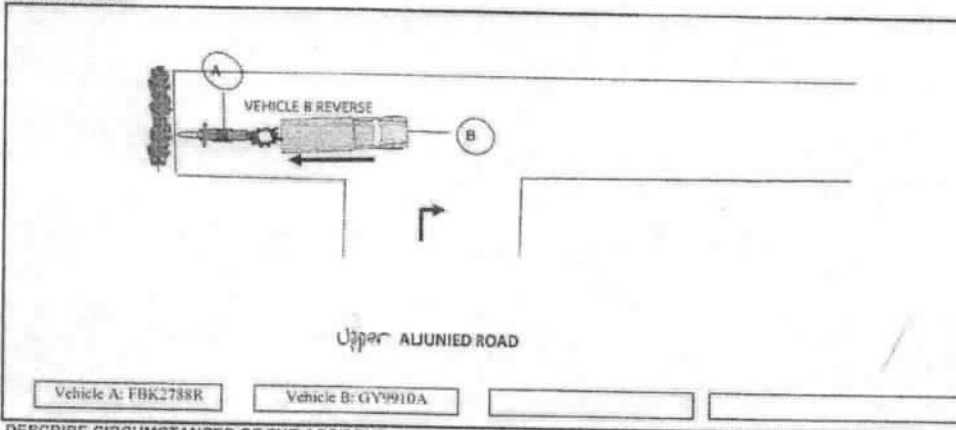
SKETCH PLAN

DESCRIBE CIRCUMSTANCES OF THE ACCIDENT

MY MOTORCYCLE WAS PARKED AT THE PARKING LOT WHEN VEHICLE B REVERSED AND HIT INTO THE REAR PORTION OF MY PARKED MOTORCYCLE. MY MOTORCYCLE THEN FELL INTO THE BUSHES.
