SINGAPORE ACCIDENT STATEMENT

VEHICLE INSPECTION REPORT

EVALUATION REPORT (PAPER SURVEY) OF ACCIDENT VEHICLE NO: SKU 2569Y
INSURED VEHICLE: SKE 8591B
ACCIDENT DATE: 06/01/2016

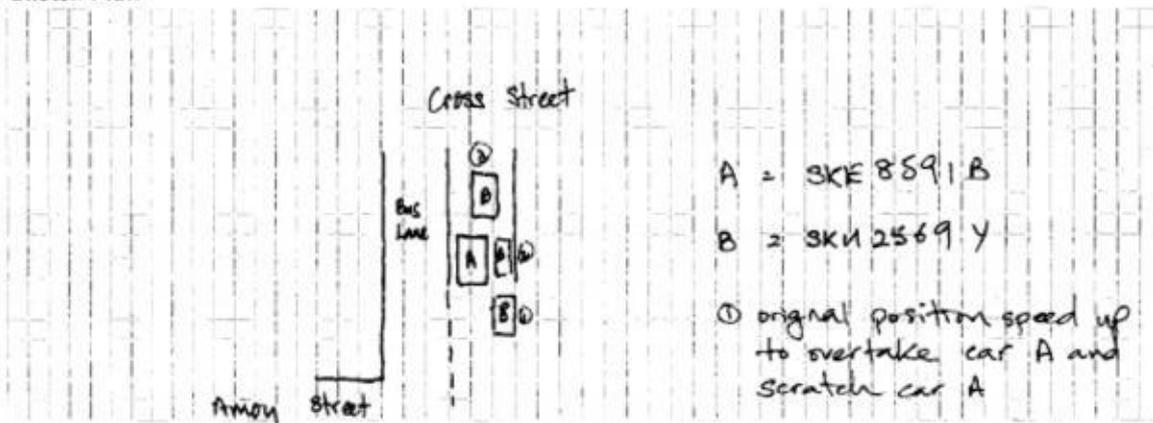
Sketch Plan

My car (3KE85916) coming out from Amoy Street. I changes lane slowly (with signal) from bus lane to the next lane. The car B (3KV2569Y) unhappy speed up and overtake car A and scratch the front right side bumper (near to the wheel)
