VEHICLE DAMAGE INSPECTION REPORT

Our File No: CS/CTI18022518/KVD3N2

Handling Insurer:	China Taiping Insurance (Singapore) Pte. Ltd.	Policy No:	DMCVSN1813271800
Claimant Vehicle No :	SLD7779C	Insured Vehicle No :	GBC4400M
Date of Loss:	12/12/2018	Nature of Claim:	TP
		Claim No:	SNM18D05783C02

Reg No:	SLD7779C	Engine No:	3ZRB745358
Make & Model:	TOYOTA HARRIER, 2.0 (A)	Chassis No:	ZSU600074162
Reg. Date:	28/06/2016 (Man. Year: 2016)	Odometer:	39405 km
Colour:	Metallic Pearl White		
Engine Capacity:	1986 cc		
Market Value/New Car Price:	N/A		
Sum Insured (\$\$):	Market Value/New Car Price

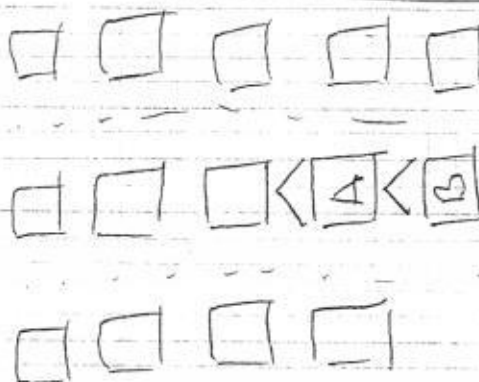
SKETCH PLAN

I was driving along MCE Tunnel "Tuiping Rd" & it was congested. Due to the heavy traffic, I was driving at a really low speed I came to a stop when vehicle B suddenly hit on my back.
