Vehicle No	: SGY5777U	Accident Date	: 12/12/2018
Make	: OPEL ASTRA	Policy No.	: 1800066896
Assignment Date	: 14/12/2018	Excess	: S\$600.00
Date of Inspection	: 18/12/2018	Est. Duration of Repair	: 5 days
Inspection At	: Auto Germany Pte Ltd (HQ) 7 Ubi Close., Alpine Centre Singapore 408604

Point of Impact / General Description of Damages

VEHICLE DAMAGE INSPECTION REPORT

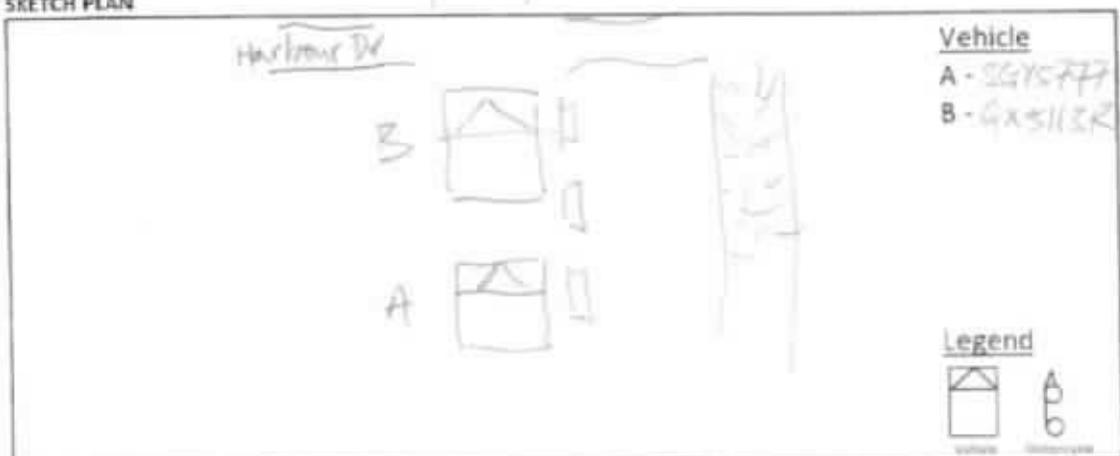
SKETCH PLAN

DESCRIBE CIRCUMSTANCES OF THE ACCIDENT

I was stopped at traffic junction beside Harbour Drive and I was in west coast Highway.

I could not brake in time and bumped into GX5113R. No damage to GX5113R but the driver took my IC just in case his van's bumper dropped.
