Preliminary Advice

Insured Vehicle No	: SBF300D	Accident Date	: 12/12/2018
TP Vehicle No	: SGT2338A	Assignment Date	: 14/12/2018
Make	: TOYOTA HARRIER	Est. Duration of Repair	: 4 days
Date of Inspection	: 17/12/2018		
Inspection At	: CP Motors Pte Ltd (HQ) BLK 34 #01-126, SIN MING DRIVE Singapore 575708

VEHICLE DAMAGE INSPECTION REPORT

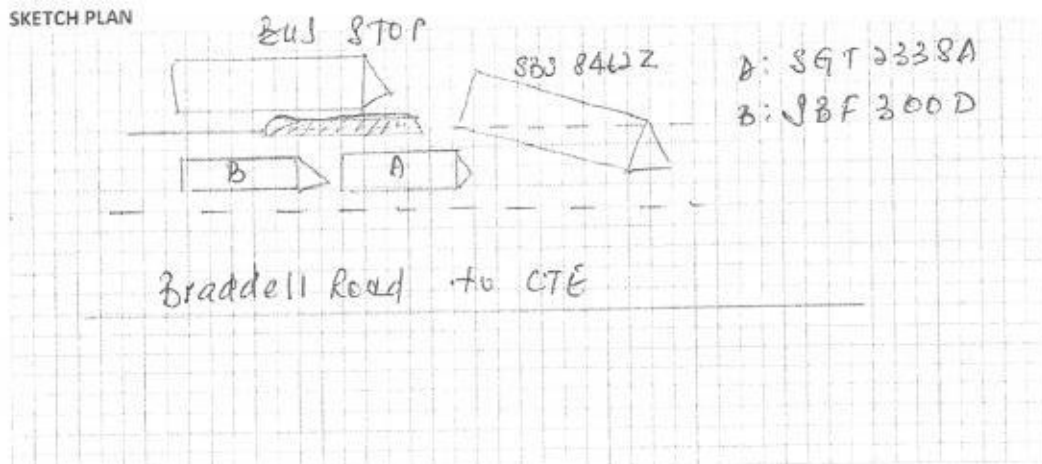
SKETCH PLAN

DESCRIBE CIRCUMSTANCES OF THE ACCIDENT

On the 12/12/18 at about 1830 hrs, I was travelling along Braddell Rd towards CTE. While approaching the bus stop, bus (SB3 8462) front was already out from the bus stop. I slow down to give way for the bus. Suddenly SBF 300D knock onto the rear of my car.
