## VEHICLE DAMAGE INSPECTION REPORT

Our File No: CS/CT118022716/DVBN2

Handling Insurer:	China Taiping Insurance (Singapore) Pte. Ltd.	Policy No:	DMCVSN3016171800
Claimant Vehicle No :	SHD6819A	Insured Vehicle No :	GX2087C
Date of Loss:	15/12/2018	Nature of Claim:	TP
		Claim No:	SNM18D05804C02

Reg No:	SHD6819A	Engine No:	D4FDEU500061
Make & Model:	HYUNDAI I40, 1.7 D (A)	Chassis No:	KMHLB41UMFU068775
Reg. Date:	23/04/2015 (Man. Year: 2015)	Odometer:	450820 km
Colour:	Blue		
Engine Capacity:	1685 cc		
Market Value/New Car Price:	N/A		
Sum Insured (\$\$):	Market Value/New Car Price

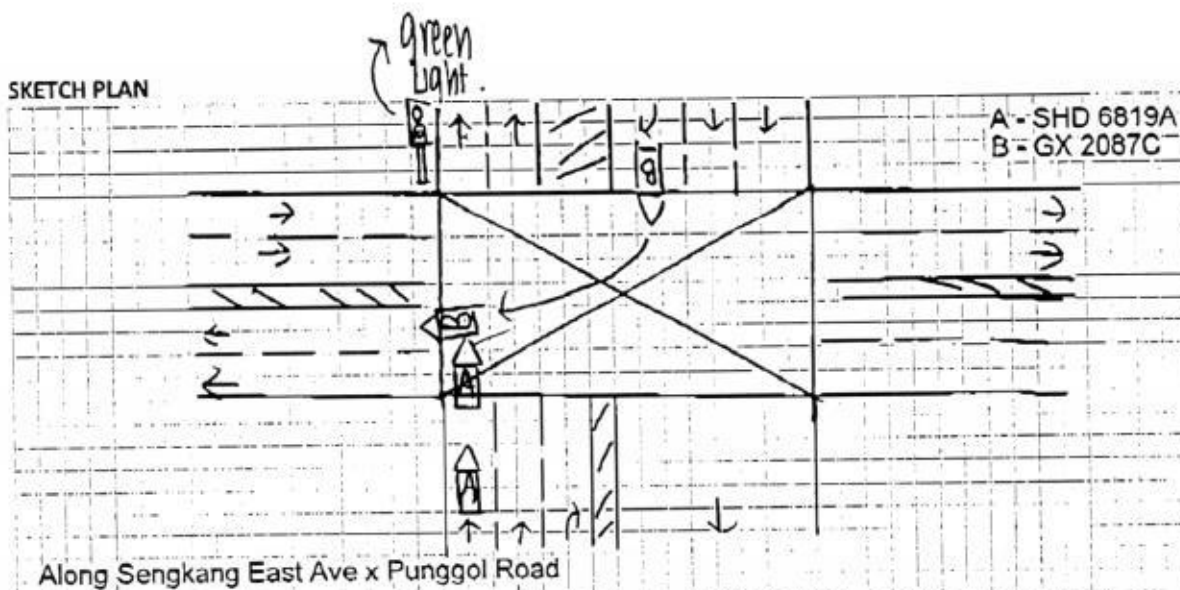
## SKETCH PLAN

On 15.12.2018 at about 03:30 hours I was travelling along Sengkang East Ave x Junction of Punggol Road with One Male Passenger onboard .

While travelling straight on the extreme left lane with green light in my favour , suddenly Veh B ( GX 2087C ) did not give way to me and collided into my taxi A - Whole Front Portion .

After the accident my taxi sustain damages on the whole front portion .
