SINGAPORE ACCIDENT STATEMENT

ACCIDENT STATEMENT

PRE-REPAIR INSPECTION REPORT			
AXA INSURANCE PTE LTD 8 SHENTON WAY #24-01 AXA TOWERS SINGAPORE 068811 ATTN: RUTH CHUA		Ref: CS3/ASM18004105/Sa3s2 Date: 03-05-2018 Code: ASM

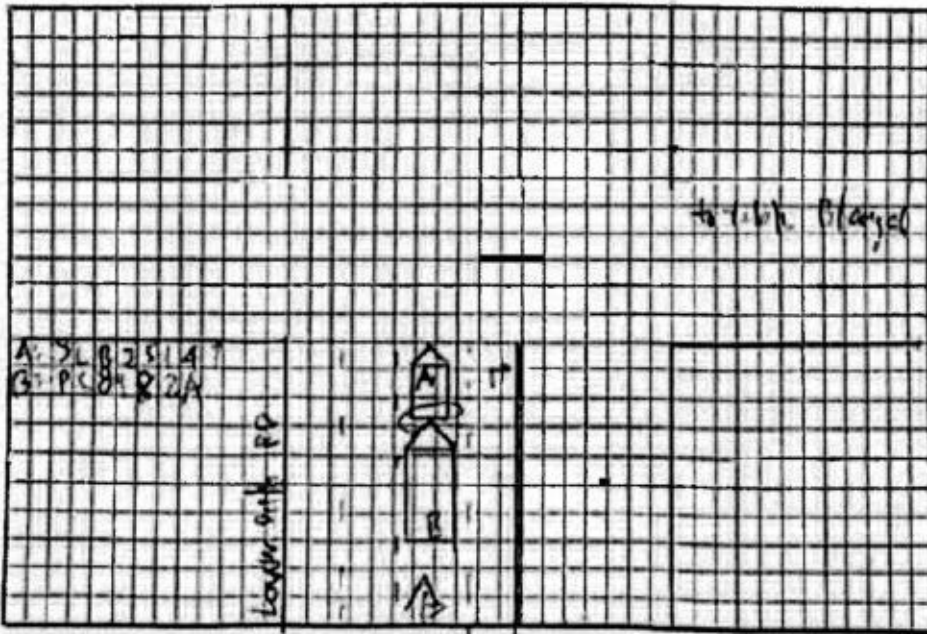
Sketch Plan

I WAS DRIVING ALONG LOWER DELTA RD TOWARDS TELOK BLANGAH AREA AND I WAS DRIVING AT THE SECOND LANE. WHEN IM ABOUT TO REACH THE CROSS JUNCTION BETWEEN BUKIT PURMEI AND TELOK BLANGAH, TRAFFIC LIGHT SHOWS RED SO I SLOW DOWN AND STOP MY VEHICLE STATIONARY. AFTER FEW SECOND, SUDDENLY I FELT A BIG IMPACT FROM REAR SO I DECIDED TO CAME DOWN AND CHECK. VEHICLE B COLLIDED ONTO MY REAR PORTION AND THE DRIVER TOLD ME HE WAS TEXTING WITH HIS PHONE AND FORGET TO APPLIED HAND BRAKED. WE TOOK PHOTO ON THE SPOT AND EXCHANGED PARTICULRAS. NO INJURIES INVOLVED. PLEASE REFER TO THE VIDEO FOOTAGE.

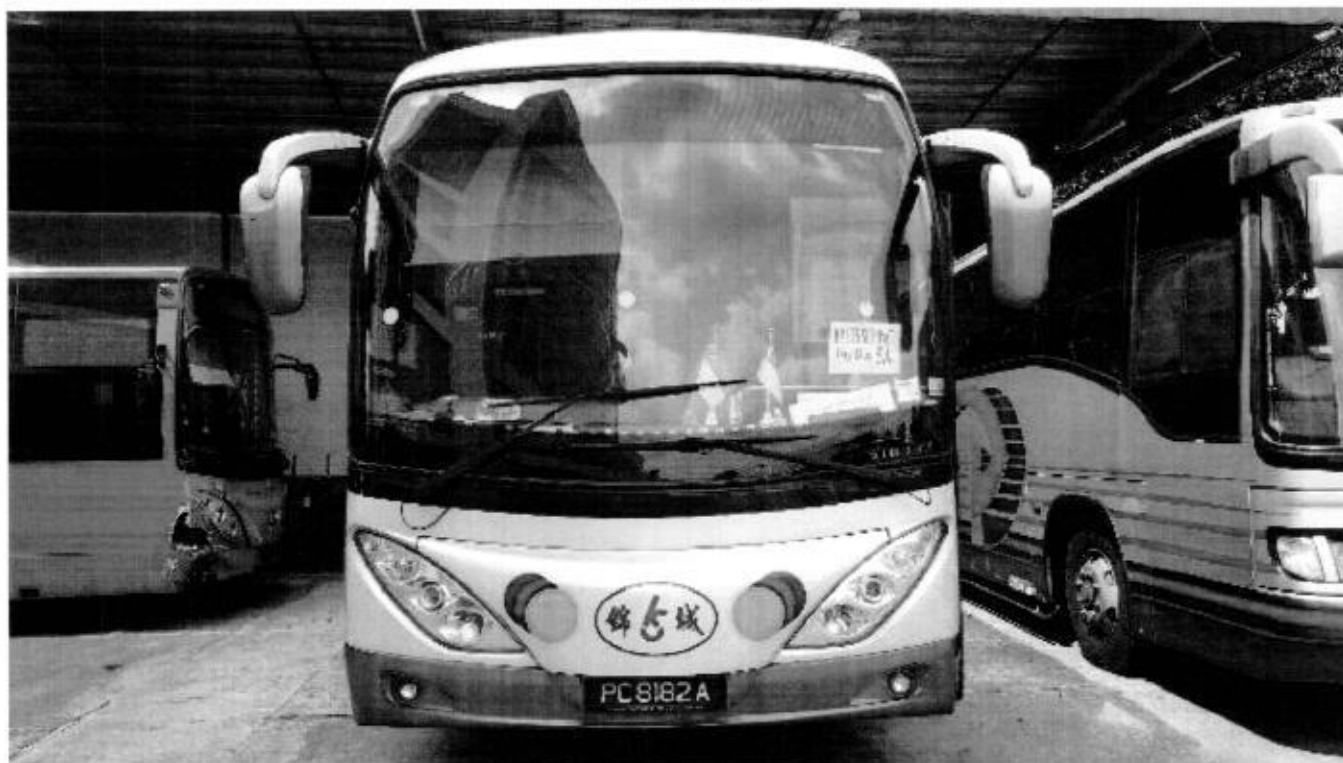
Accident Photo

4. Description of Damages			
THE VEHICLE SUSTAINED DAMAGES AT THE REAR PORTION.		 	
5. General Information			
Accident Date	26/02/2018	Inspect Date / Time	05/03/2018 (09:35 AM)
Survey held at	HAN CAR REPAIRS BLK 1001 #01-49 BUKIT MERAH LANE 3 ALEXANDRA VILLAGE SINGAPORE 159718		
5a. Remarks

At the time of inspection, we noted that the vehicle has sustained an impact damages on the rear portion(s). For more detail of the damages, please see photograph attached.
