REF: CS3/LPC18011517/Ggd3-1<sup>m2</sup>  
 ASS. REC. BY: Guo Guang  
 Surveyor: Ong li li  
 From (Person): LPC Date/Time: 19/12/2018  
 Estimated Cost: \_\_\_\_\_ Bill to: \_\_\_\_\_

# PROMINENT APPRAISER SERVICES PTE LTD

<b>4. Description of Damages</b>			
THE VEHICLE SUSTAINED DAMAGES AT THE FRONT AND REAR PORTION. DAMAGES SEE DETAILS.			
<b>5. General Information</b>			
Accident Date	20/06/2018	Inspection Date	26/06/2018
Survey held at	MOTOR INTEL AUTOMO PTE LTD 13 KAKI BUKIT ROAD 4 @ BARTLEY BIZ CENTRE #01-20 SINGAPORE 147807		
<b>5a. Remarks</b>			
A)THE INSPECTION WAS CONDUCTED ON A"WITHOUT PREJUDICE" BASIS. B)IN ACCORDANCE TO YOUR INSTRUCTIONS, WE HAVE NOT AUTHORISED REPAIRS.			
<b>5b. Estimate Days of Repair</b>			
ESTIMATED NORMAL PERIOD FOR REPAIR:		<b>9 Working Days</b>

### ADJUSTMENT ON REPAIR COST FOR VEHICLE NO. SKR 6292J

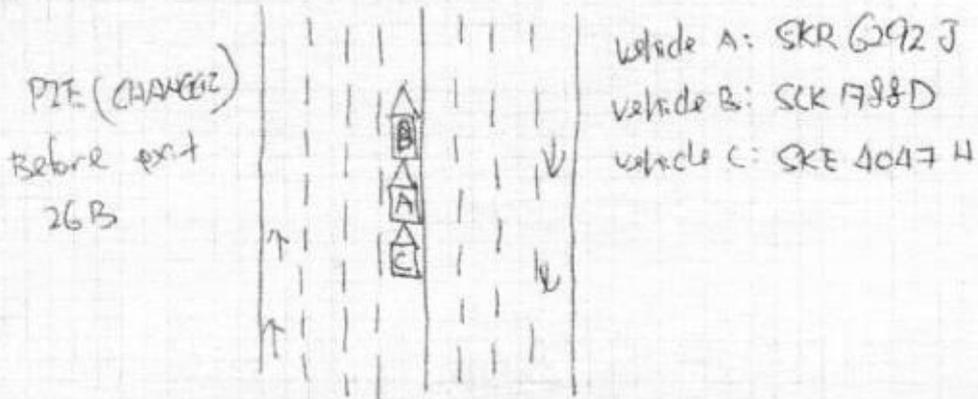
Sketch Plan #2 Pg. 1

DESCRIBE CIRCUMSTANCES OF THE ACCIDENT

On 2<sup>nd</sup> Jun 2018 around 4:20pm, I was travelling along PIE towards changez before exit 26B. Car B slowed down and stop and I followed to stop behind car B. Suddenly, car C hit my the rear portion of my vehicle. Car C forced me to hit car B.
