SINGAPORE ACCIDENT STATEMENT

**Re : Third Party Claim
Vehicle Registration No. SKW 3224 A**

VEHICLE INSPECTION REPORT

ADJUSTMENT ON REPAIR COST FOR VEHICLE NO. SKW 3224A

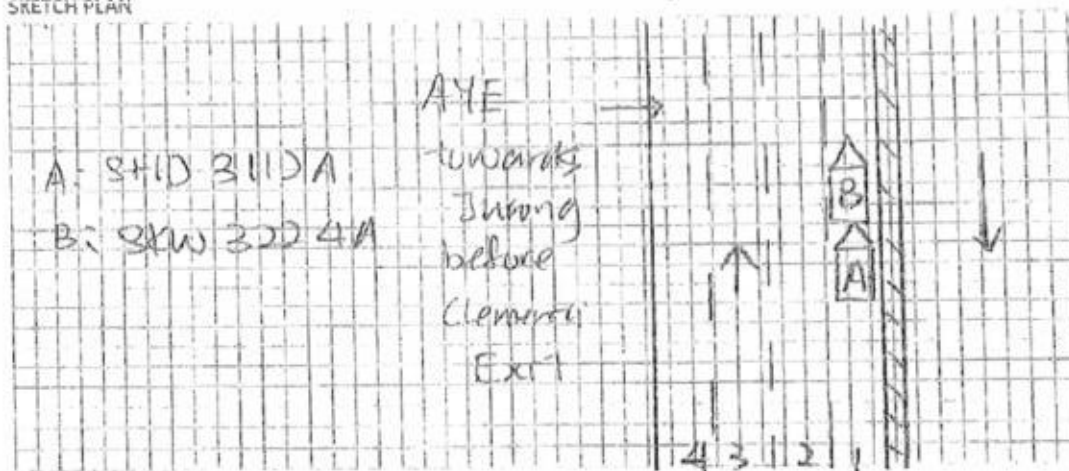
SKETCH PLAN

On 21/9/18 at about 18:30 hrs, I was driving on lane 1 along AYE towards Jurong before Clementi Exit.

Shortly after Veh B in front of my taxi braked to stopped, I immediately applied brake upon noticed it. Unfortunately, I'm not able to stop my taxi in time and gently collided onto the rear portion of Veh B.

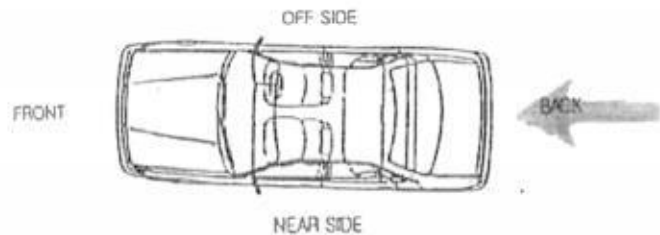
IMPACT OF VEHICLE

Direction of Impact (←→)

Damages sustained were consistent with the subject vehicle being involved in a collision with another vehicle and the impact was delivered onto the rear portion of the vehicle.
