RE: Post Survey for SLR 7190B

VEHICLE INSPECTION REPORT

**EVALUATION REPORT (PAPER SURVEY) OF ACCIDENT VEHICLE NO:
SLR 7190B INSURED VEHICLE: PUBLIC LIABILITY ACCIDENT DATE: 02/06/2018**

ADJUSTMENT ON REPAIR COST FOR VEHICLE NO. SLR 7190B

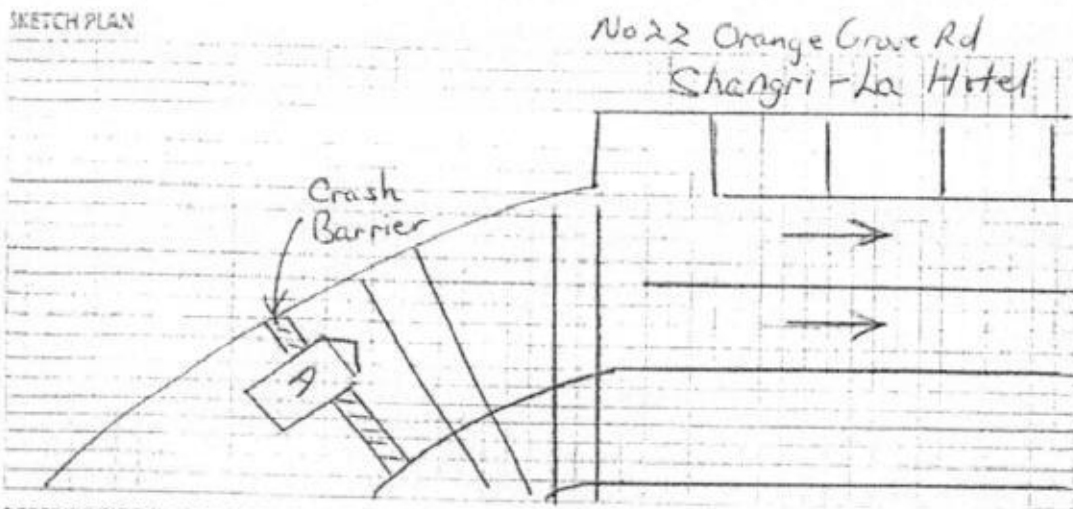
Sketch Plan #2

On 02/06/2018, I drove into (SLR7190B) Shangri-La Hotel and there were a few security pit stops. I went through the screening point twice as I was searching for the car park. As I was about to turn into the car park, a crash barrier suddenly elevated and lifted the mid-portion of my vehicle. My wife (Gurpreet Kaur D/O Jagjit Singh, S8511539A) and 18-month old daughter were also inside the vehicle. We managed to exit from the vehicle ourselves and we were not injured.

There were damages underneath my vehicle which I am not able to assess the full extent of the damages, and my vehicle's right skirting came off.
