SHB 8810X

# ASSIGNMENT

Rear o/s

## VEHICLE DAMAGE INSPECTION REPORT

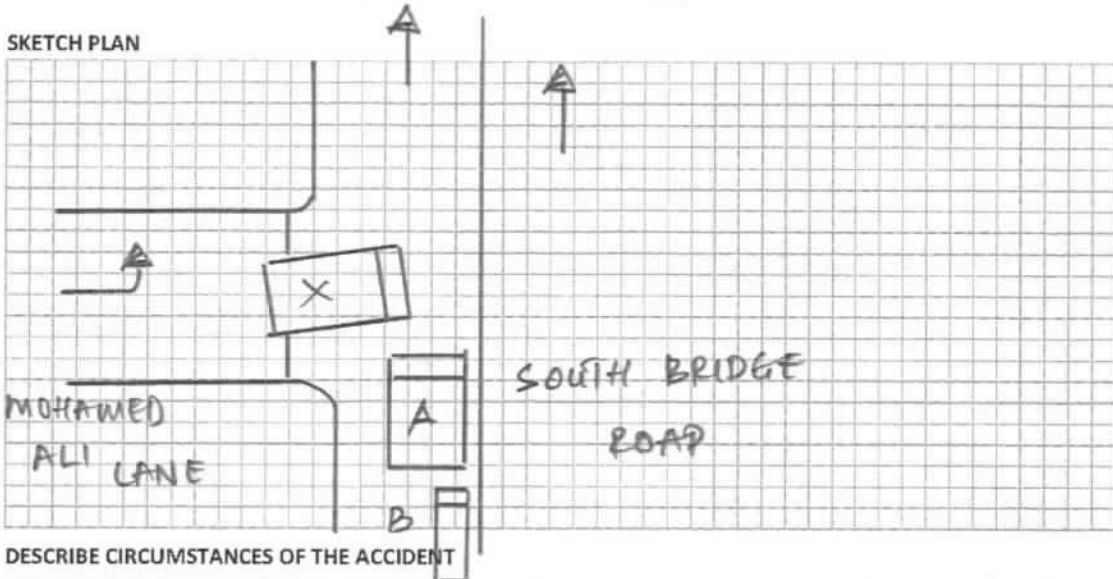
## SKETCH PLAN

ON 18/12/2018 @ 2310 HRS, I WAS DRIVING MY TAXI (SHB 8810 X) TRAVELLING ALONG SOUTH BRIDGE ROAD IN THE EXTREME LEFT LANE.

I STOPPED MY TAXI – AS AN UNKNOWN SMRT TAXI SUDDENLY SURGED FORWARD FROM MOHAMED ALI LANE (ON MY LEFT) INTO MY LANE (IN FRONT ) AND SUBSEQUENTLY I FELT AN IMPACT FROM THE REAR.

WHEN INSPECTED, I DISCOVERED THAT VEHICLE B ( FBH 7586 P – M/CYCLE ) WHICH WAS BEHIND ME, HAD COLLIDED ONTO THE REAR OF MY TAXI.

DUE TO THE IMPACT, MY VEHICLE WAS DAMAGED ON THE REAR & REAR RIGHT PORTION. VEHICLE B HAD SOME DAMAGES AS WELL.

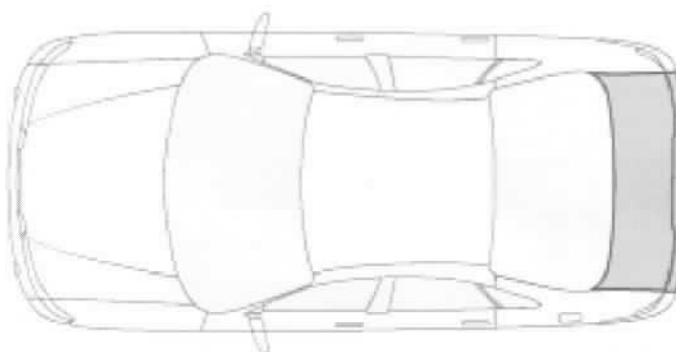
### Damage Areas

Code	Description	Time Base 10 WU/h	Price = 50.00 SGD/h	
			WU	Price SGD
86520R00	RENEW REAR BUMPER (REMOVED)		11.0	55.00
	<b>Labour Cost</b>		<b>Hrs</b>	<b>WU</b>
	<b>Panel / Mechanical Labour</b>		1.10	11.0
	<b>Total of Labour</b>			55.00

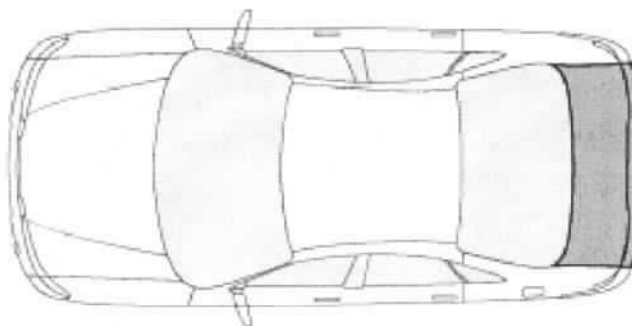
**Damage Areas**

Code	Description	Time Base 10 WU/h	Price = 50.00 SGD/h	
			WU	Price SGD
86520R00	RENEW REAR BUMPER (REMOVED)		11.0	55.00
	<b>Labour Cost</b>		<b>Hrs</b>	<b>WU</b>
	<b>Panel / Mechanical Labour</b>		1.10	11.0
	<b>Total of Labour</b>			55.00
