Veh No: SKW16765 Yr Regn: 29 Feb 2012
 Type: Car / M.Cycle / Bus / Van / Lorry / Taxi / Prime Mover /
 Truck / Trailer or _____
 Make: Merce CLS350 c.c. 3498
 Colour: Brown A/C: Insured / Std / NI / NA
 Sp. Reading: - T/Radio: Insured / Std / NI / NA
 Eng/No: _____
 C/No: WDD2183592A029731
 Gen. Cond: Good / Fair / Poor / Burnt
 Steering: Inorder / Jammed / Leaked / Burnt or _____
 Brake: Inorder / Jammed / Leaked / Burnt or _____
 Modi: Nil / S/Rim / STD / A/Rim or _____
 Tyre Size: F: 285/35R18
 R: 17

Subject: SKW1676S - ONE DAMAGE CLAIM - SNM18D05829C01/6

PRELIMINARY ADVICE OF VEHICLE NO. SKW 1676S

VEHICLE DAMAGE INSPECTION REPORT

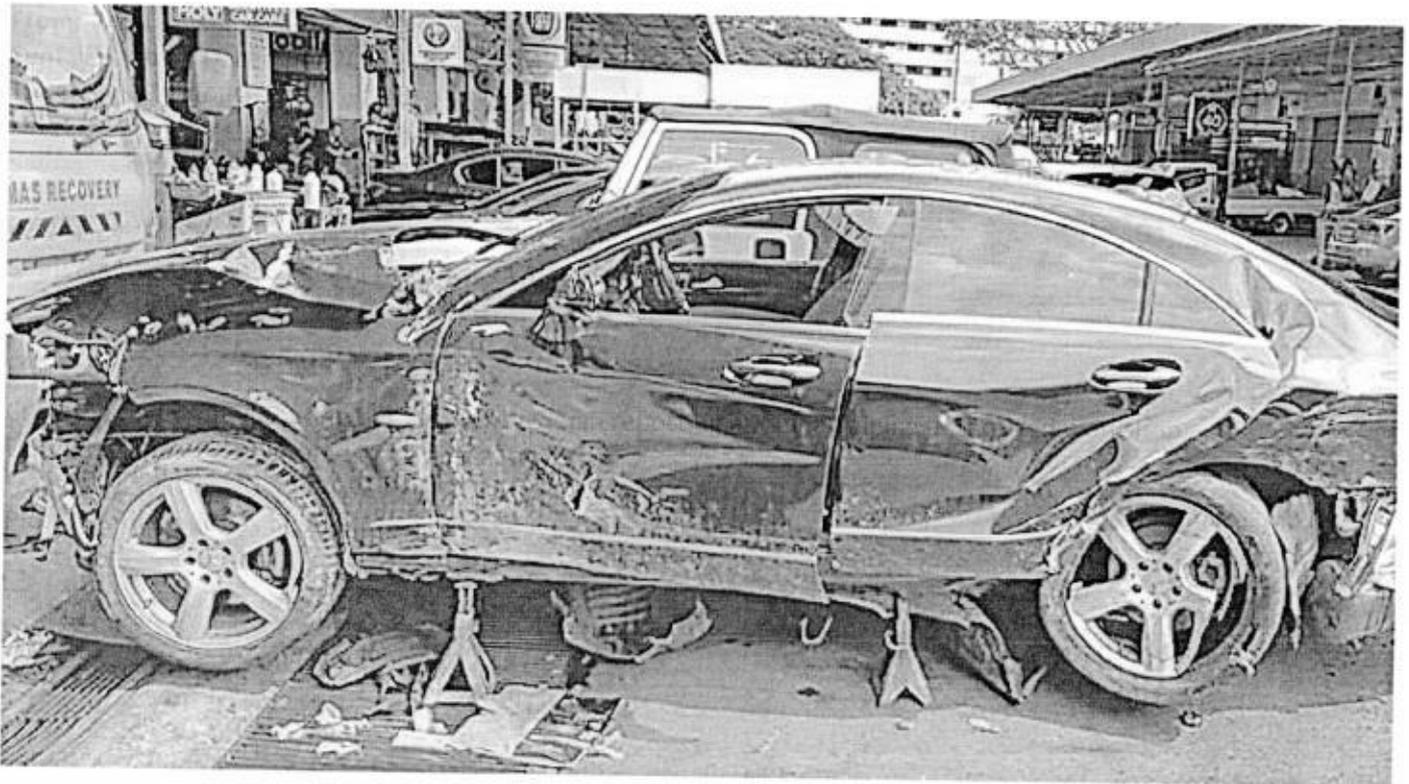
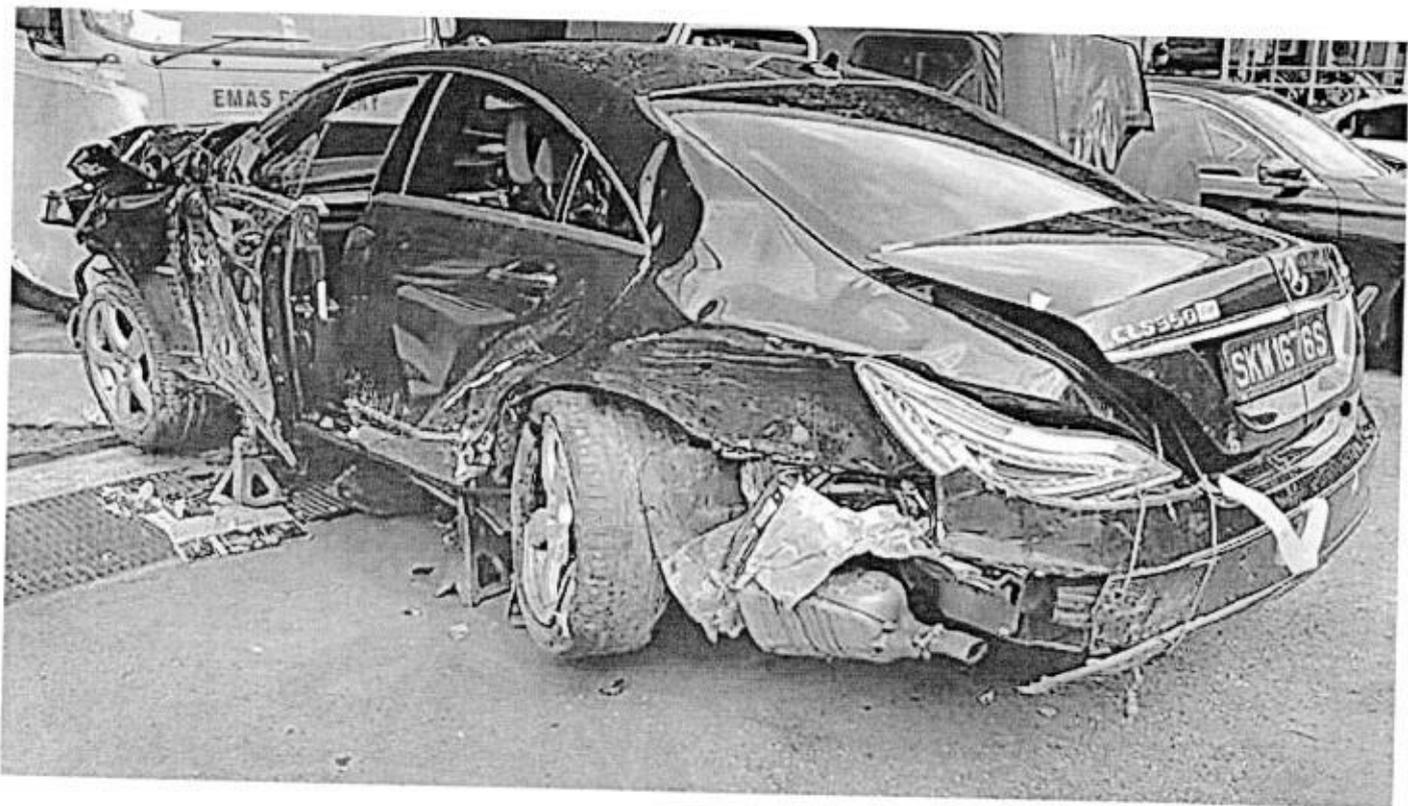
The U/C / Chassis frame / Body Structure affected due to collision.

Customer mentioned that he has already made an reporting at China Taiping authorized workshop.
Due to the vehicle is not able to be tow at all.

Please find images as below:

The vehicle sustained damages at the front, rear, o/s, n/s portion & undercarriage.

Repair cost not economical.

In view of the above, the vehicle is uneconomical to be repaired, you are advised to invite tender for the wreck.
