Claim Type:	Own Damage
Vehicle number	SJU 8184X
Make and Model	TOYOTA COROLLA ALTIS (A)
Date of registration	29/12/2009
Excess	NIL
Market Value	\$18,000.00
Parf Rebate	\$11,565.00
Nett Loss	\$6,435.00

The vehicle sustained damages at the n/s rear portion

MOTOR CLAIM – FINAL REPORT

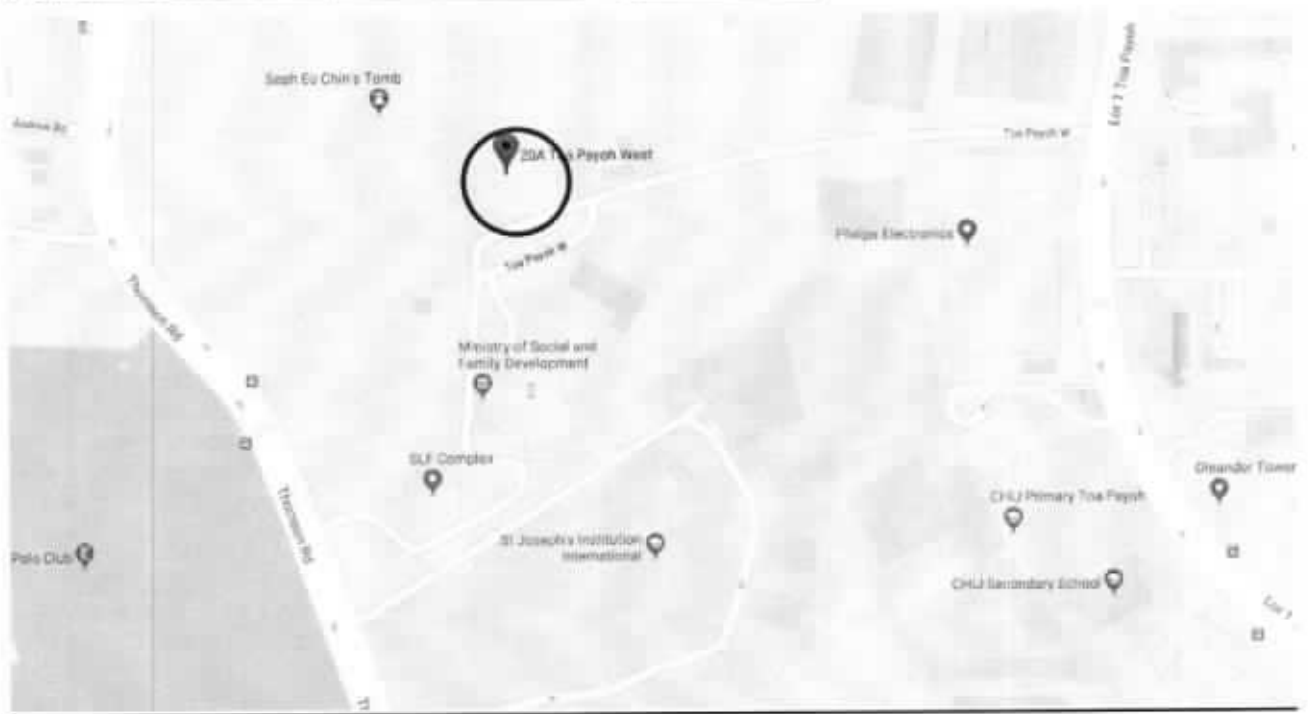
Fig 1.1 – 20A Toa Payoh West – Samsung Site Office:

20 While insured driver was reversing, he accidentally grazed the left rear portion of his motor car against the metal pillar.

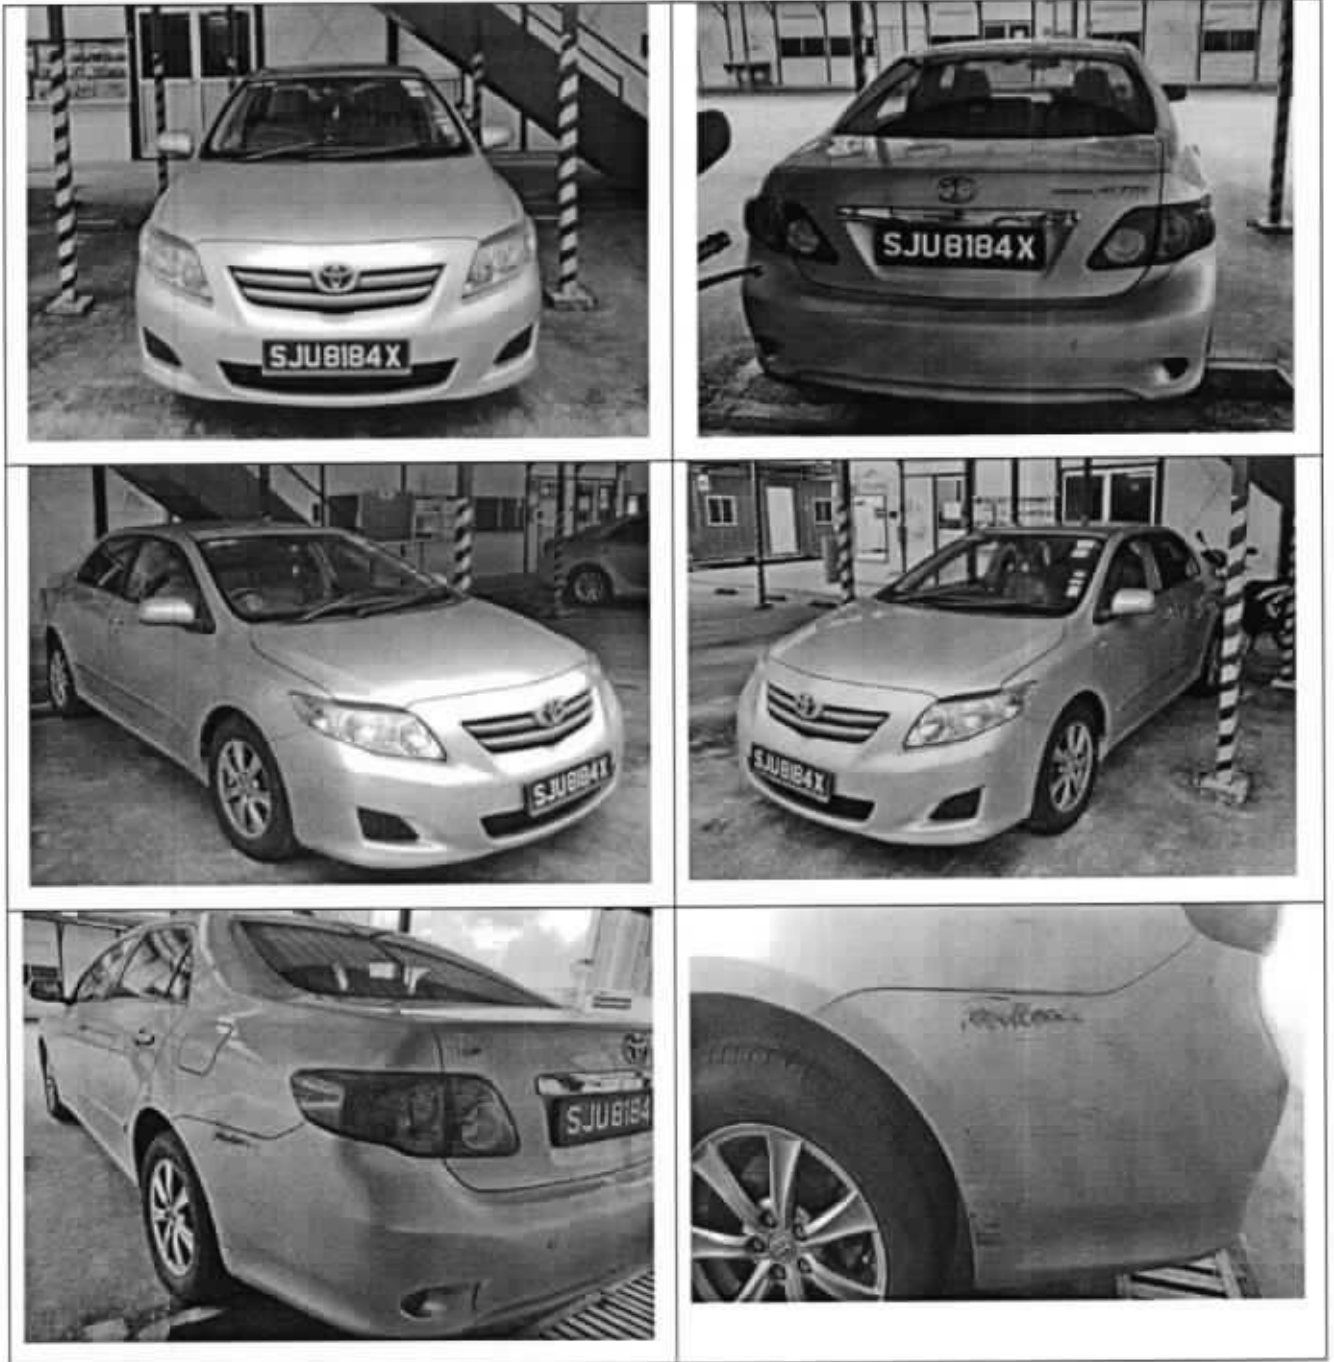
INSURED DRIVER VEHICLE PHOTOS

The U/C / Chassis frame / Body Structure affected due to collision.

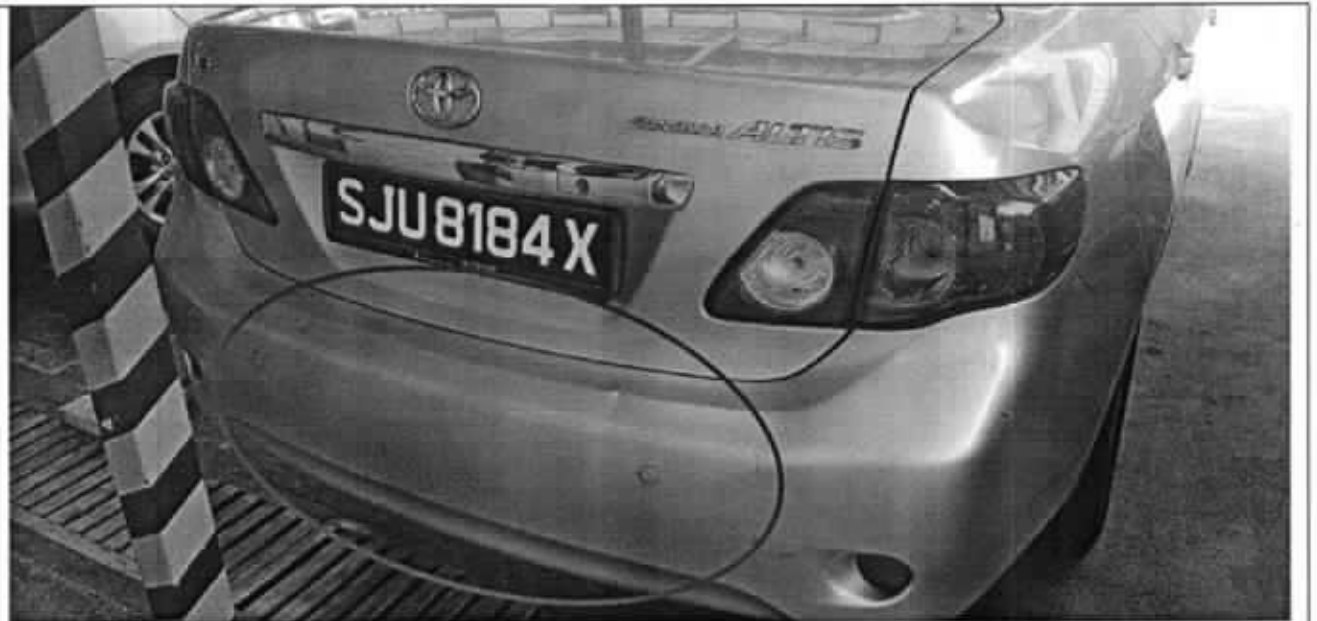
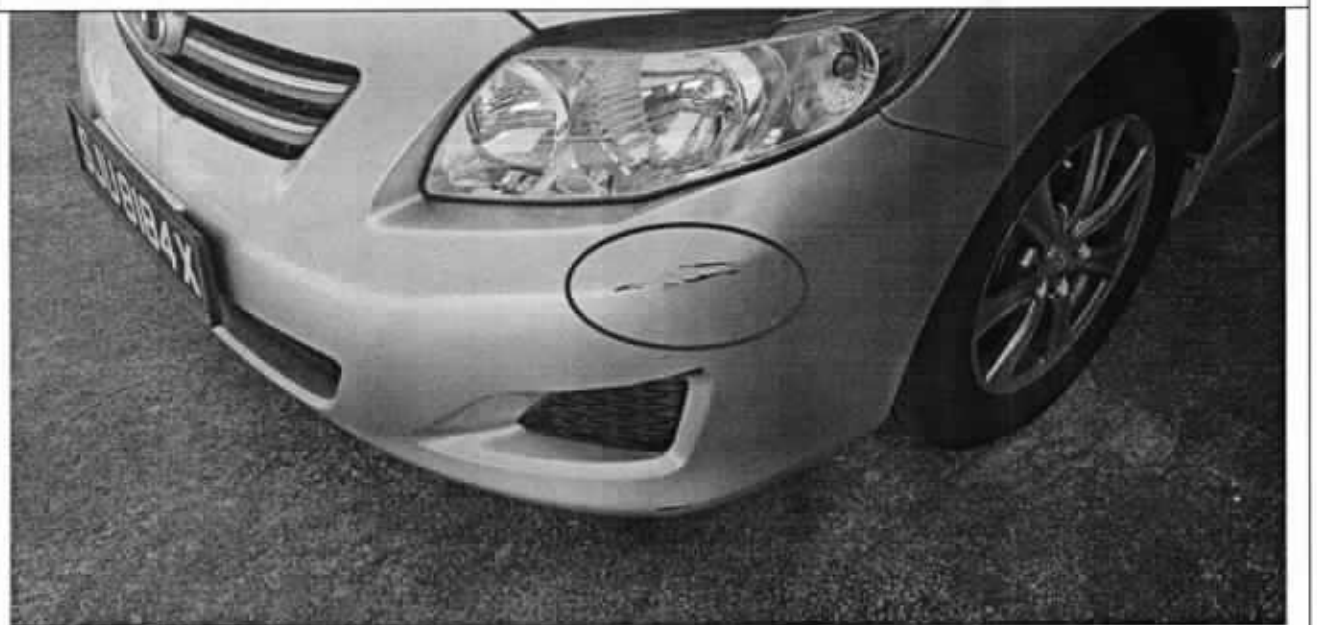
PRE-EXISTING DAMAGES

27 Insured driver also shared the following were the pre-existing damages:

Hi Veron, As spoken, please do not authorise the pre-existing damages. Investigation is cleared, please proceed to authorise if damages consistent. We have informed workshop to get insd to bring the car to workshop for survey. Thank you.

Hi Please refer to our loss adjuster's report page 9 on the pre-existing damages. Please advise if the damages are included in the estimate and do not authorise the pre-existing damages. Thanks.

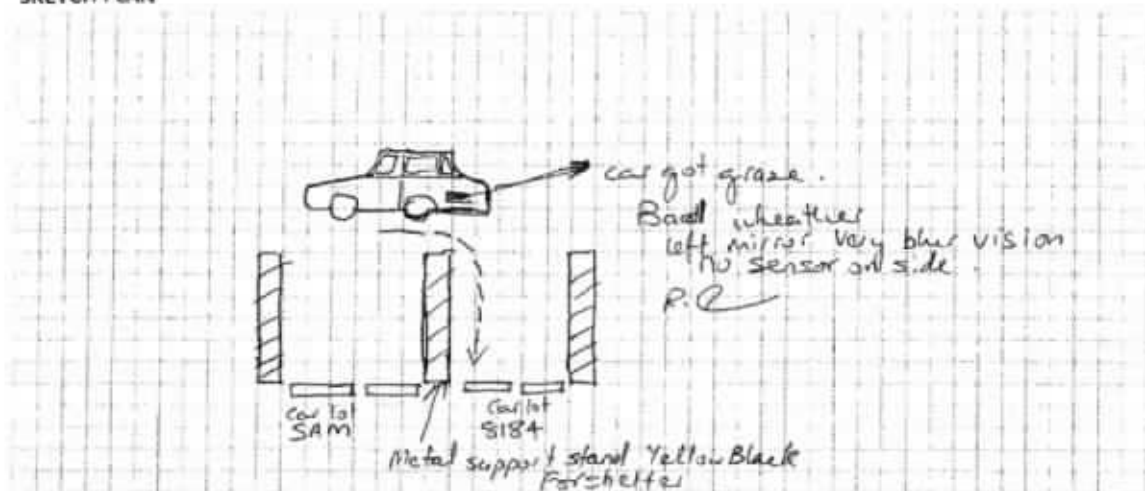
SKETCH PLAN

I Rajendren sb RATA GOPAL S1702137/I drive company Rental car STU 8184 X TOYOTA Corolla ALTIS from T-213 TEL Samsung office to Too Payoh Lorong 1. buy supper. Returning back to office about 1.30pm while reverse vertical parking into carpark lot with shelter and metal support stand. car slightly grazed on left side of passenger seat side car my left side mirror with vapour ~~and~~ after heavy rain. P.R.
