Pre repair inspection request - GBD1051B VS YN4076K (OI) DOA: 24/12/2018

**RE: ACCIDENT INVOLVING GBD 1051 B / YN 4076 K ON 24/12/18 ALONG CTE TOWARDS AYE BEFORE PIE (CHANGI EXIT)**

## VEHICLE DAMAGE INSPECTION REPORT

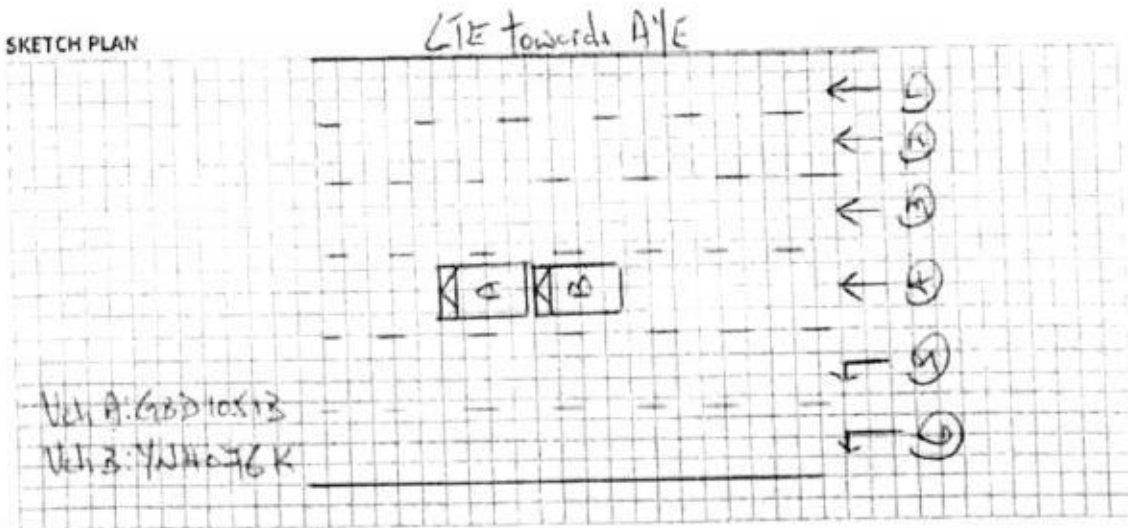
## SKETCH PLAN

On 24/12/2018 @ ord 1430hrs, I was travelling along CTE towards A/E. Just before PIE (Change exit) due to heavy traffic, I slowed down my lorry and eventually came to a stop. Suddenly I felt an strong impact from the rear of my vehicle. I got out and realised that veh B (YN4076K) had collided into my vehicle rear portion.
