OD/TP Re-inspection/ Evaluation

To Inspect Vehicle No: SLT 7573U
 at Workshop m/s Horizon Auto
 of 25 Kaki Bukit Rd 4 #01-48

VEHICLE DAMAGE INSPECTION REPORT

ADJUSTMENT ON REPAIR COST FOR VEHICLE NO. SLT 7573U

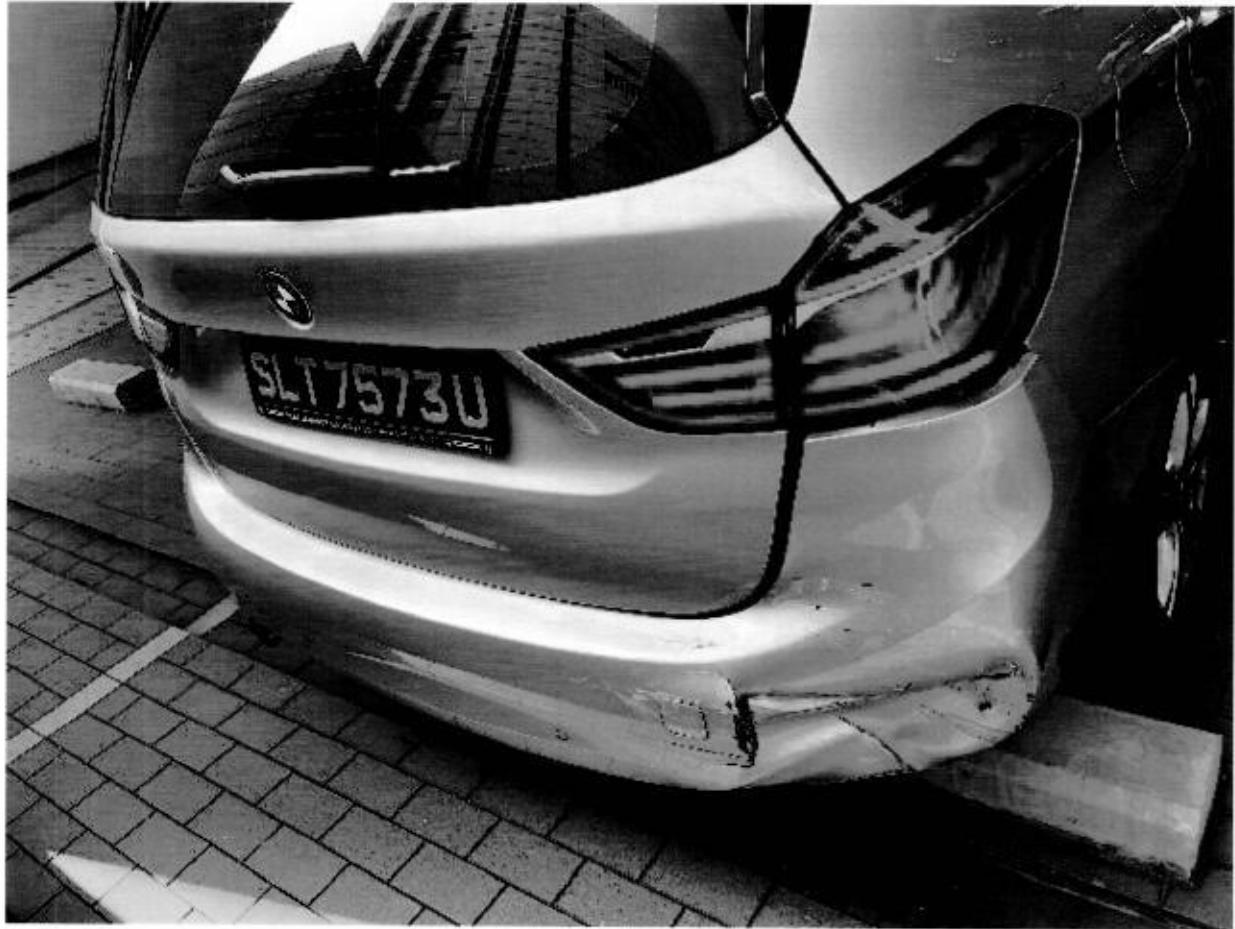
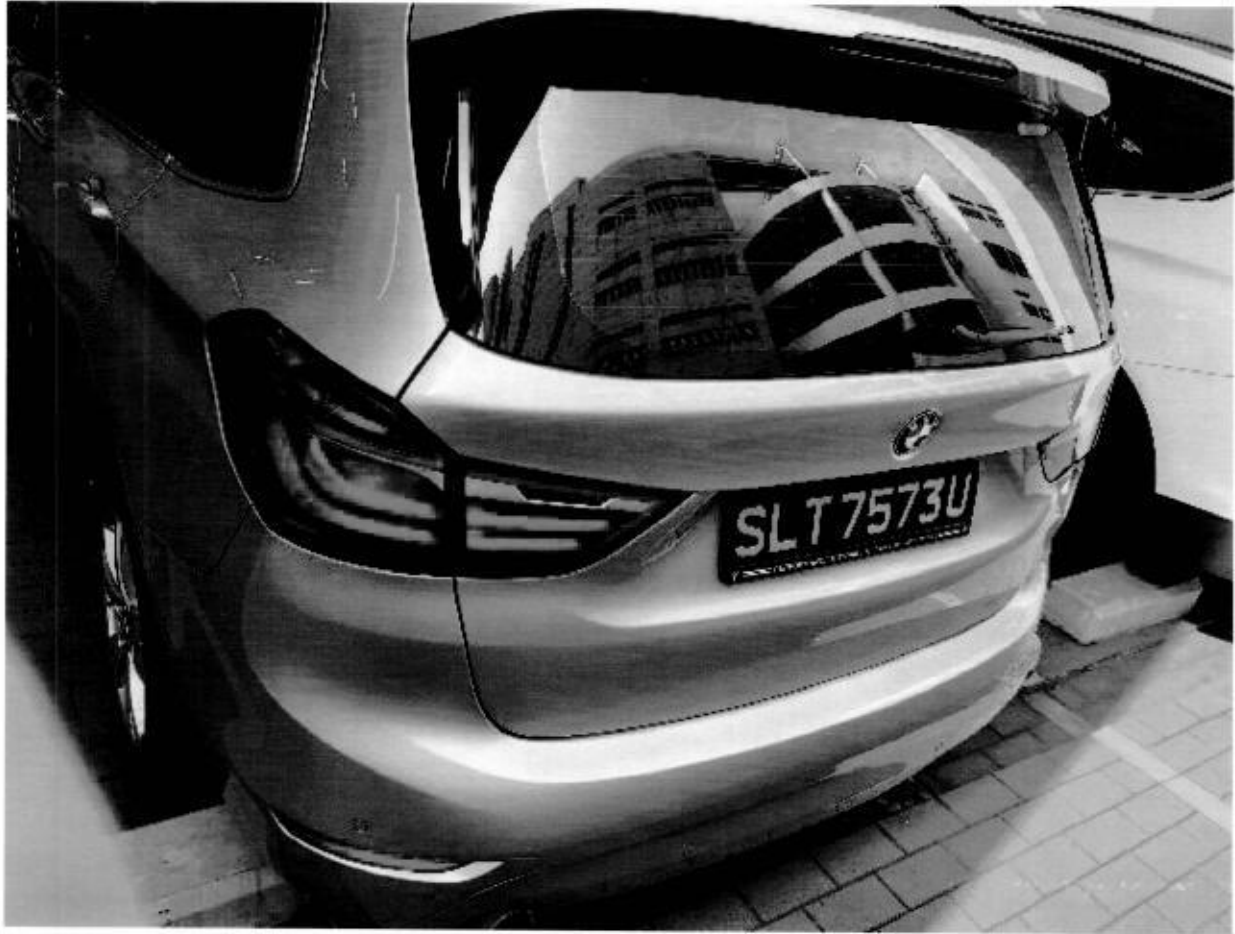
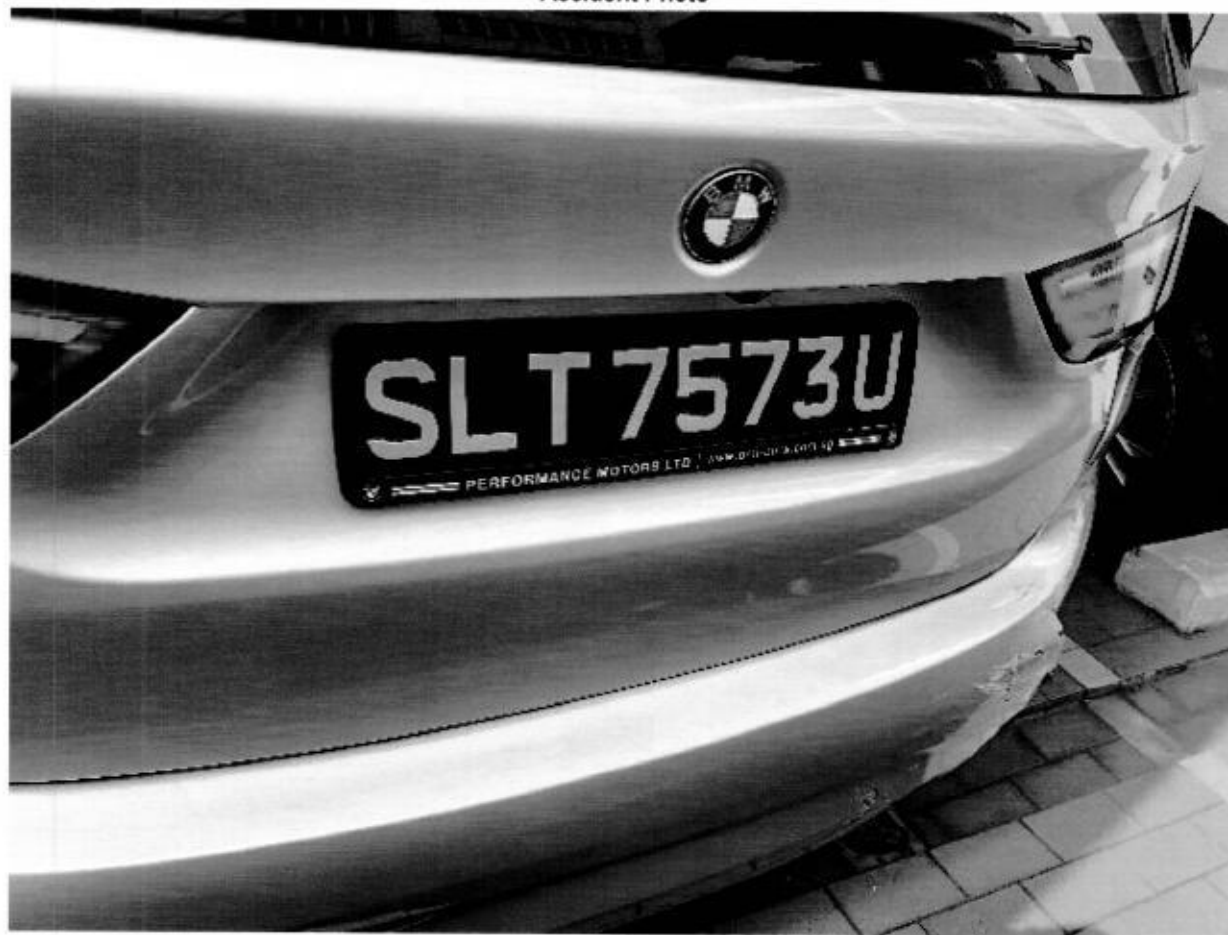
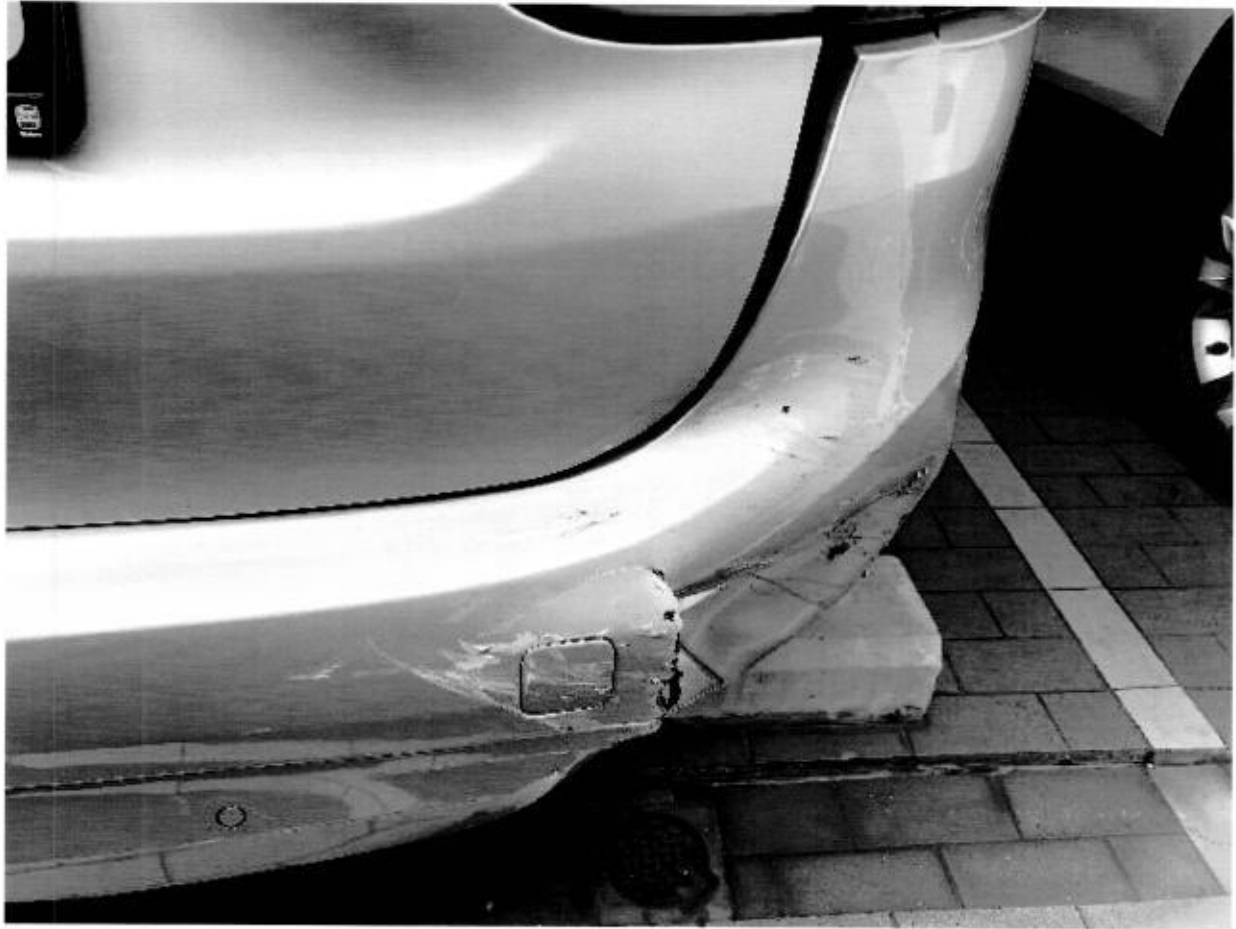
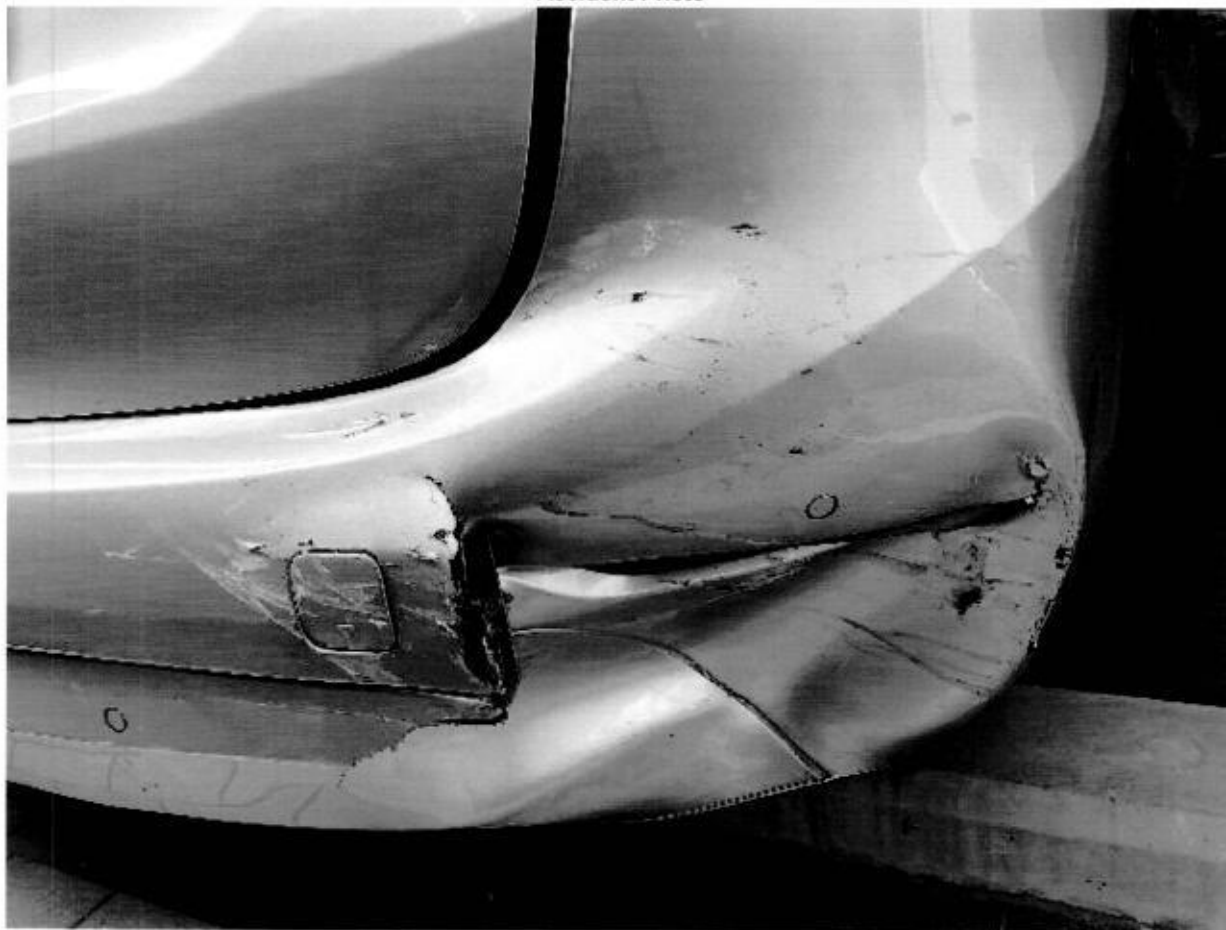
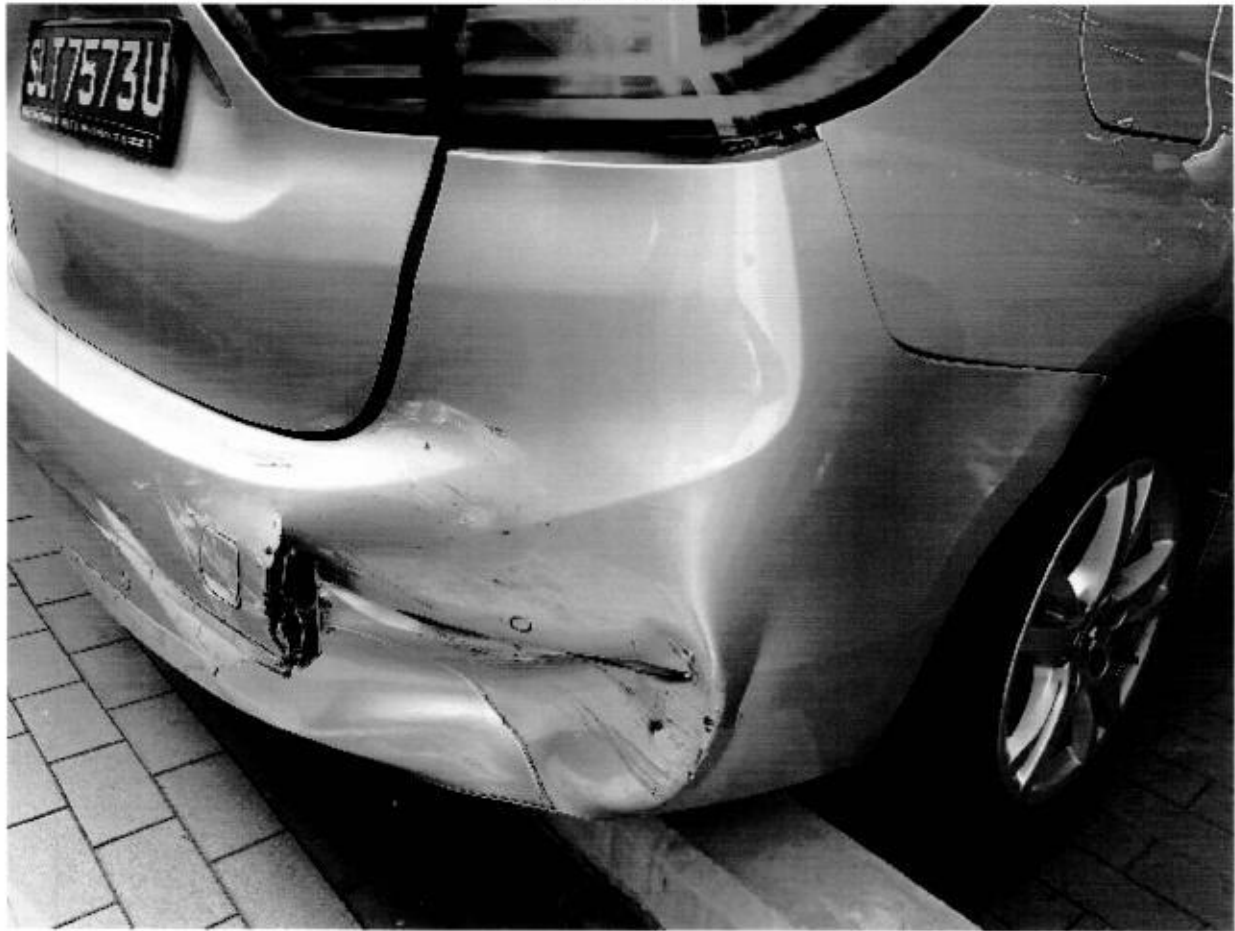
I was driving along left lane of Bishan Street 21 towards Maynard Road when I was just outside Raffles Institution, my car was hit on the rear bumper, right side by car SJM 3409Z driven by Mr Lim Jhi Zhong, Nicholas. The car sustained (SJM 3409Z) sustained damage to its left front headlight and bumper.
