Make: BMW R 1200 GS c.c. 1,170

- OWN DAMAGE CLAIM FBJ9706L

ASSESSMENT FOR REPAIR: B.M.W. R1200GS - FBJ9706L

VEHICLE DAMAGE INSPECTION REPORT

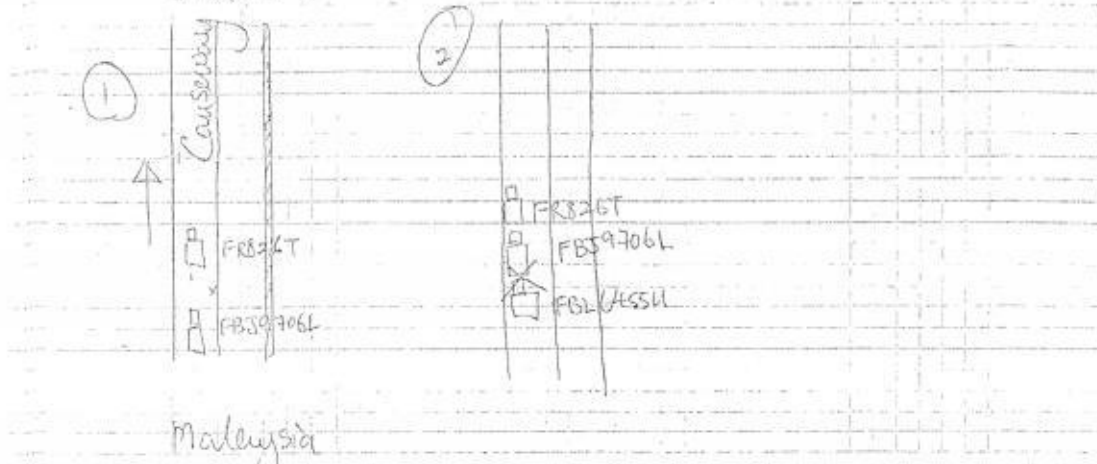
SKETCH PLAN SINGAPORE

I was riding back from Malaysia. After passing Malaysia custom, and heading back via the Causeway to Singapore, the accident happened on the Causeway ~~that~~ towards Singapore.

The motor bike in front of me, FR826T, stopped suddenly in front of me, when he noted that he dropped something on the road.

The bike behind, FB6455U rode by Ms Lee Poo Ling NRIC number 37960367H, collided with me from behind and cause me to fall on the right side.
