UNIQUE APPRAISERS SERVICE

VEHICLE NO	: SLM 6955 U	COLOUR	: Silver
MAKE/MODEL	: Toyota Senta	AIRCON	: Fitted
CHASIS NO	: NSP170-7065134	SPORTRIM	: Not Fitted
ENGINE NO	: Hidden	SEATBELT	: Fitted
MILEAGE	: 95,270 km	C/RADIO	: Fitted
ENG. CAP.	: 1,496 cc	OTHER	: -

The vehicle sustains damages to the rear portion, description are listed overleaf.

VEHICLE DAMAGE INSPECTION REPORT

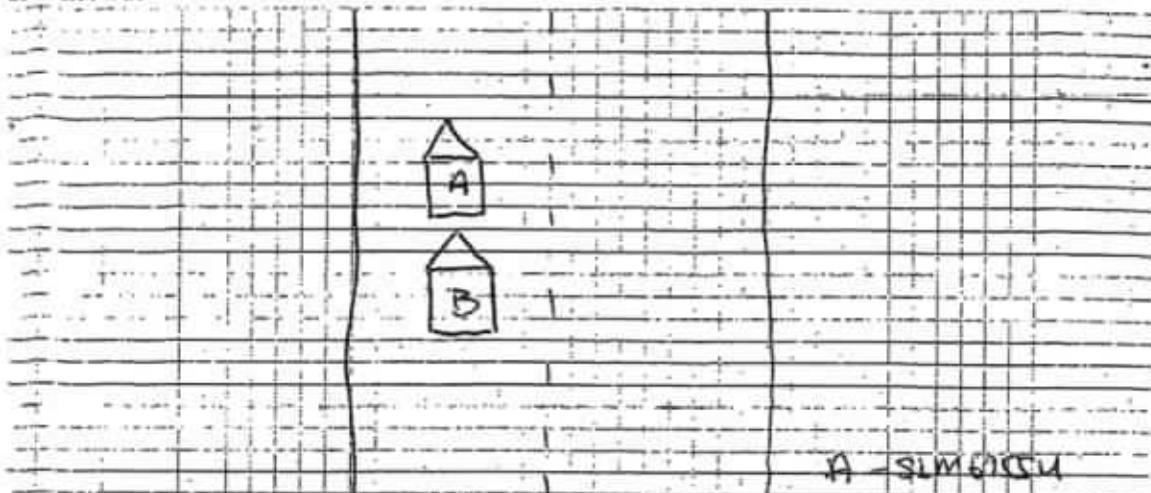
SKETCH PLAN

On Saturday 9:40am, 13/10/18 when I was stop at a traffic light along West Coast Rd. When the green lights on, I have a rear collision collision when I was moving off.

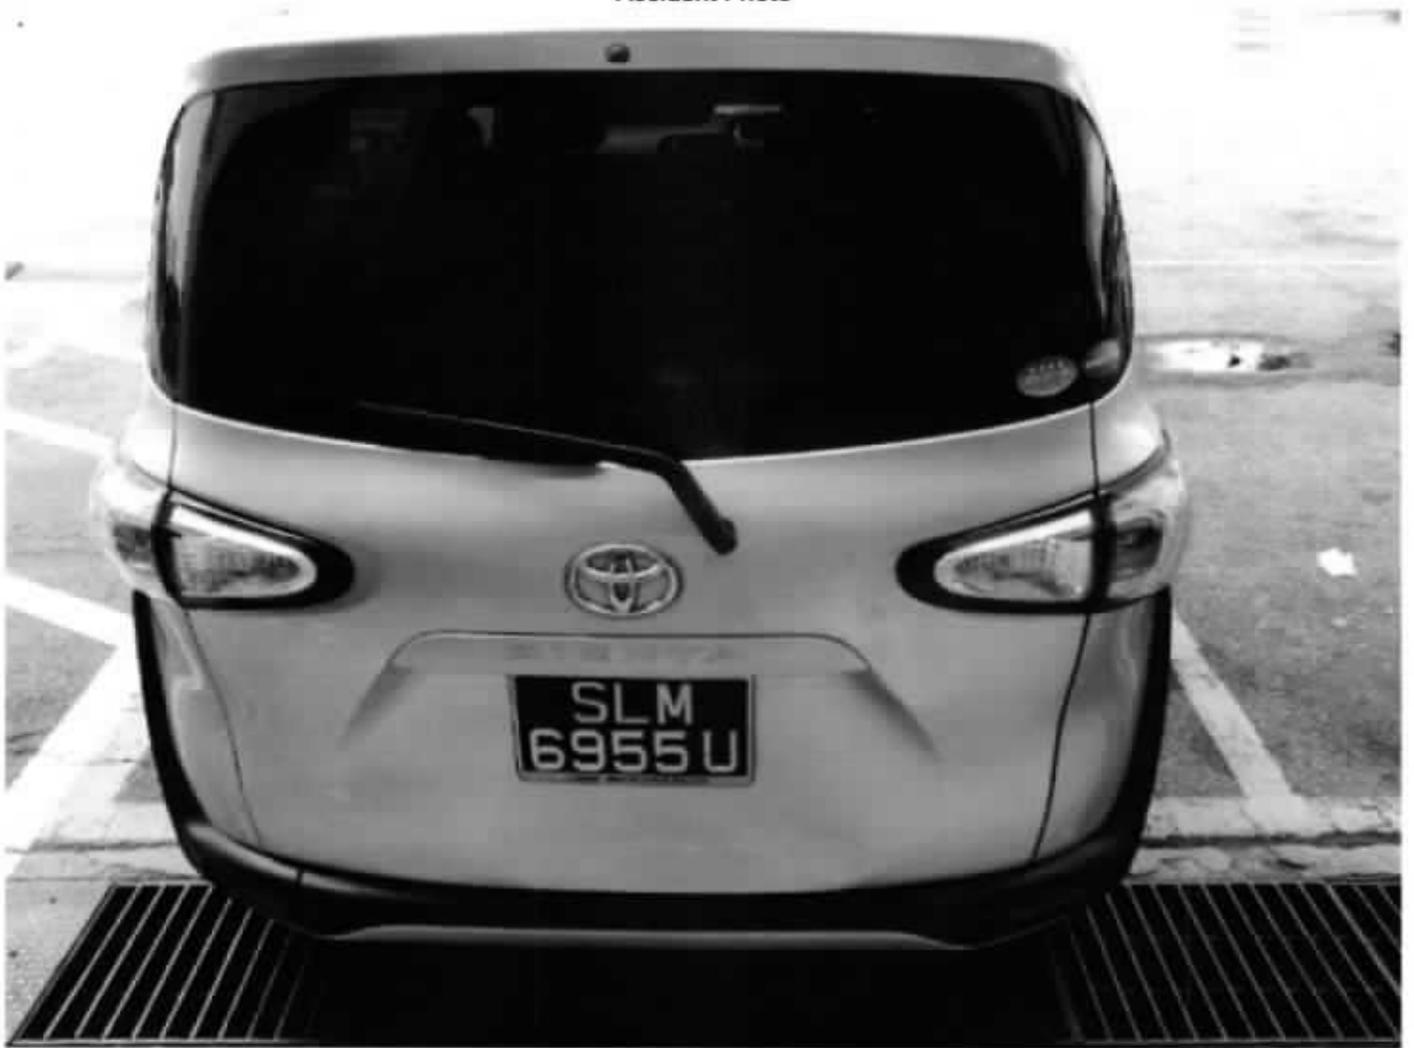
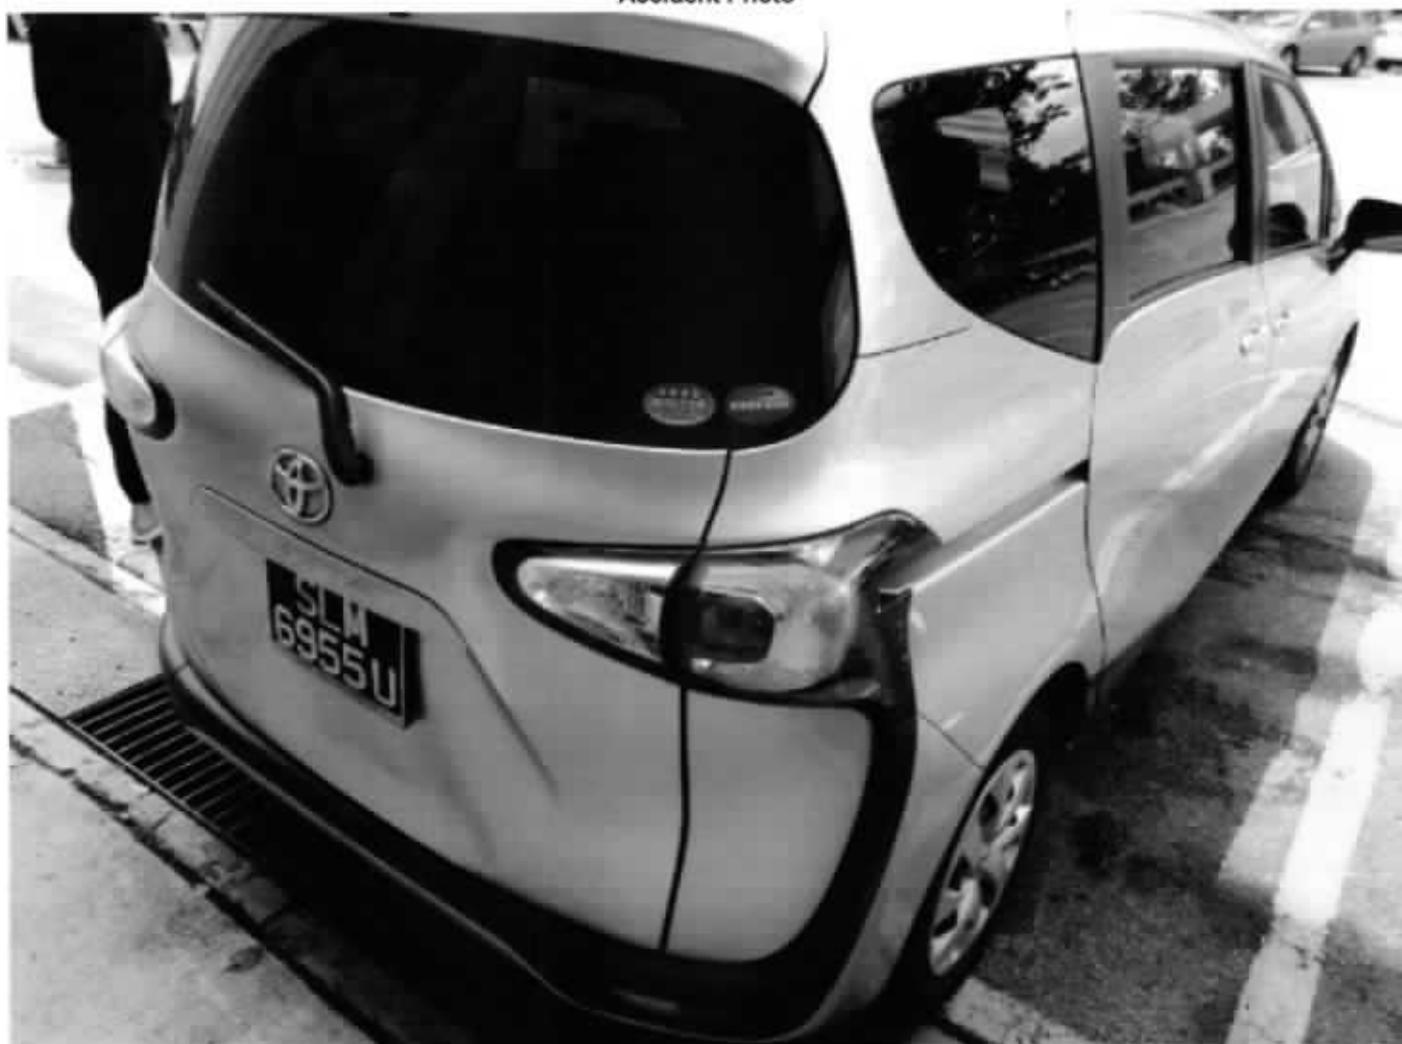
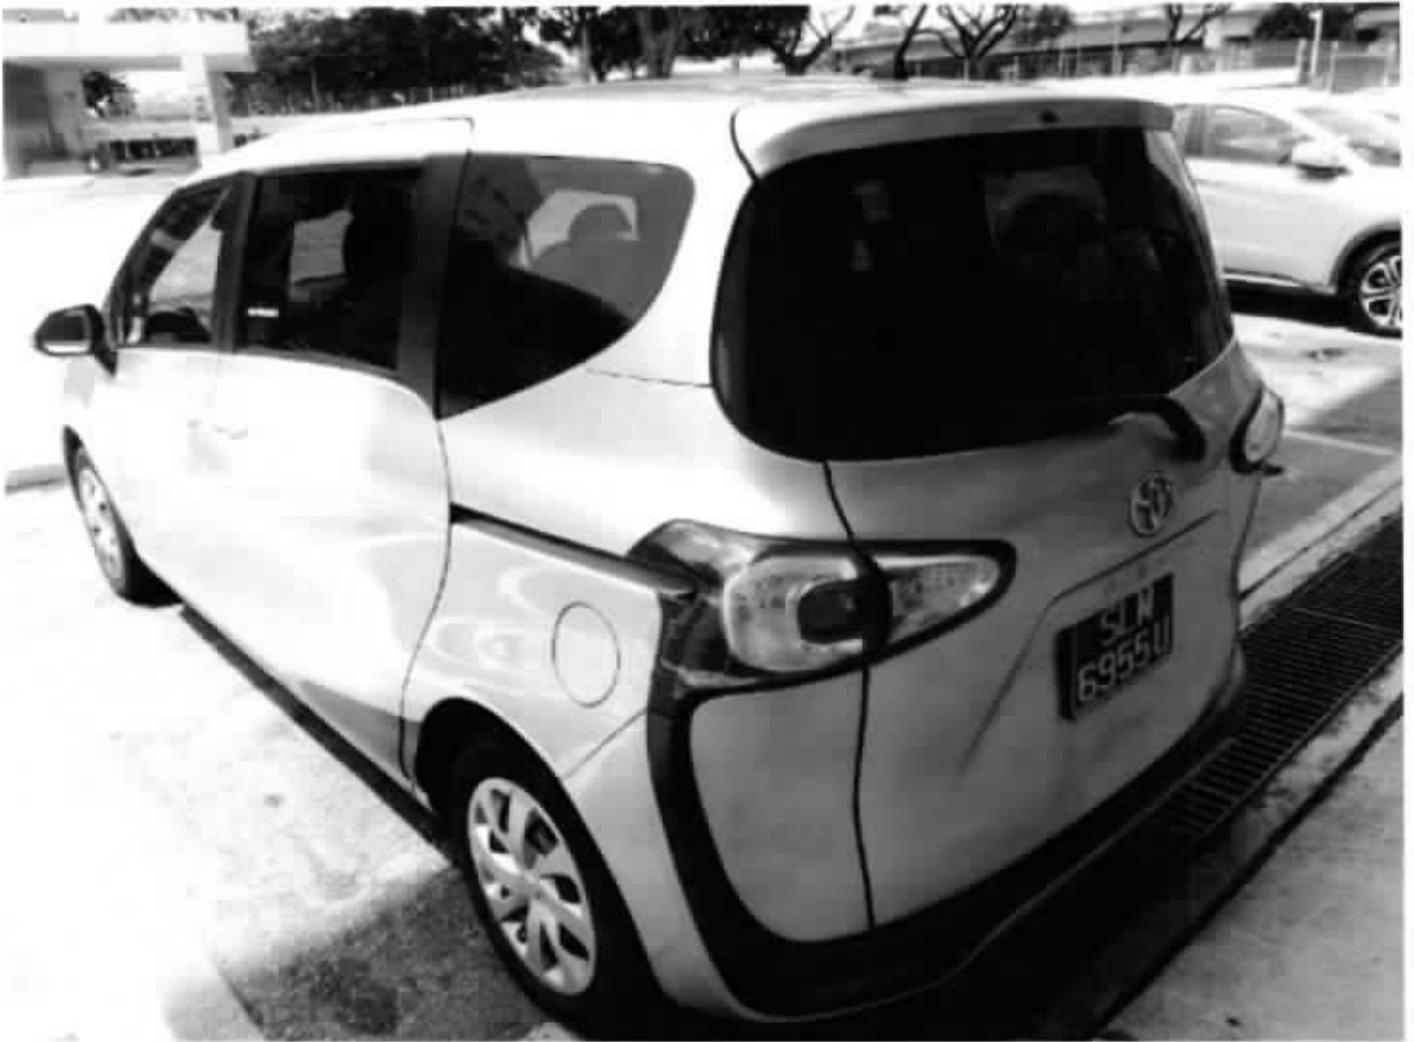
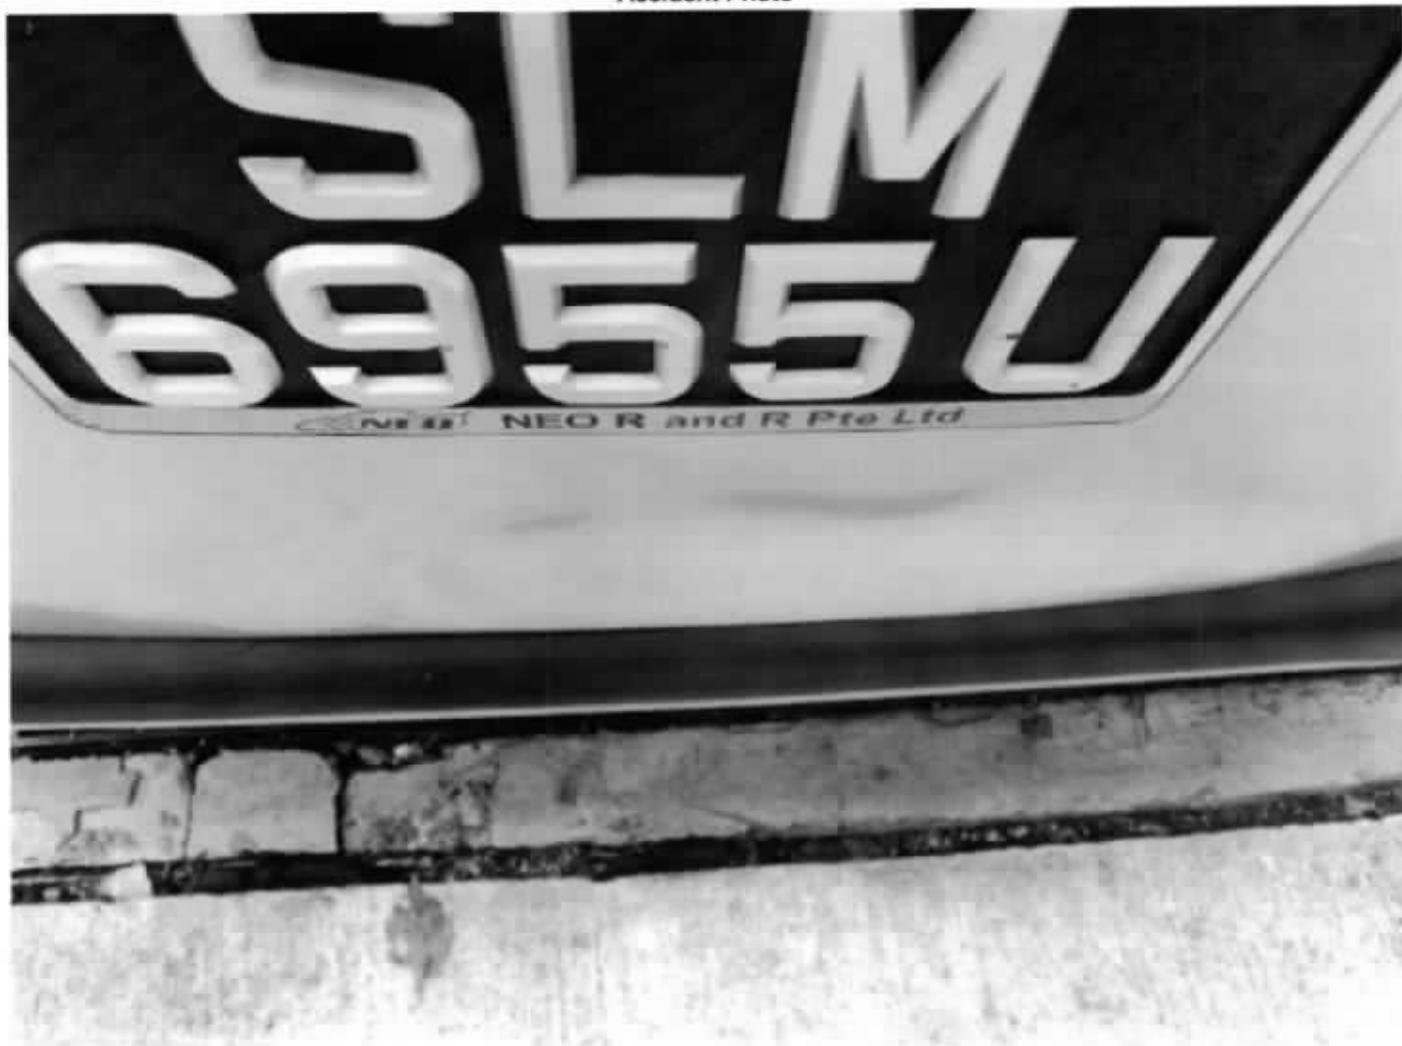
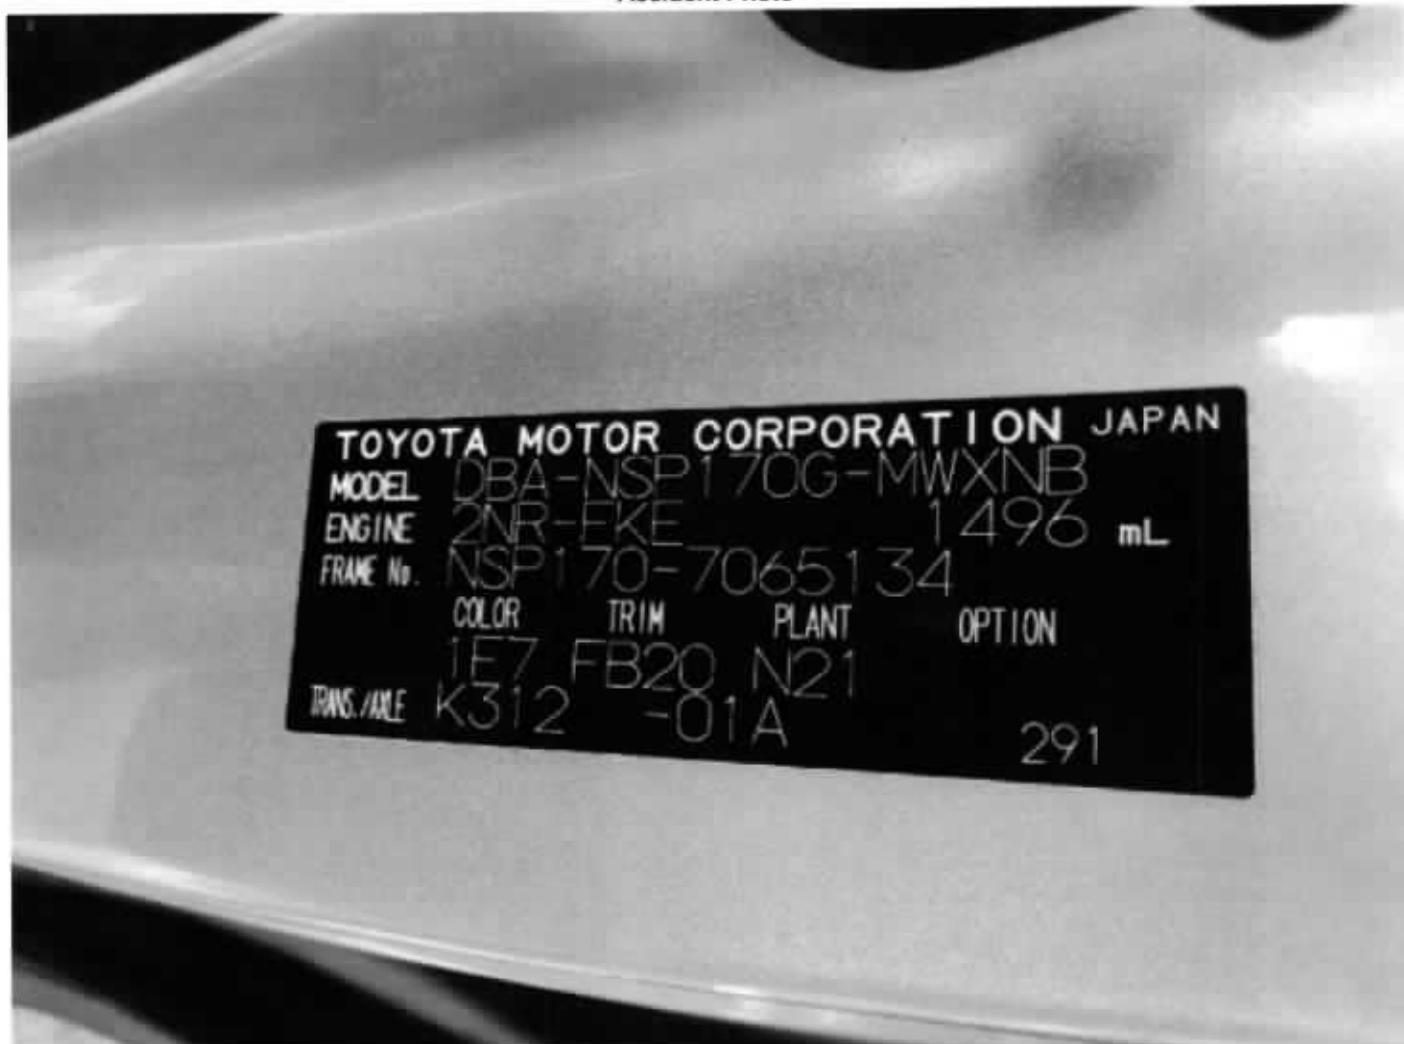
QTY	DESCRIPTION OF PARTS AND LABOUR	DESCRIPTION OF DAMAGE	REPAIR'S EST.	OUR REVISED
1 pc	rear bumper fascia	DD ✓	\$ 801.40	\$ 801.4
1 pc	rear bumper centre pad	DD ✓	721.50	721.5
2 pcs	rear bumper side pad (o/s only)	DIS ✓	524.60	262.3
2 pcs	rear bumper reflector (o/s only)	NN X	220.20	= 110.1
2 pcs	rear bumper side holder	NN X	136.00	= 136.0
2 pcs	rear bumper centre holder	NN X	136.00	136.0
1 pc	tailgate	DD ✓	1,486.80	1,486.8
2 pcs	tailgate lamp (o/s only)	DD ✓	802.40	×401.2
1 pc	tailgate centre garnish	NN X	398.10	398.1
1 pc	tailgate centre emblem	NEC ✓	99.10	99.1
1 pc	tailgate inner lock	NEC ✓	336.15	×336.15
1 pc	tailgate inner lock latch	NN X	49.20	×49.2
1 pc	tailgate weatherstrip	NN X	270.55	270.55
1 set	tailgate trim board clip	DD ✓	40.00	30 40.00
1 pc	rear o/s body panel splash shield	NEC ✓	79.10	×79.10
1 pc	rear end panel	NN X	599.10	×599.10
1 pc	rear end panel trim cover	Repair X NN X	221.10	×221.10

To putty & respray paint on affected accident sections.			\$ 1,200.00	\$ 700 1,000.00
Continue page 2.....			\$ 11,251.30	\$ 8,010.77
