CS/TMI19000254/Nsd3

Veh No: SHA 8445Y Yt Regn: 31 JUL 2018
 Type: M.Car / M.Cycle / Bus / Van / Lorry / Taxi / Prime Mover /
 Truck / Trailer or
 Make: HYUNDAI SONATA c.c. 1,991
 Colour: YELLOW A/C: Insured / Std / NI / NA
 Sp. Reading: 314,418 T/Radio: Insured / Std / NI / NA
 Eng/No: _____
 C/No: KMHE41UMBA 814777
 Gen. Cond: Good / Fair / Poor / Burnt
 Steering: Inorder / Jammed / Leaked / Burnt or
 Brake: Inorder / Jammed / Leaked / Burnt or
 Modi: Nil / S/Rim / STD A / Rim or
 Tyre Size: F: 215 / 60 R16
 R: 11

Front Rear
 R/Bal. 5 mm R/Bal. 5 mm
 L/Bal. 5 mm L/Bal. 5 mm
 D.O.A. 4/1/19 D.O.I. 4/1/19
 Survey held at CDRE LOYANG
 Des. of Damages: Frt Rear / O/S / N/S / U/C / Rooftop or

VEHICLE DAMAGE INSPECTION REPORT

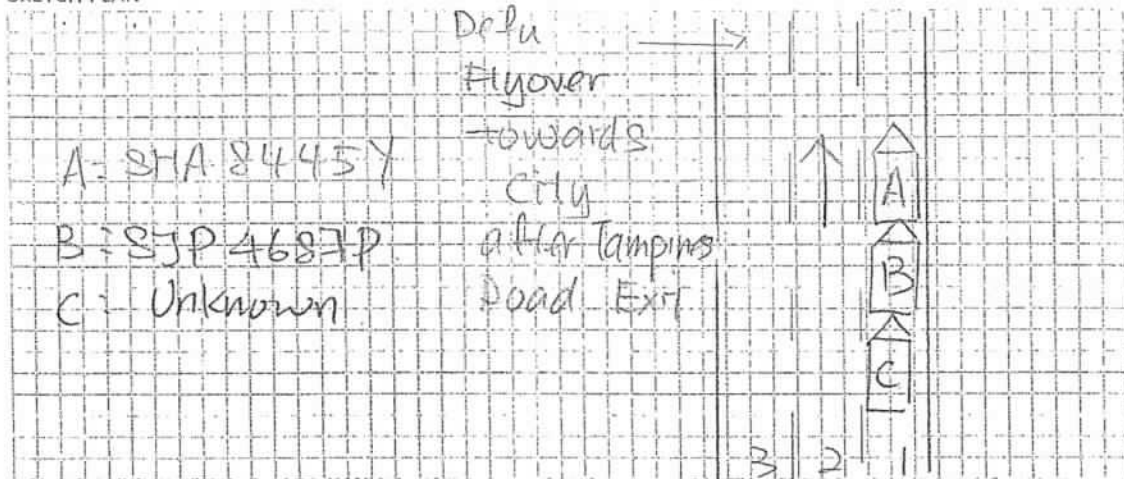
SKETCH PLAN

On 4/1/19 at about 08:30 hrs, I was driving at above said location with a female pax. Shortly veh in front braked to stopped and I follow suit. A few second later, Veh B came from behind collided onto the rear portion of my taxi. Later on I found Veh C also involved in this chain collision.

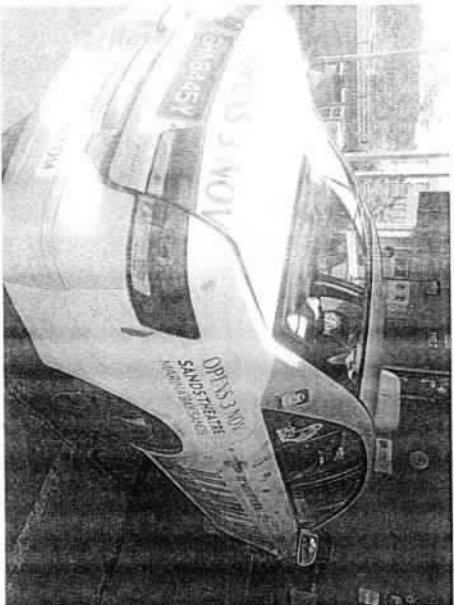
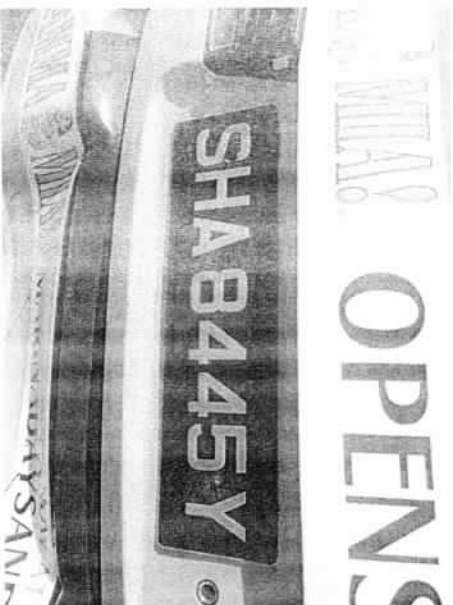
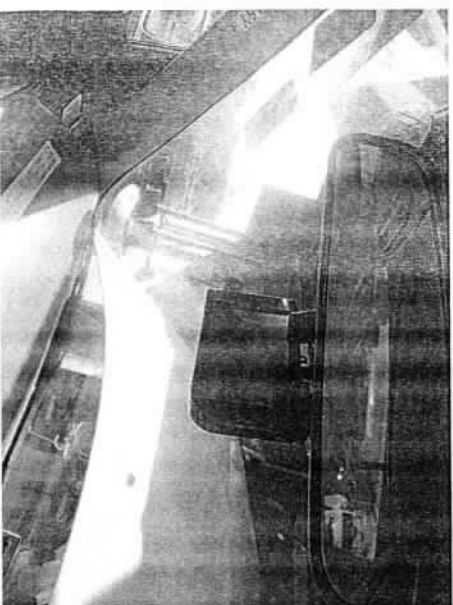
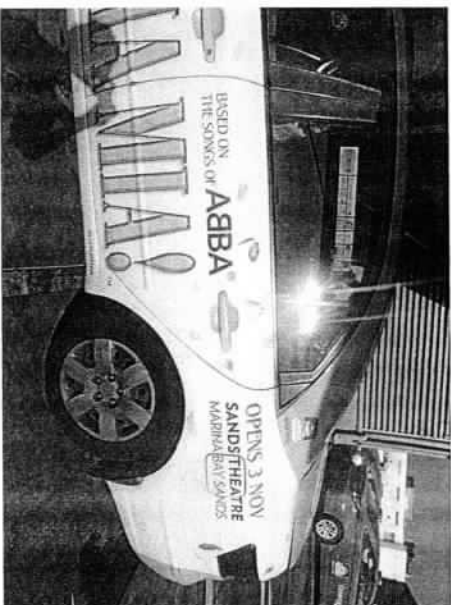
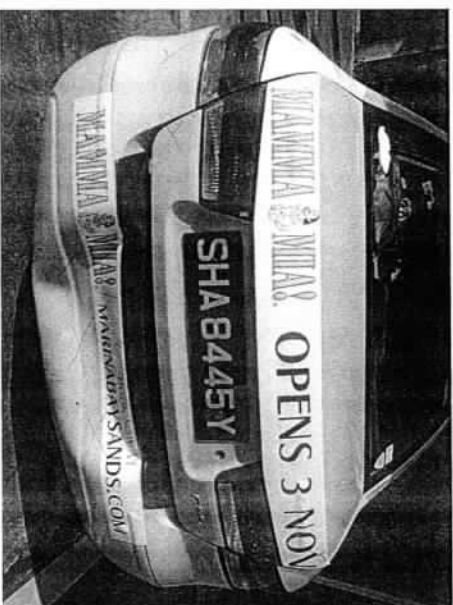
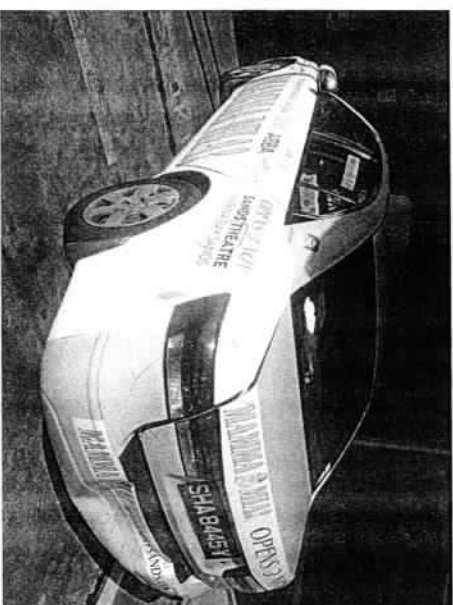
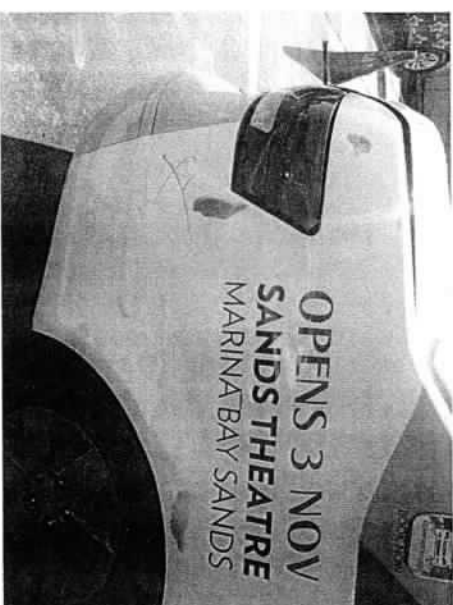
(Policy Condition)
 Remark: The veh had commenced its repair at the time of inspection.

The U/C / Chassis frame / Body Structure affected due to collision.

18/1/19 FINALIZED LUMP SUM REPAIR \$2000.00 / 4 DAYS
 21/01/19 Confirmed HS - \$2,000/- @ 4 days with Naz
 (\$3,868.02 Red - 66%)

No.	Qty	Part No.	Particulars	Condition	Repairer's	Amount
1	1		*BOOT LID	Repair	1,349.50 FL	*- FL
2	1		*BOOT LID RUBBER	Serviceable	110.90 FL	*- FL
3	1		*BOOT LID LOCK UPPER	Serviceable	132.10 FL	*- FL
4	1		*BOOT LID LOCK LOWER	Serviceable	30.30 FL	*- FL
5	1		*BOOT LID SONATA PLATE	Necessary	43.60 FL	*43.60 FL
6	1		*BOOT LID HYUNDAI PLATE	Necessary	24.20 FL	*24.20 FL
7	1		*BOOT LID H EMBLEM	Necessary	26.10 FL	*26.10 FL
8	1		*BOOT LID CRDI PLATE	Necessary	22.70 FL	*22.70 FL
9	1		*REAR BUMPER	Deformed	578.40 FL	*578.40 FL
10	1		*REAR BUMPER REINFORCEMENT	Bent	483.30 FL	*483.30 FL
11	10		*REAR BUMPER CLIP	Necessary	22.00 FL	*22.00 FL
12	1		*REAR BUMPER SPONGE	Broken	137.40 FL	*137.40 FL
13	1		*REAR BUMPER UNDERCOVER	Serviceable	185.80 FL	*- FL
14	1		*TAIL LAMP -RH	Serviceable	344.00 FL	*- FL
15	1		*REAR PANEL	Serviceable	391.80 FL	*- FL
16	1		*REAR PANEL GARNISH	Cracked	95.80 FL	*95.80 FL
17	1		*BOOT LID CITYCAB & TEL NO. STICKERS	Necessary	30.00 FS	*30.00 FS

No	Particulars	Lab.Type	Repairer's	Amount
Labour Items				
1	PANEL BEATING	New	850.00	400.00
2	SPRAY PAINTING	New	1,000.00	400.00
3	WIRING CHARGE	New	50.00	30.00
4	TUFF KOTE	New	80.00	40.00
5	REMOVE/REFIX REVERSE SENSOR	New	100.00	20.00
Gross Labour Cost (S\$)			2,080.00	890.00
