## VEHICLE DAMAGE INSPECTION REPORT

Our File No: CS3/AIG18018367/GCD3E2

Handling Insurer: AIG Asia Pacific Insurance Pte. Ltd. Policy No: 2100344323  
 Claimant Vehicle No: SFY5088L Insured Vehicle No: SKK2858R  
 Date of Loss: 05/10/2018 Nature of Claim: TP Claim No: 1495507370SG

## ADJUSTMENT ON REPAIR COST FOR VEHICLE NO. SFY 5088L

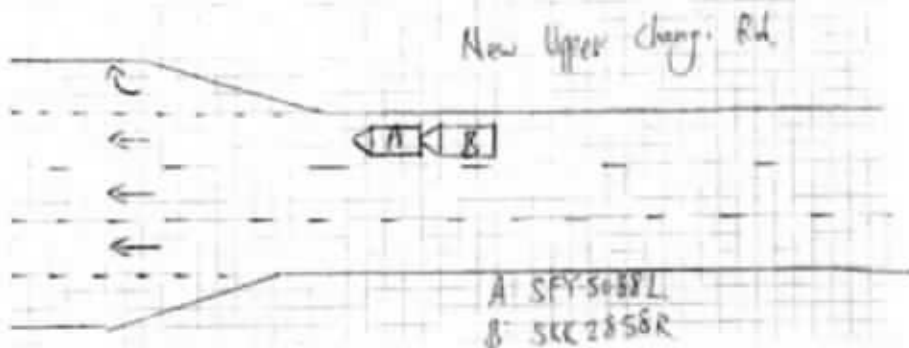
### SKETCH PLAN

I was driving along New Upper Changi Road and stop at traffic junction due to Red light, car skid and bang into my back and stop.

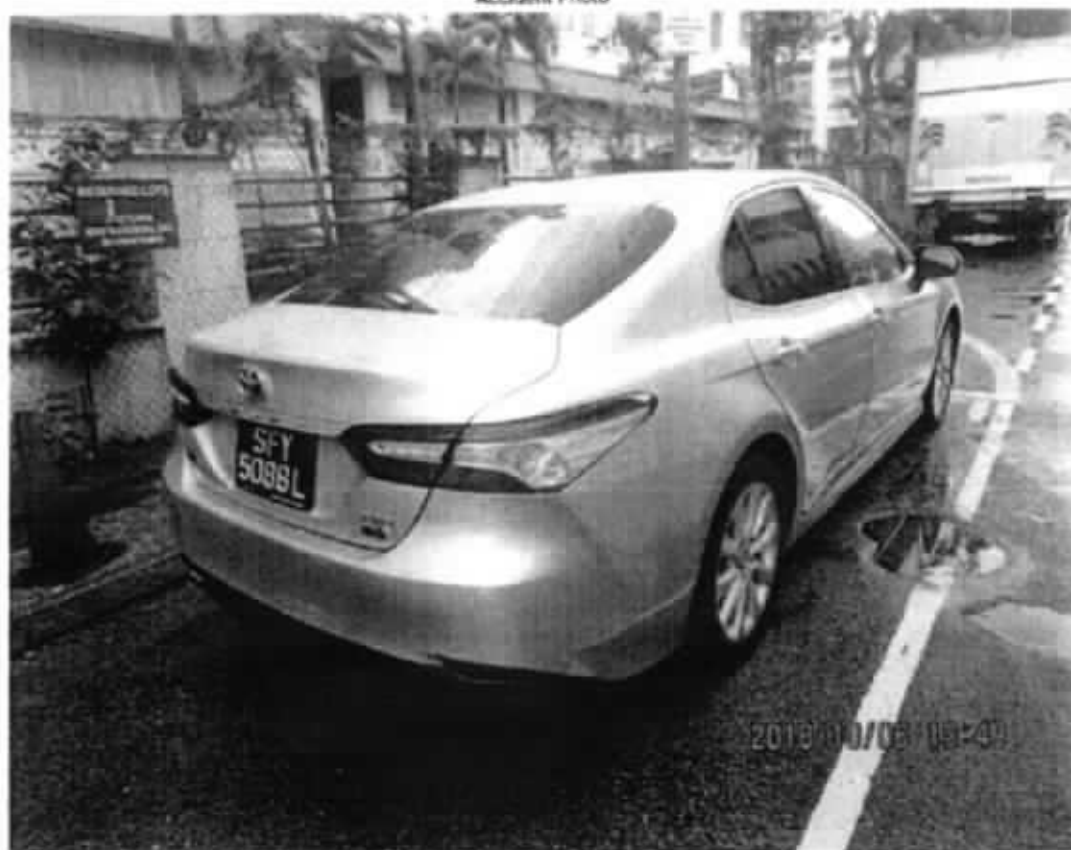
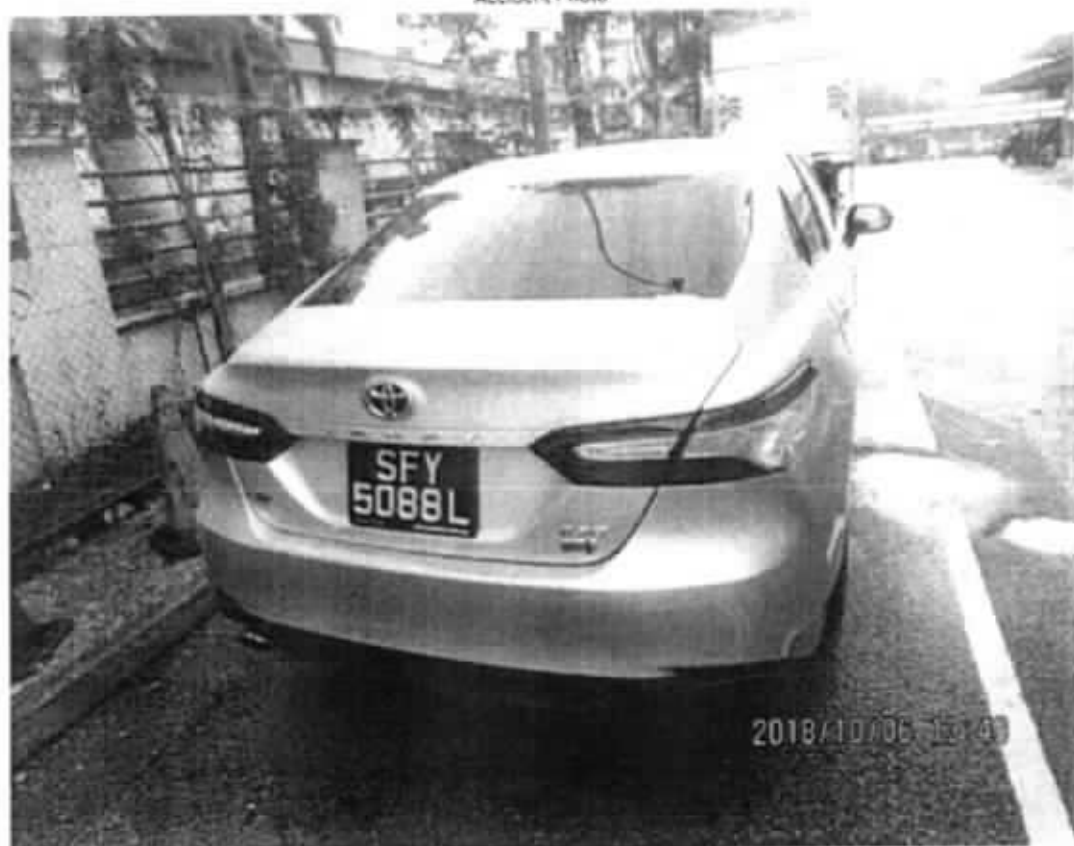
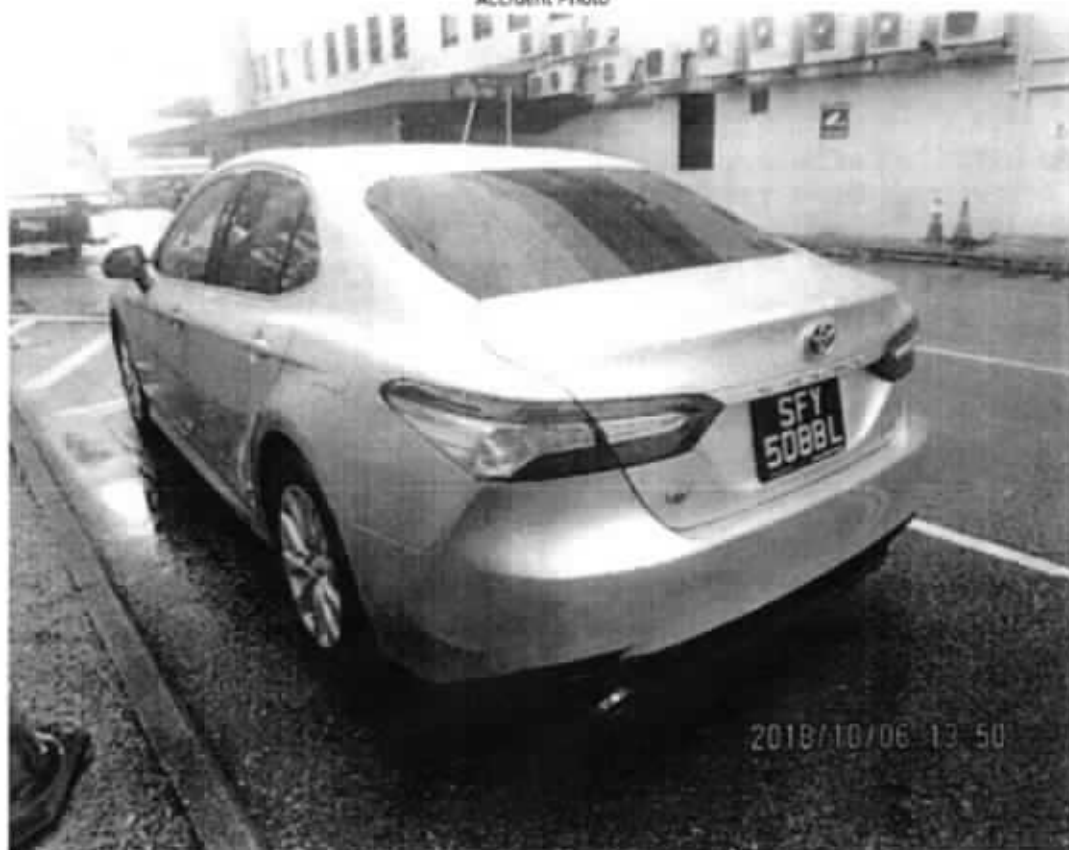
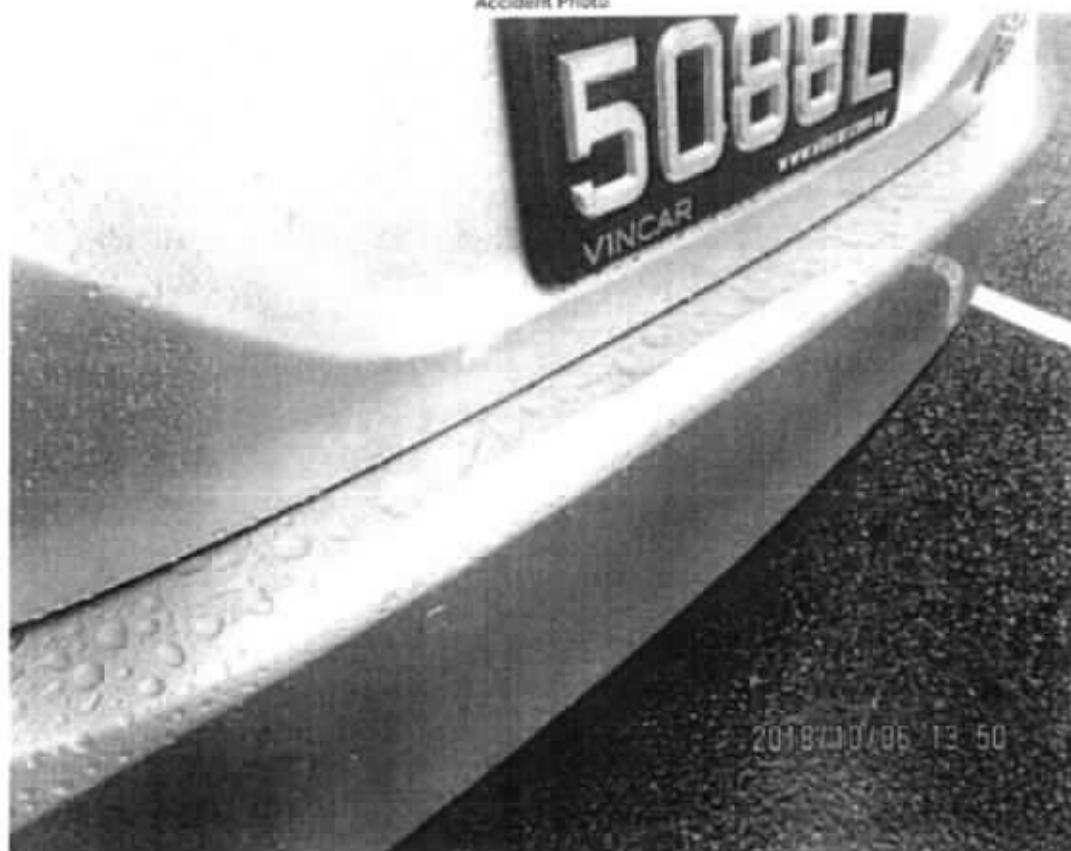
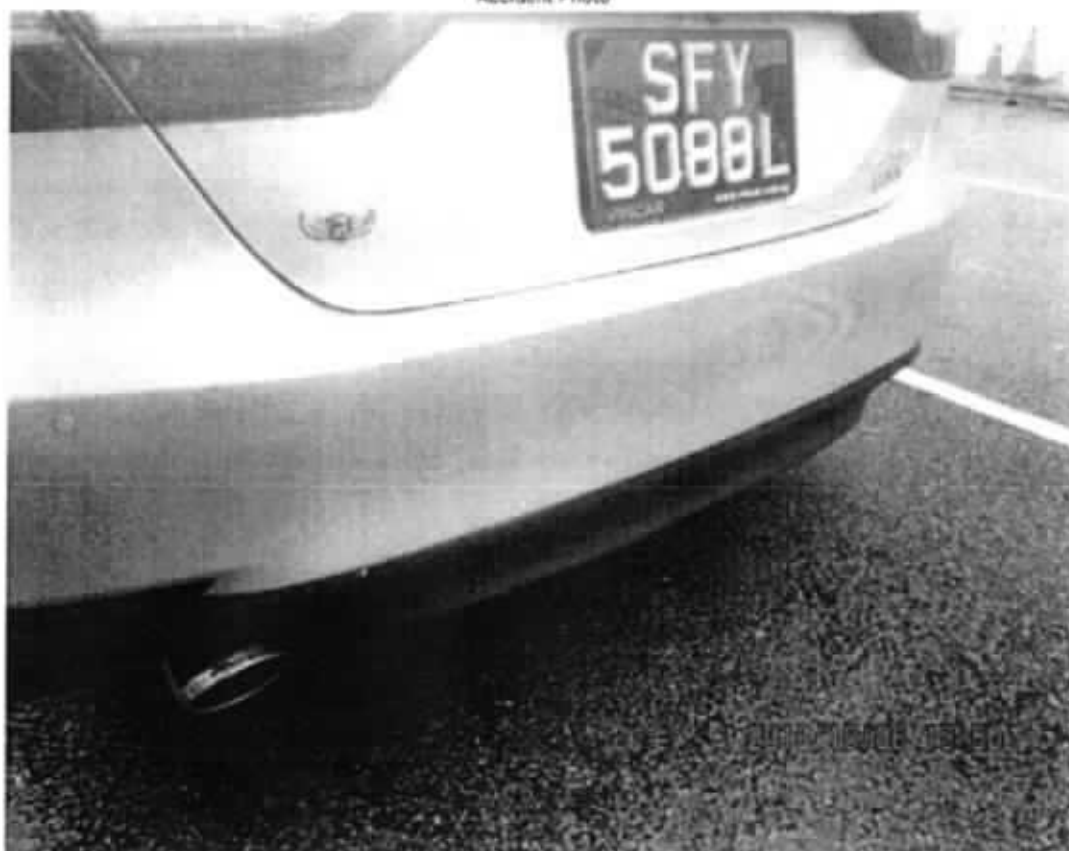
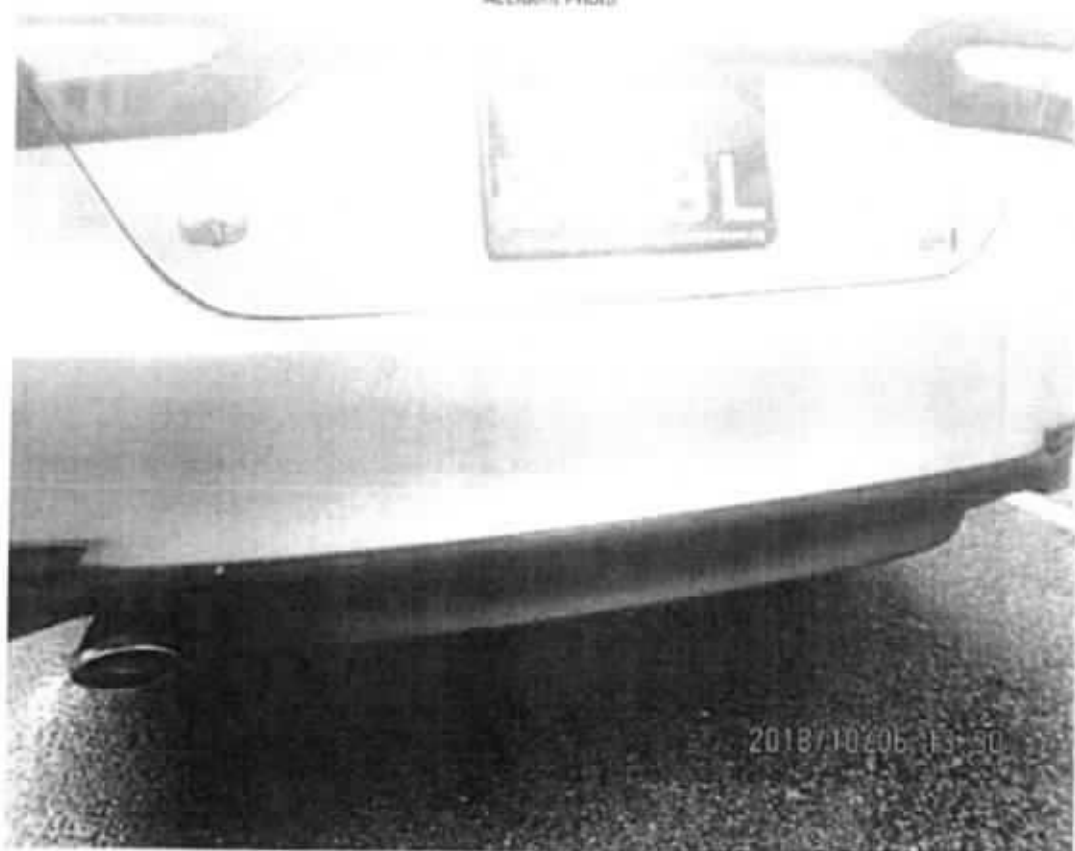
The damages sustained on the vehicle were apparently confined at its rear portion.

Our assessment to reinstate the vehicle is **\$7488.00** revised amount of the repairer's estimate of **\$11016.00**. The aforesaid recommendation, in our opinion, is fair and reasonable for the restoration of the vehicle to its pre-accident condition.

However, after taken into consideration the age and condition of the vehicle and the availability of the recondition components and to economize the repair, we therefore recommend a contract **Lump Sum** at **\$6400.00** corresponding to supply of parts, labour and spraypainting charges.

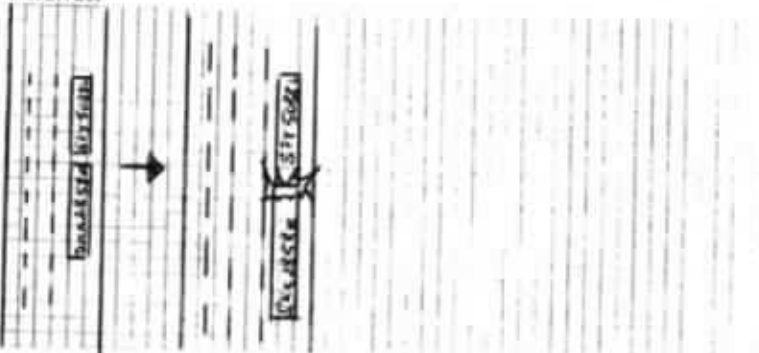
SKETCH PLAN

After leaving British Mall, I was driving along Upper Chancery Road at the right hand lane. There was a queue, so I stopped my car (SHE 225RN) behind SEY 508RY. When I noticed the traffic ahead of me started to move, I pressed my accelerator & hit SEY 508RY. It was a small impact. My car (SHE 225RN) sustained no damage (see photos). The bumper of SEY 508RY sustained some cracks near the left rear sensor (see photos). At the time of my accident, my son, David Wong was in the car with me.
