VEHICLE DAMAGE INSPECTION REPORT

Our File No: CS/CTI19000486/JQD3E2

Handling Insurer:	China Taiping Insurance (Singapore) Pte. Ltd.	Policy No:	DMCVSN30546818000
Claimant Vehicle No :	SLN8927H	Insured Vehicle No :	GBE277T
Date of Loss:	02/01/2019	Nature of Claim:	TP
		Claim No:	GBE277T

Reg No:	SLN8927H	Engine No:	2ZRS048670
Make & Model:	TOYOTA PRIUS, 1.8 HYBRID CVT (A)	Chassis No:	JTDKB3FU903558880
Reg. Date:	22/05/2017 (Man. Year: 2017)	Odometer:	132310 km
Colour:	Silver		
Engine Capacity:	1798 cc		
Market Value/New Car Price:	N/A		
Sum Insured (\$\$):	Market Value/New Car Price

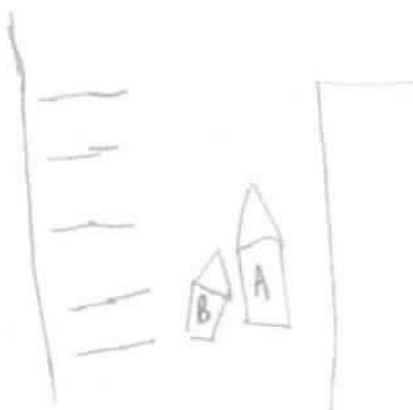
Sketch Plan

A. SUN8907H
B. GBE 277T

On 2/1/19, 7:55am I was travelling straight towards Ager Rajah community club
Out of sudden, a white GBE333T release without signalling and hit on my left side car
