VEHICLE DAMAGE INSPECTION REPORT

Our File No: CC3/MSG19000785/UTD3E2

Claimant Vehicle No: SKS7311B

Make & Model: TOYOTA ALPHARD, 2.4 CVT (A)

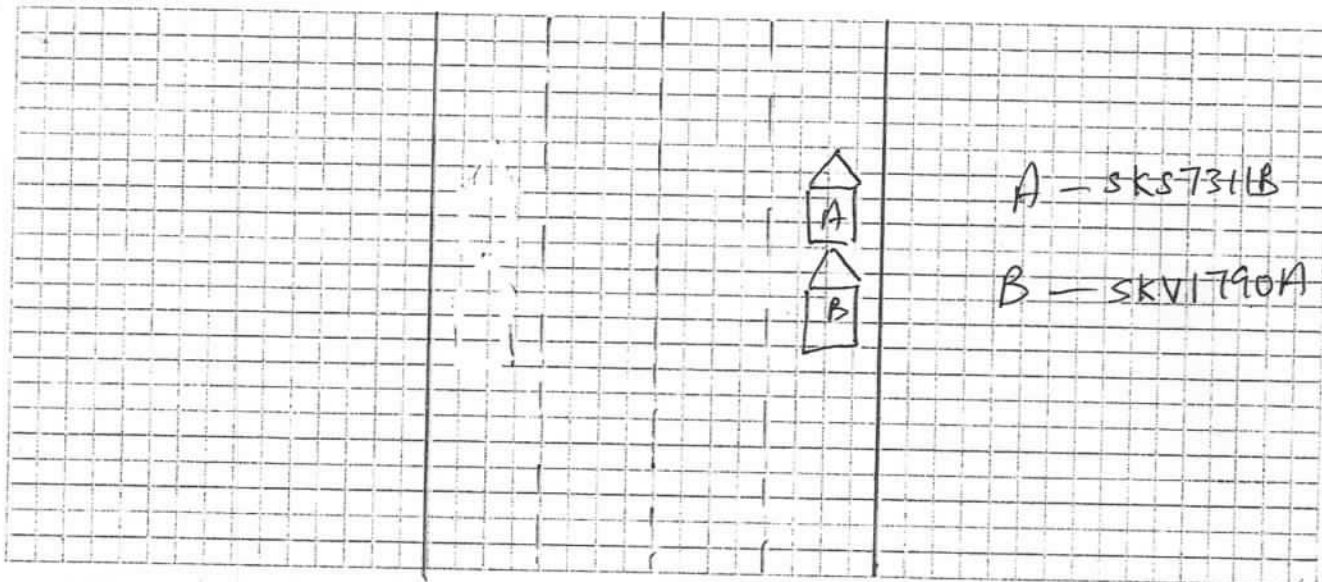
SKETCH PLAN

on the stated date and time I was driving my vehicle
A along telok Blangah. I stop my car due to amber light
suddenly vehicle B hit on my rear portion.
