Veh No: **SLM 72224** Yr Regn: **2017 HPL**  
 Type: **C** M Car / M Cycle / Bus / Van / Lorry / Taxi / Prime Mover /  
 Truck / Trailer or  
 Make: **TOYOTA WISH 1.8 CVT** C.C: **1798**  
 Colour: **WHITE** A/C: Insured / Std / NI / NA  
 Sp. Reading: **-** T/Radio: Insured / Std / NI / NA  
 Eng/No: \_\_\_\_\_  
 C/No: **J706h2awx0 300 655**  
 Gen. Cond: Good / **C** / Poor / Burnt  
 Steering: **C** In order / Jammed / Leaked / Burnt or  
 Brake: **C** In order / Jammed / Leaked / Burnt or  
 Modi: Nil / S/Rim / STD A/Rim or  
 Tyre Size: F: **145/65R15**  
 R: \_\_\_\_\_  
 BS / DUN / EXNOVA / **C** GT / FS / LIZA / MIC / OHTSU / PIR / SUMI /  
 TOYO / YOKO or  
 Front: \_\_\_\_\_ Rear: \_\_\_\_\_  
 R/Bal: **6** mm R/Bal: **6** mm  
 L/Bal: **6** mm L/Bal: **6** mm  
 D.O.A: **14/01/19** D.O.I: **16/01/19**  
 Survey held at: **GOLDBELL**  
 Des. of Damages: Frt / Rear / O/S / N/S / U/C / Rooftop or

**0/3 FR**  
 The U/C / Chassis frame / Body Structure affected due to collision.

## VEHICLE DAMAGE INSPECTION REPORT

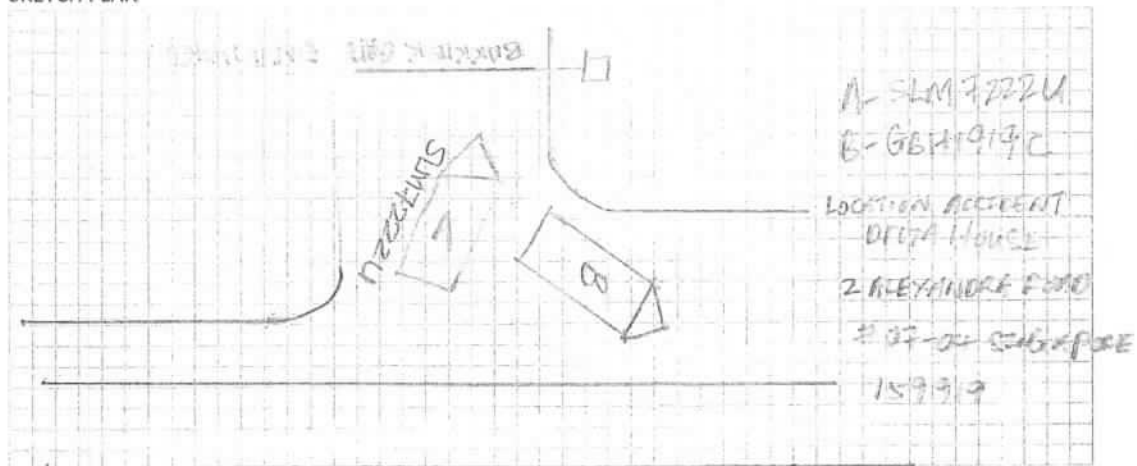
SKETCH PLAN

DESCRIBE CIRCUMSTANCES OF THE ACCIDENT

TIME AROUND 15.30HRS TO 16.30HRS.

I DRIVING TO DETA HOUSE AT THE MAIN ENTRANCE. NOTICE A VAN GBH 1919C ~~STATION~~ THE SITE OF THE ROAD. ~~STATION~~.

DRIVING TO THE BARRIER, NOTICE A VAN IS REVERSEING. I quickly stop the car and press HORN AT THE VAN. AS THE VAN STILL ~~REVERSEING~~ <sup>REED</sup> REVERSEING. IN THE END, THERE A loud BANG ON my driver sit. DRIVER SIT SCREEN, ~~AND~~ MIRROR, door AND STE SIT damage. AFTER THE GBH 1919C DRIVER DRIVE AWAY ~~ON~~ THE SPOT. AS I STATION AT THE GATE MANAGE TO OPEN MY CAR DOOR TO TAKE PHOTO.
