SLG 3721D

SNM19D200227C02/5

Make: Honda Shuttle c.c. 1496

## VEHICLE DAMAGE INSPECTION REPORT

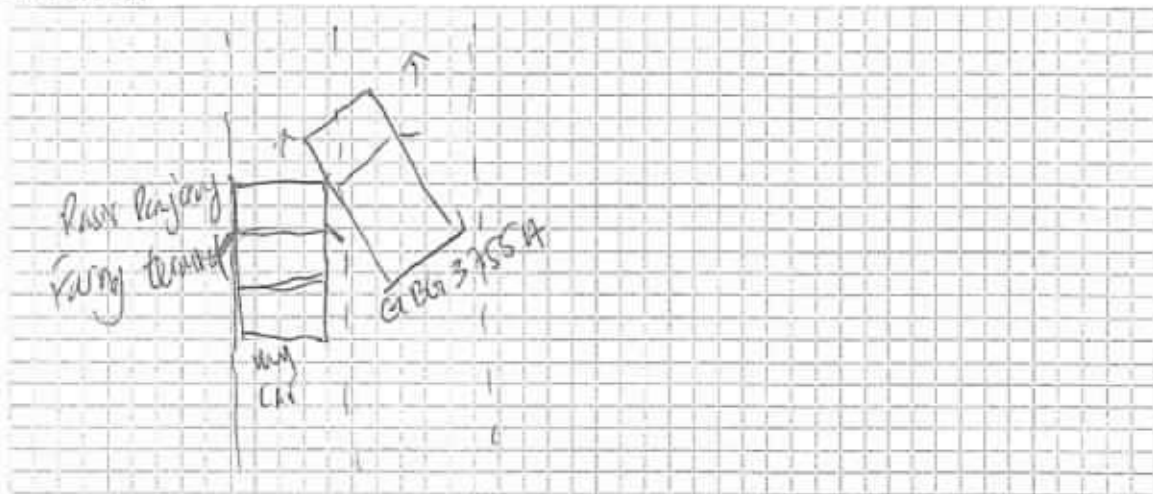
SKETCH PLAN

After dropping passengers at Pasar Panjang Ferry terminal  
 I release my <sup>brake</sup> to allow my car to row forward.  
 Then suddenly van GB613755A cut into my lane at  
 fast speed with impact to the right front corner of  
 my car. ~~it~~ <sup>brake</sup> ~~did~~  
 I ~~brake~~ immediately but the van ~~did~~ not  
 stop immediately until it so close that the side ~~mirror~~ of  
 my car was also scratched.
