MOTOR SURVEY ASSIGNMENT**Date** 16-01-2019 **Our Ref No.** D19000461MFSH**Accident Date** 07-01-2019 **Claim Type.** Third Party**Insured Vehicle** SHD6687M **Third Party Vehicle.** SCY5550D**Survey Location** 1 KAKI BUKIT AVENUE 6 #01-46/48/50AUTOBAY**Contact Person.** NANCY LAM**Contact No.** 67465405/ 0 **Fax No.** 67458520**Survey Type** WITHOUT PREJUDICE: LIABILITY UNCLEAR:**Appointed Surveyor** LKK AUTO CONSULTANTS PTE LTD**Contact Person** NA **Fax No.** 68416315**Contact Number.** NA**FOR DIRECT SETTLEMENT**

1. Policy Particulars :- THIRD PARTY CLAIM				
Insured Veh.	SHD 6687M	Veh. Inspected	SCY 5550D	
Policy No.		Coverage (\$)	0.00	
Claim No.	D19000461MFSH	Excess (\$)	0.00	
Assign From	JOANNE YONG	Assign Date	16/01/2019

4. Description of Damages				
THE VEHICLE SUSTAINED DAMAGES AT THE O/S FRONT PORTION.THE UNDERCARRIAGE AFFECTED DUE TO COLLISION. DAMAGES SEE DETAILS.

ADJUSTMENT ON REPAIR COST FOR VEHICLE NO. SCY 5550D

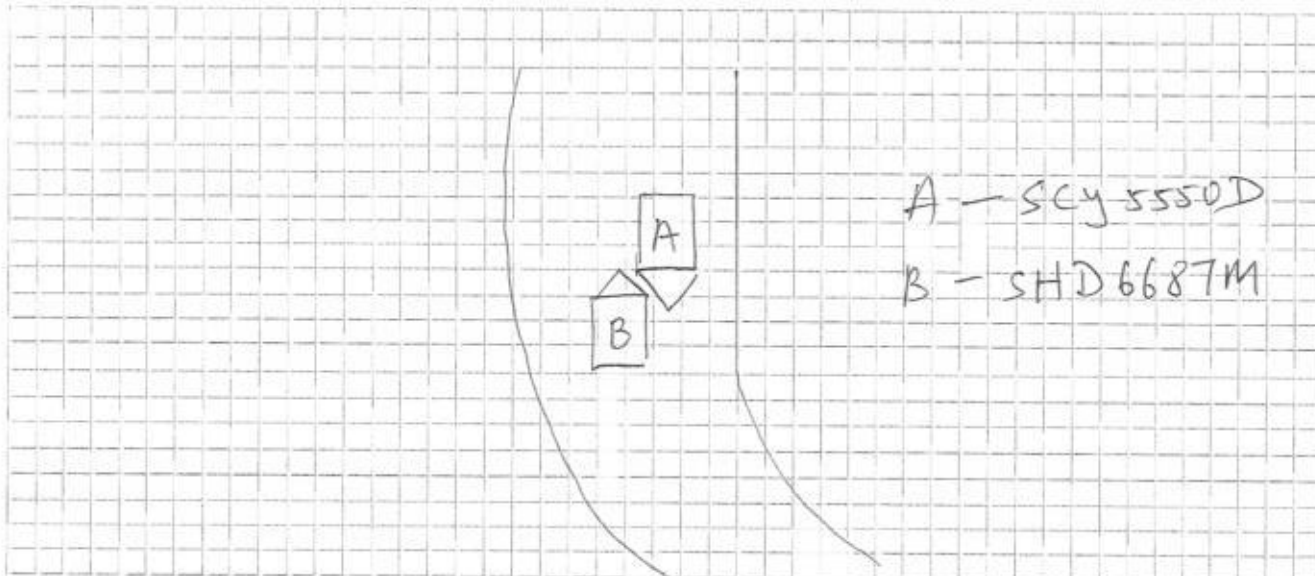
SKETCH PLAN

On the stated date and time, I was driving my vehicle A at BLK 124 Greyland East Ave 1 open carpark. I stop my car to wait for on coming taxi to pass through, suddenly he hit on my RH side portion.
